**Phase 1: Rapid Assessment and Evaluation  
Of Restoration Options at State Parks  
Affected by Hurricane Michael  
Task Assignment No.: FN-016  
Contract No.: 10109**

**Draft Interim Report to the Florida Park Service  
Department of Environmental Protection**

February 2019

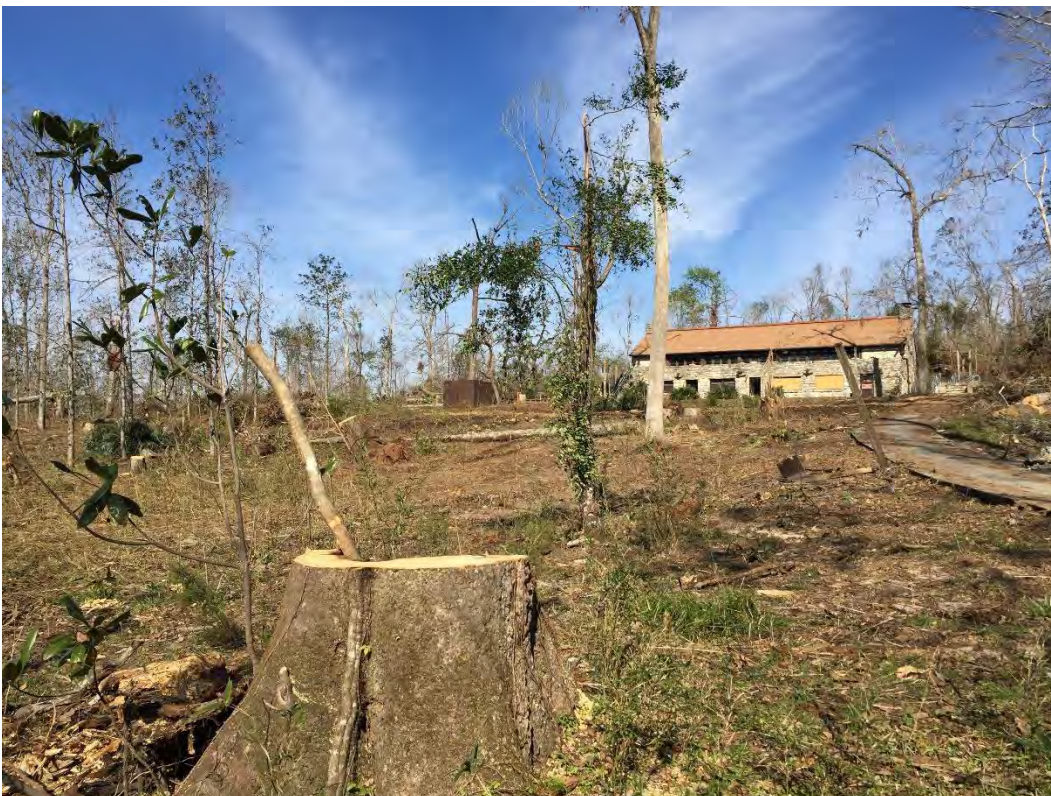
The upland hardwood forest surrounding the Visitor Center has also already been cleared of downed trees near the building, sidewalks, and parking lot (Figure 12). This upland hardwood forest, which was once occupied by large hardwoods, now has an open canopy. Tree replanting of this area may be needed; we recommend an assessment of existing small/understory tree stock to determine whether or not additional planting is needed.

*Figure 12. Visitor Center and surrounding forest after Phase 1 clearing. Large southern magnolia tree stump in the foreground.*

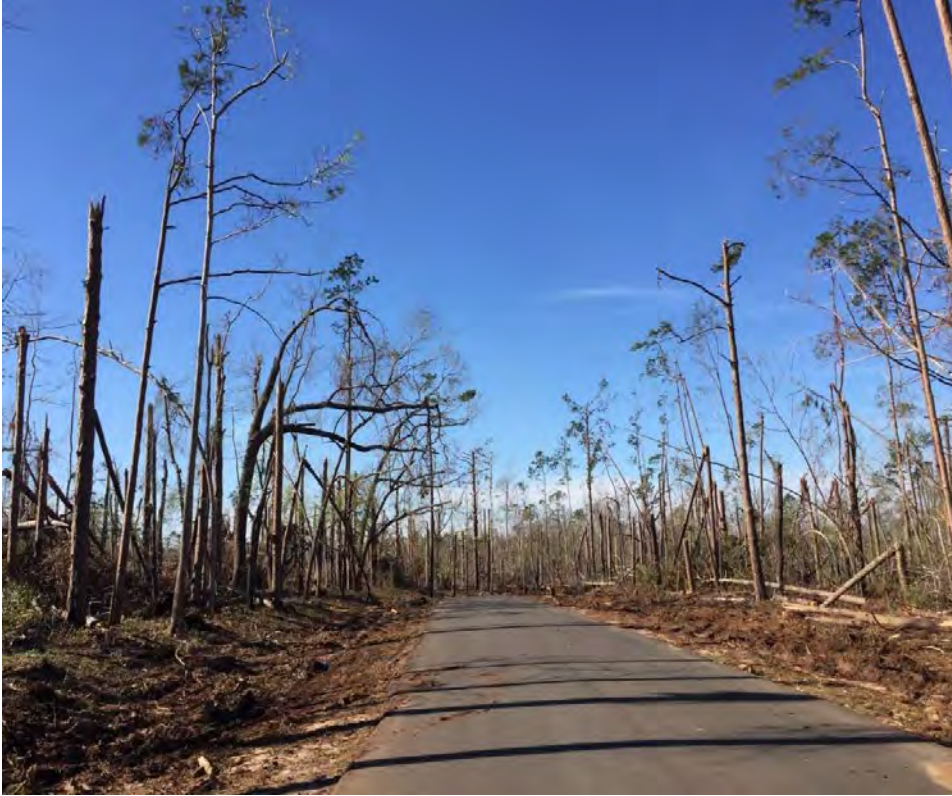
*Figure 13. The zones along the entrance drive. Trees along the road shoulder have been removed. Pines are the majority of the trees remaining standing in this historic upland pine area.*

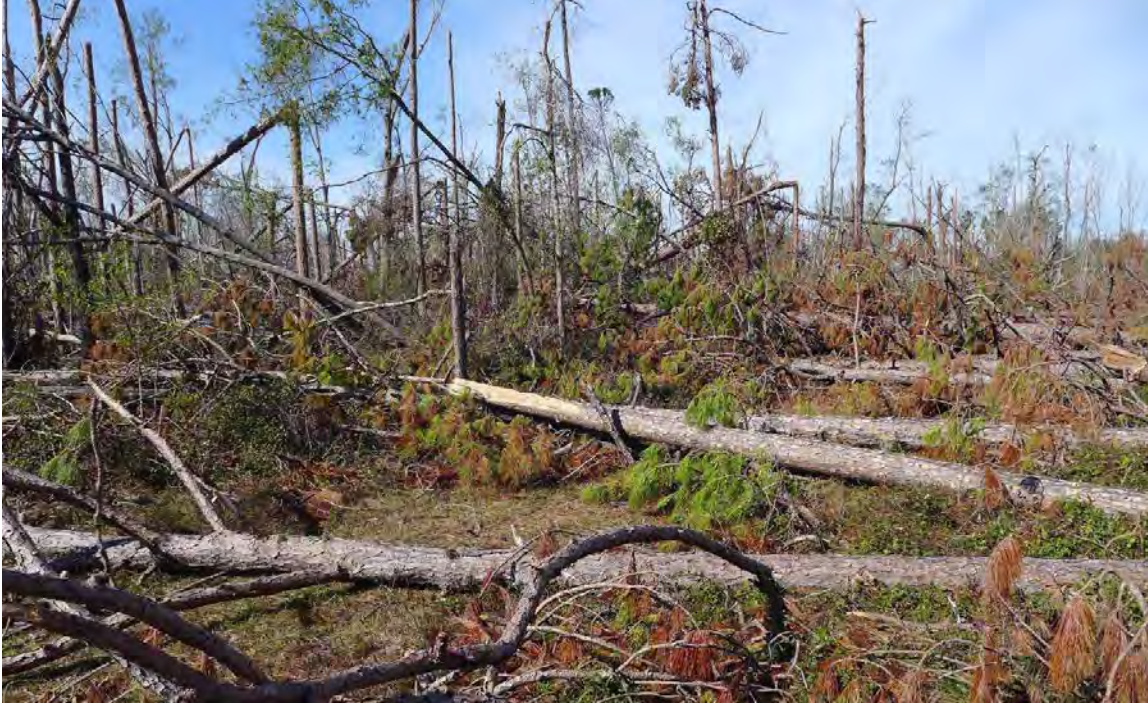
Figure 15. Longleaf pines near the property line just north of the park entrance damaged during the storm.

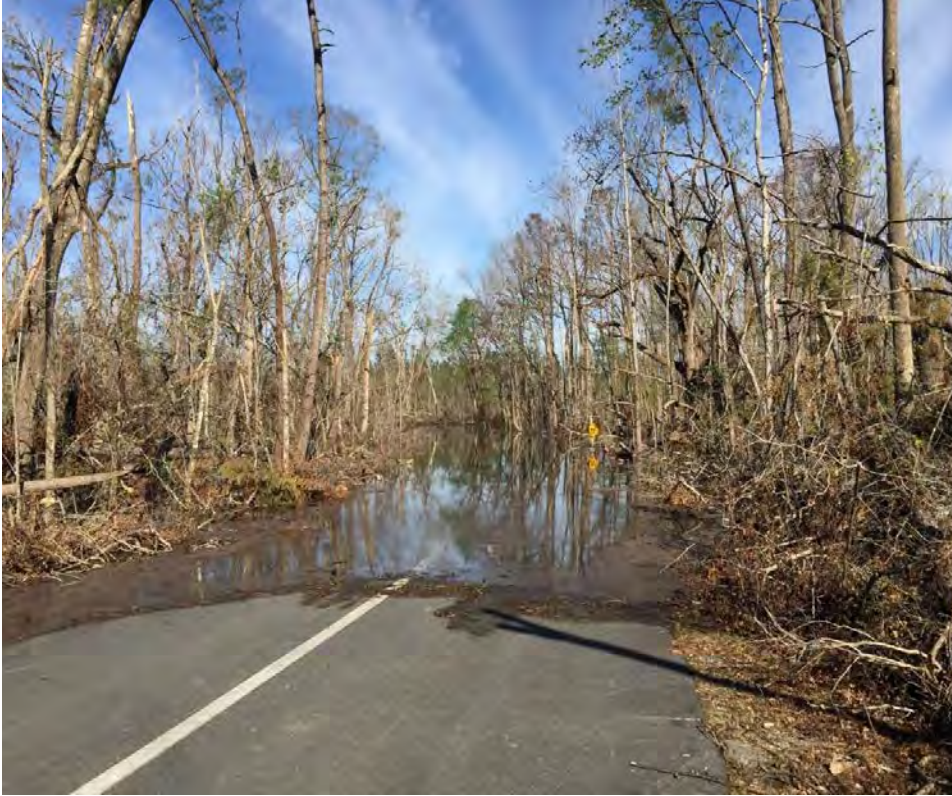
*Figure 16. Flooding along Muddy Branch taken in the bottomland forest along the entrance drive. Flooding extended almost to the upland hardwood forest.*

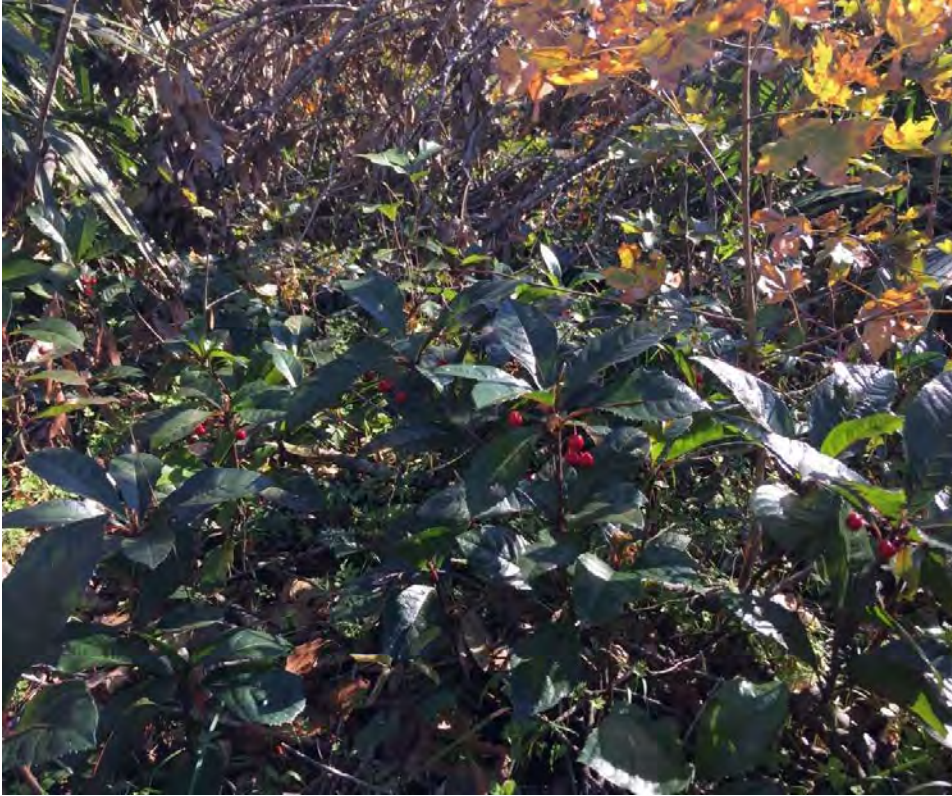
*Figure 19. Japanese ardisia observed fruiting after the storm in the southwest portion of Zone 8.*

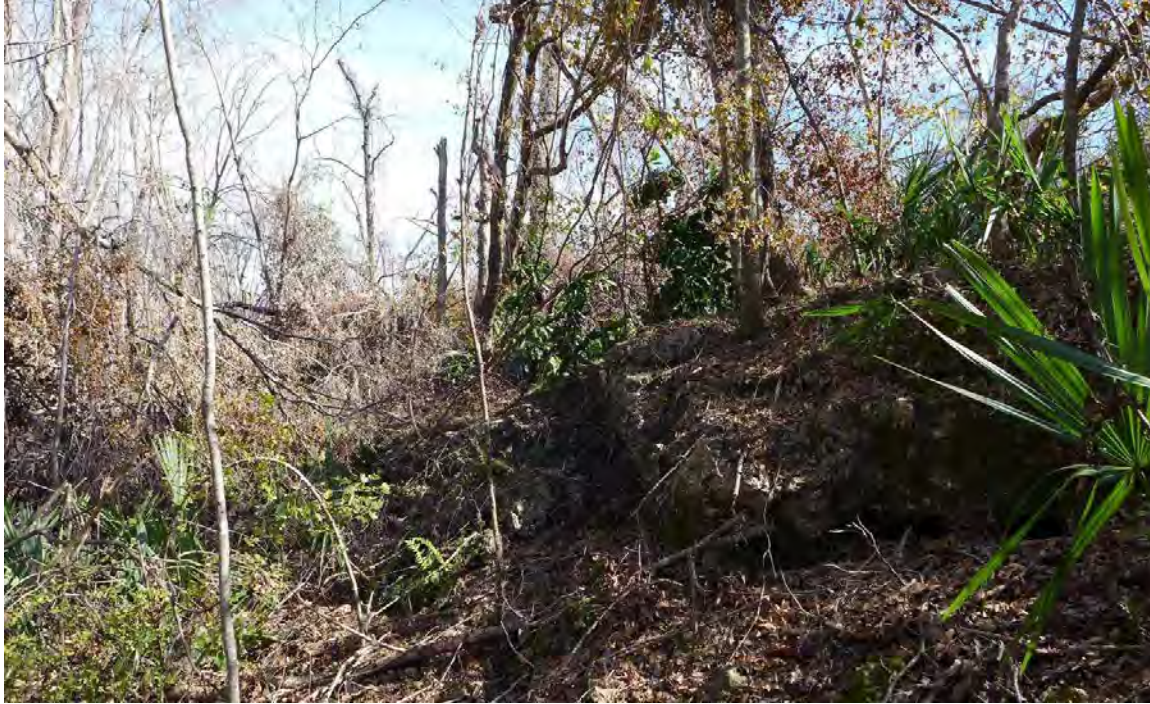
*Figure 20. Intact limestone outcrop in Zone 11 with significant canopy damage over it.*

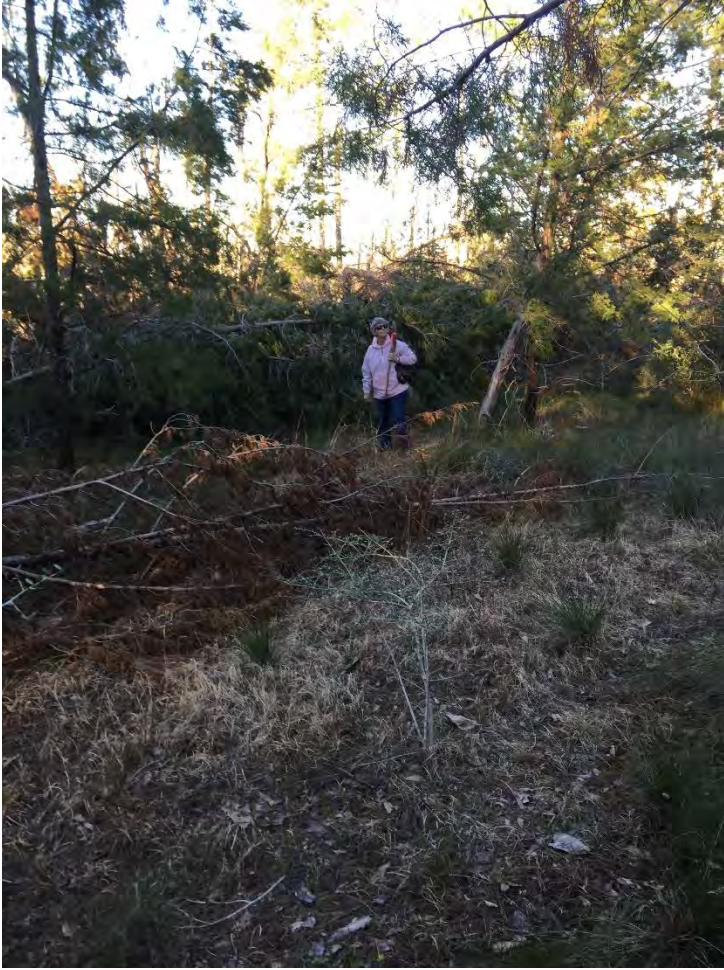
Figure 21. Downed cedar trees on the upland glade.

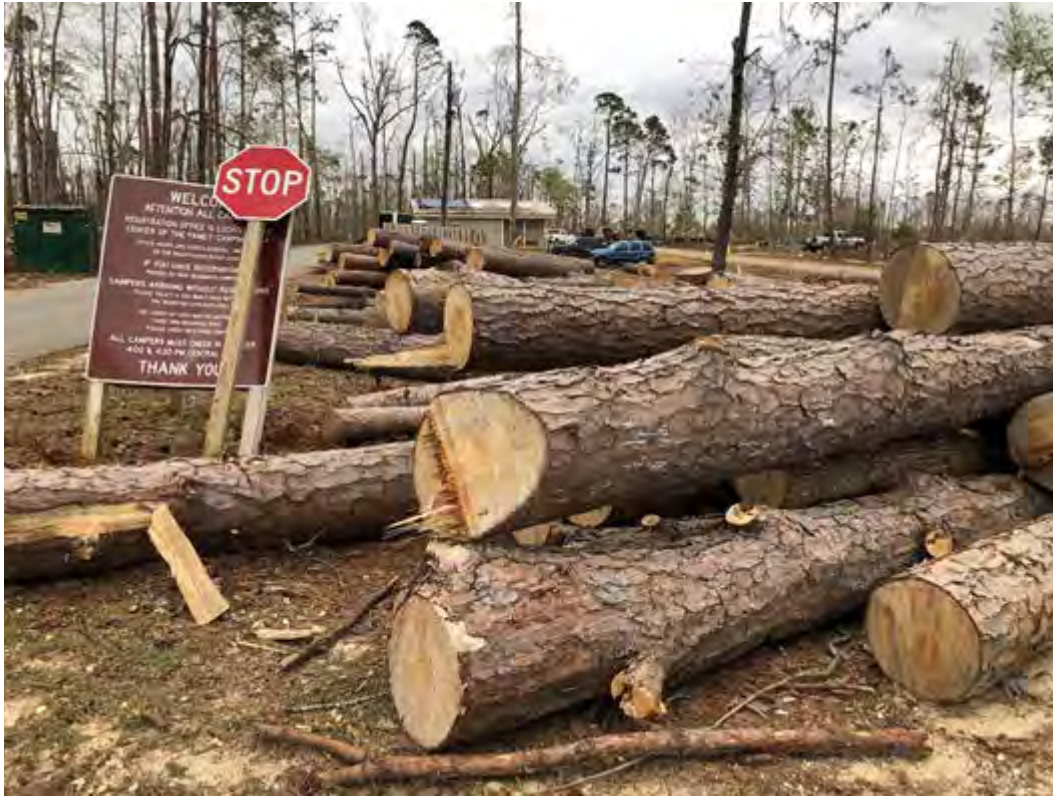
(Figure 30) at time of our survey. Blue stain was observed in some of these stacks on December 13 (Figure 31).

Figure 30. Stacked timber near the park campground entrance.

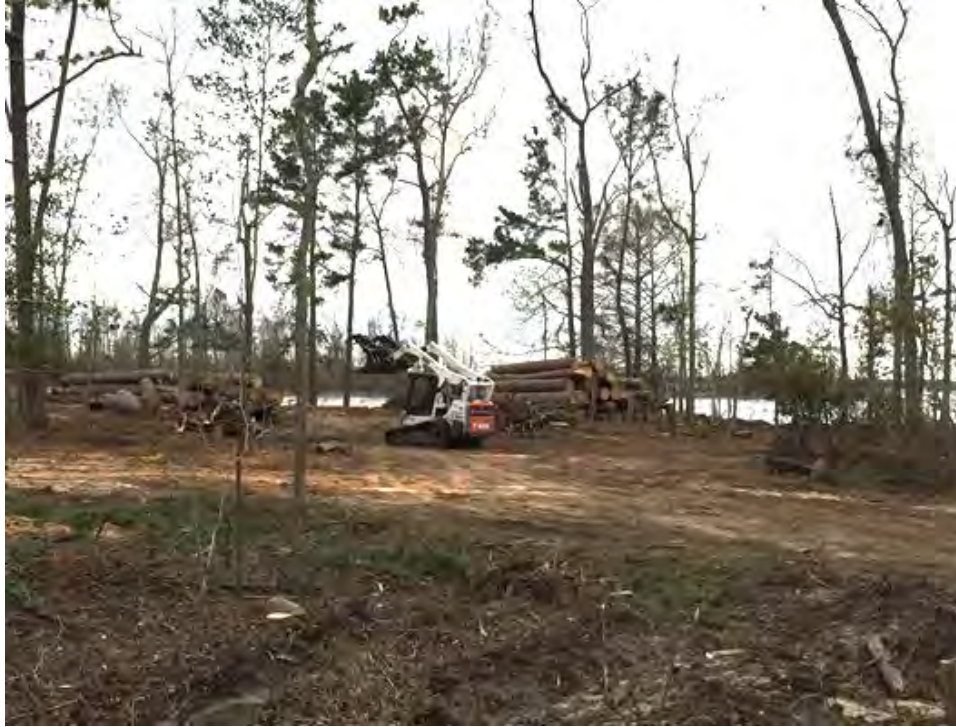
*Figure 32. Campground during active cleanup of downed trees.*

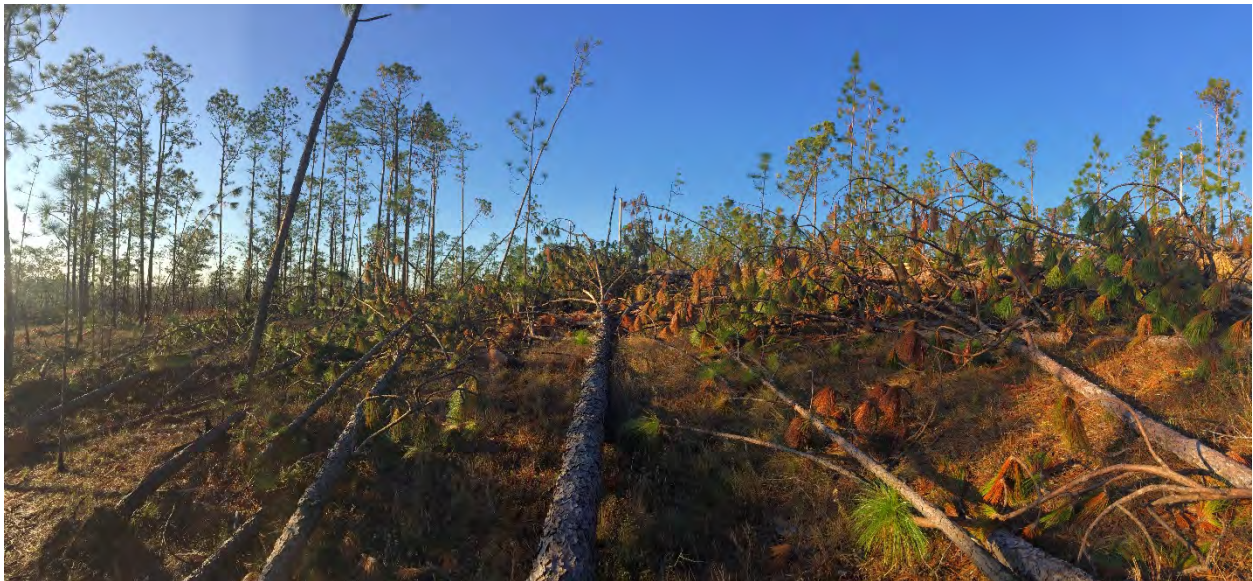
*Figure 51. Severe damage to longleaf canopy in small area of Zone TY-A. These areas of severe damage were generally found along exposed ridges and hill tops.*

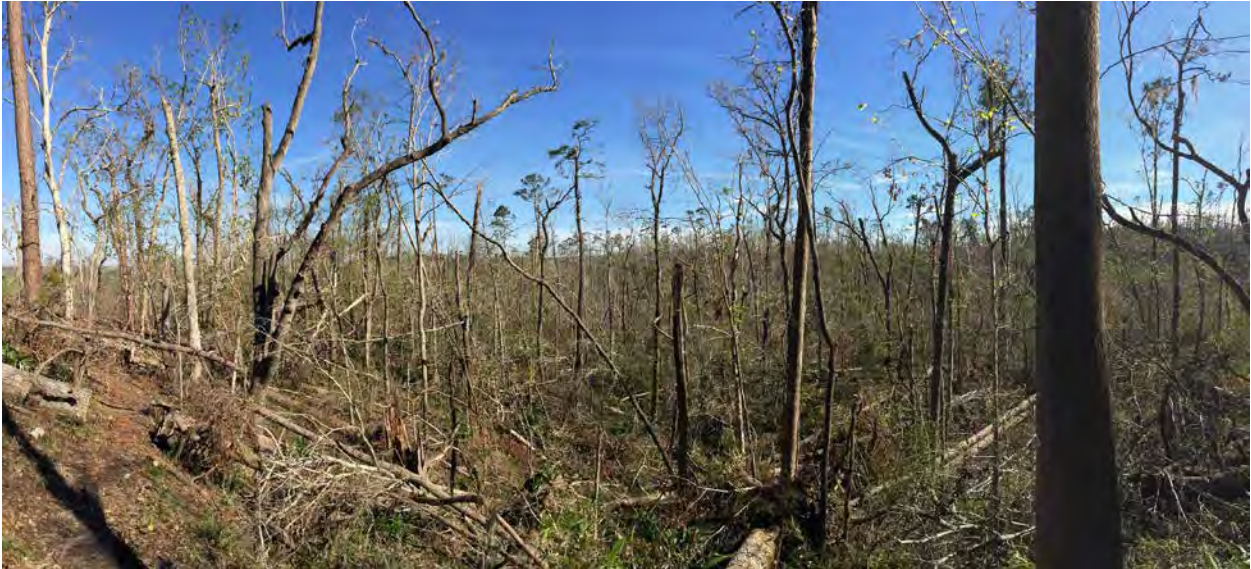
Figure 58. Rich slope forest with heavy canopy damage in Zone TY-X near the Gregory House.

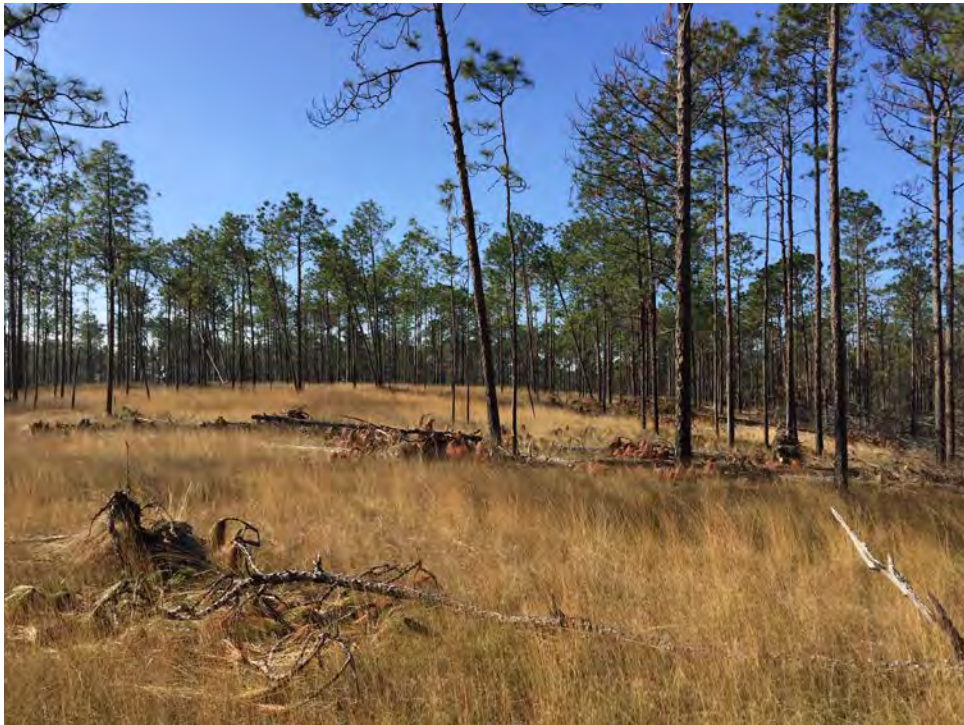
Figure 67. Minor canopy damage in high quality upland pine in Zone FW-B with evidence of significant wiregrass bloom. Damaged trees have been dropped and canopies trimmed to blend in more with the landscape aesthetically.

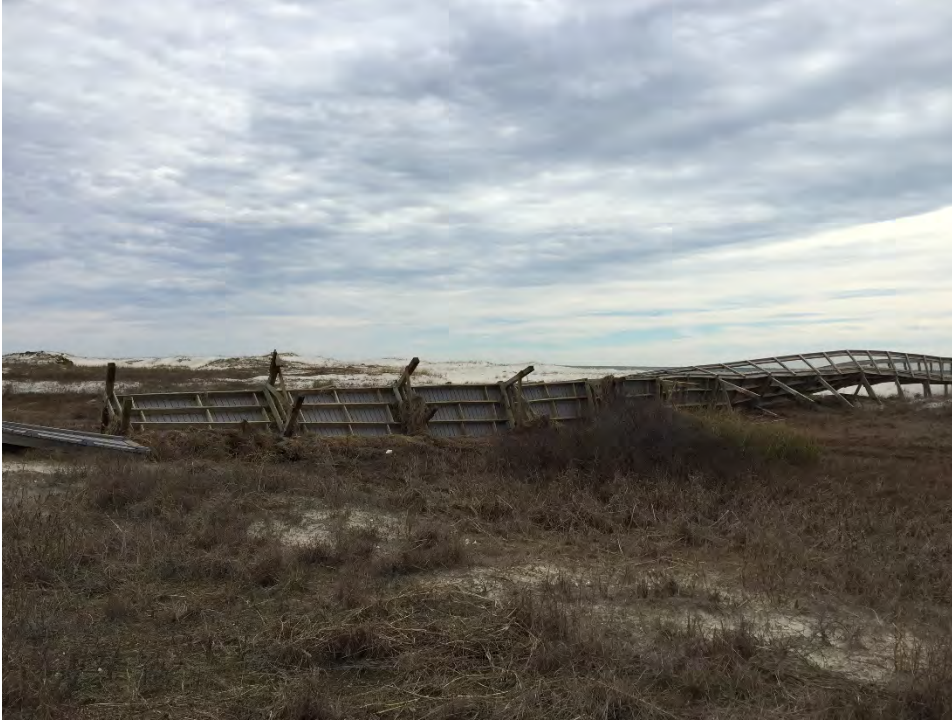
Figure 81. Beach crossover damaged by the storm in Zone SG-12.

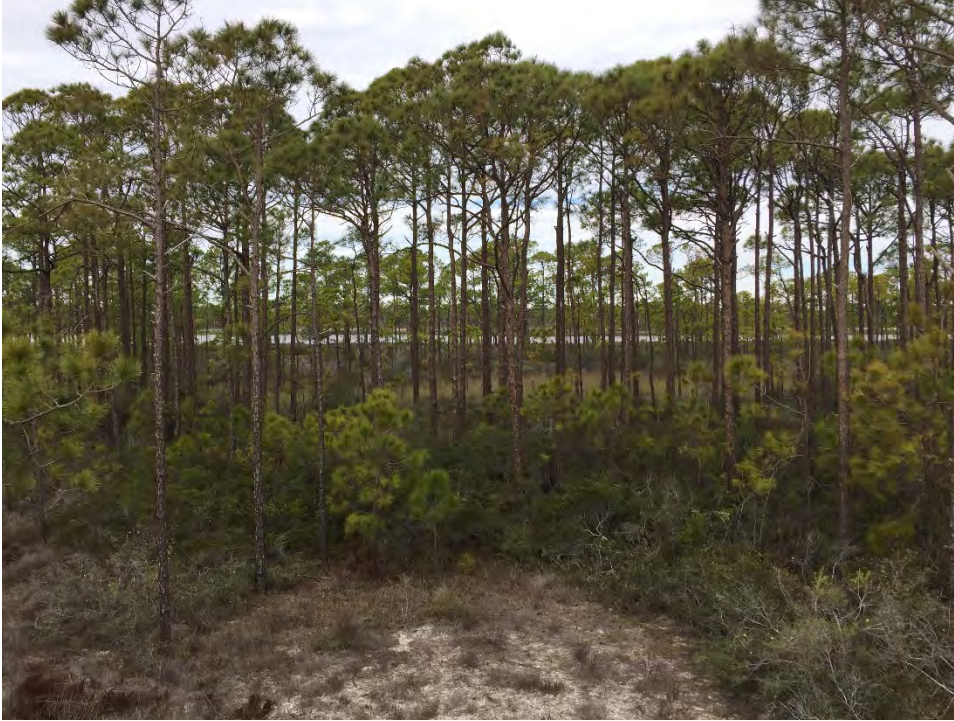
*Figure 82. Wet flatwoods in Zone SG-02 as seen from a tall tertiary dune with no apparent wind damage to the canopy. Many of the slash pines are yellowing, a likely result of salt water.*

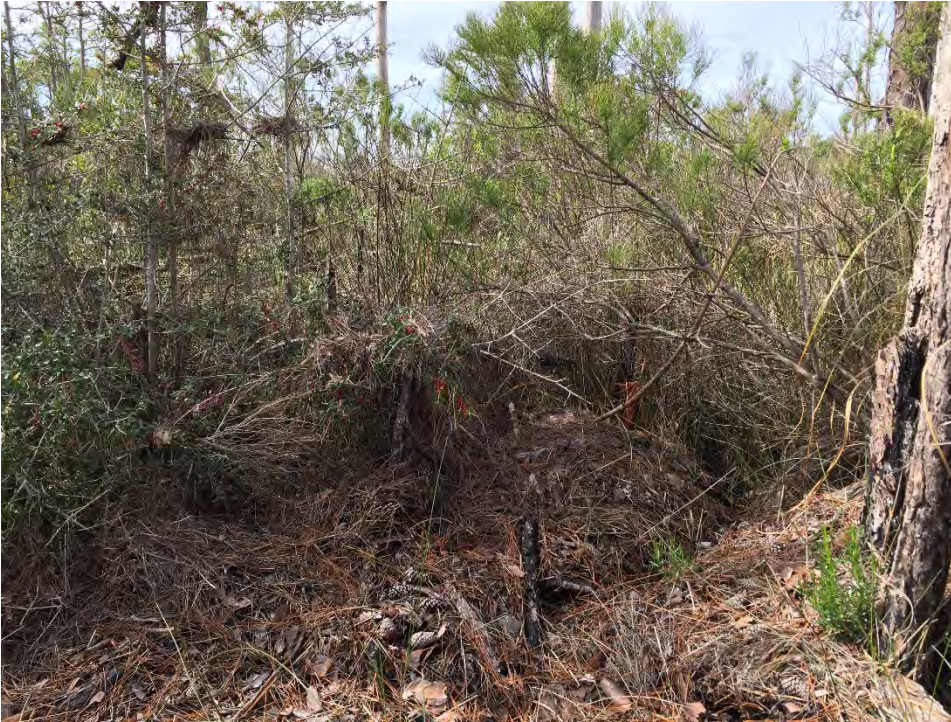
*Figure 85. Heavy storm debris deposited on a wet flatwoods very near the bay in Zone SG-03.*

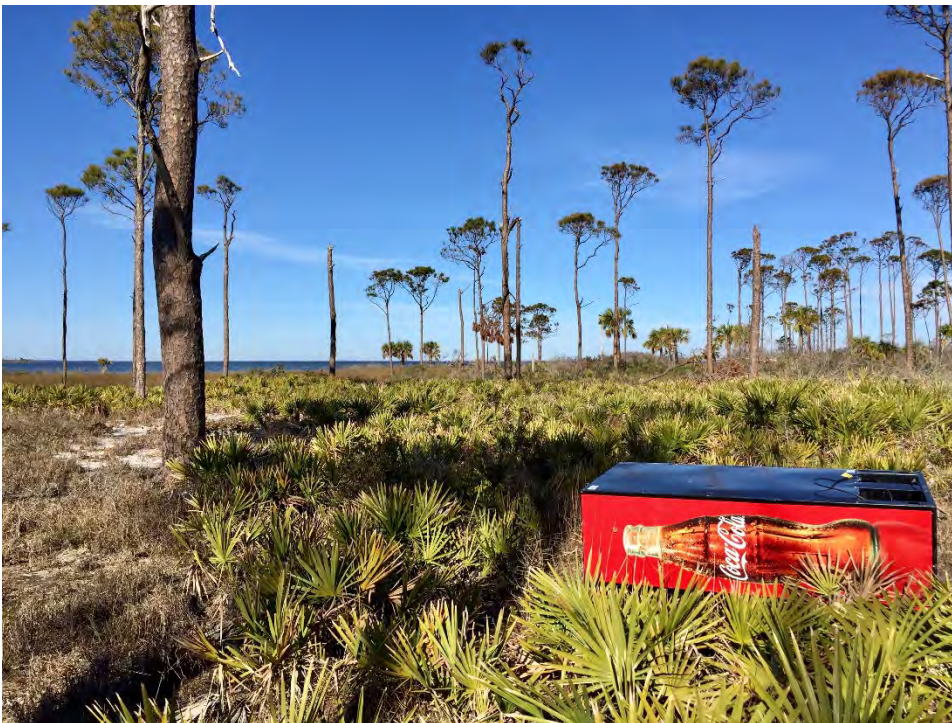
Figure 101. Large items that washed up remain in the flatwoods just south of Eagle Harbor.

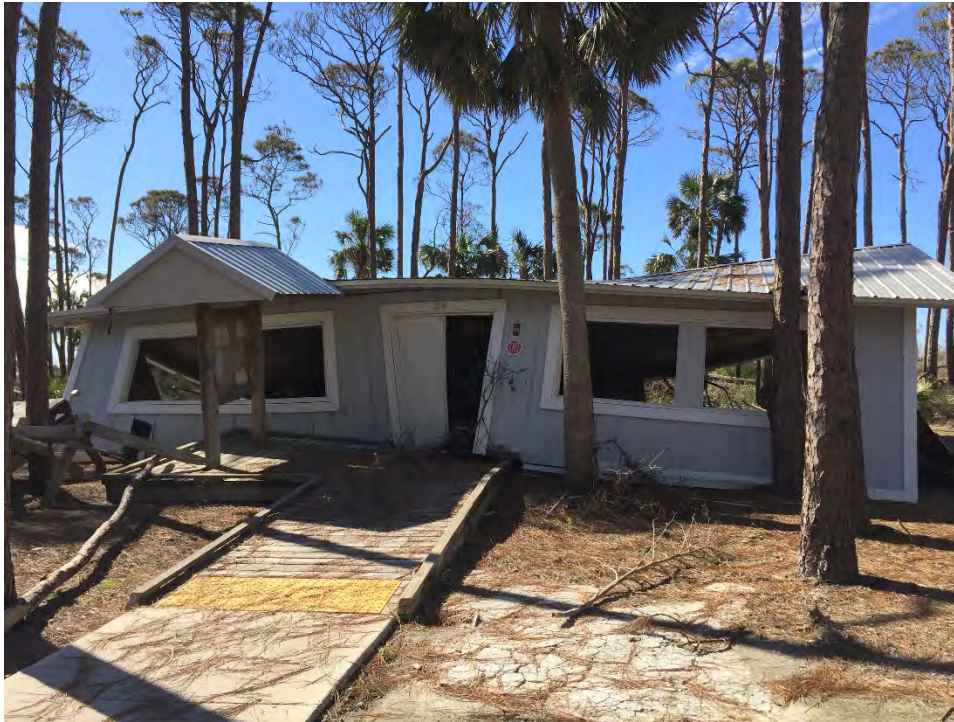
*Figure 102. Significant damage to pavilion in Shady Pine campground.*

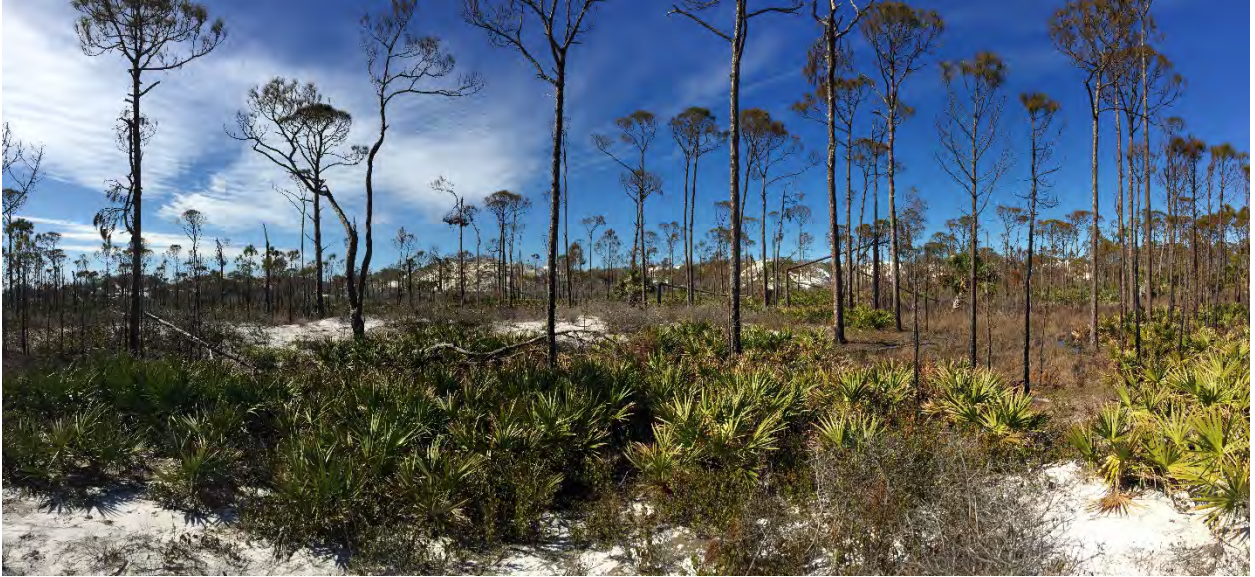
*Figure 106. Minor canopy damage in high quality Scrubby flatwoods in Zone SJ-09.*

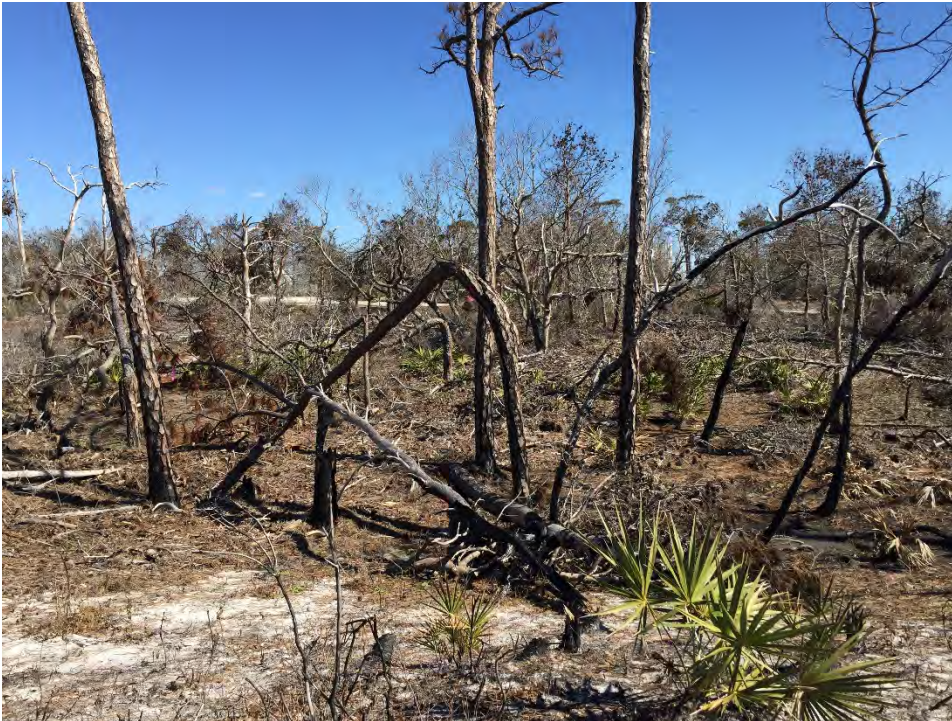
*Figure 107. Heavy canopy damage in scrubby flatwoods in Zone SJ-10.*

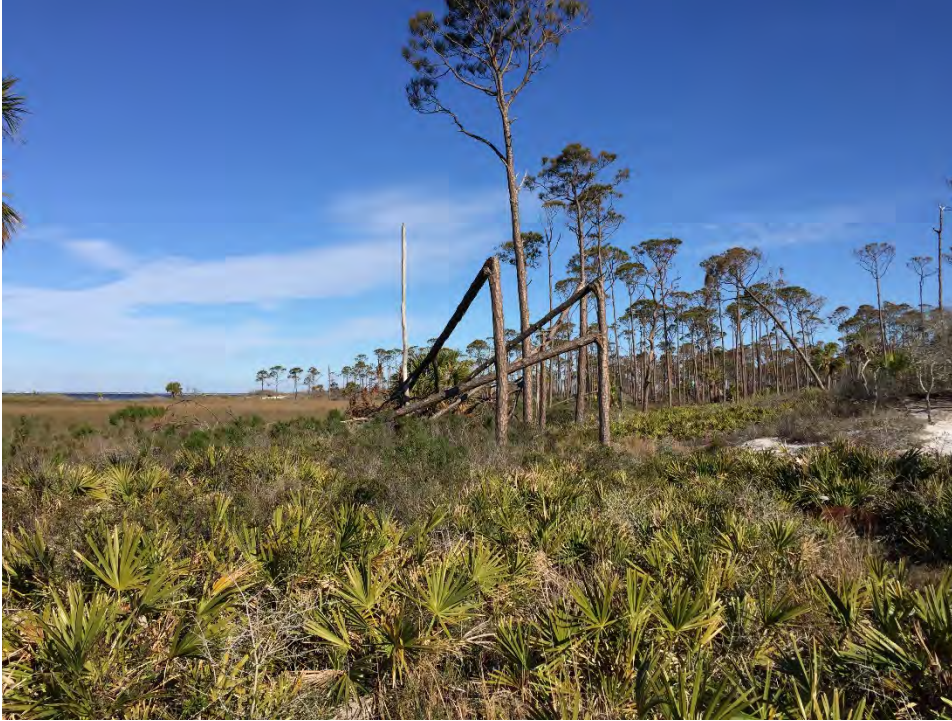
*Figure 108. Moderate canopy damage observed in mesic flatwoods in Zone SJ-05A.*

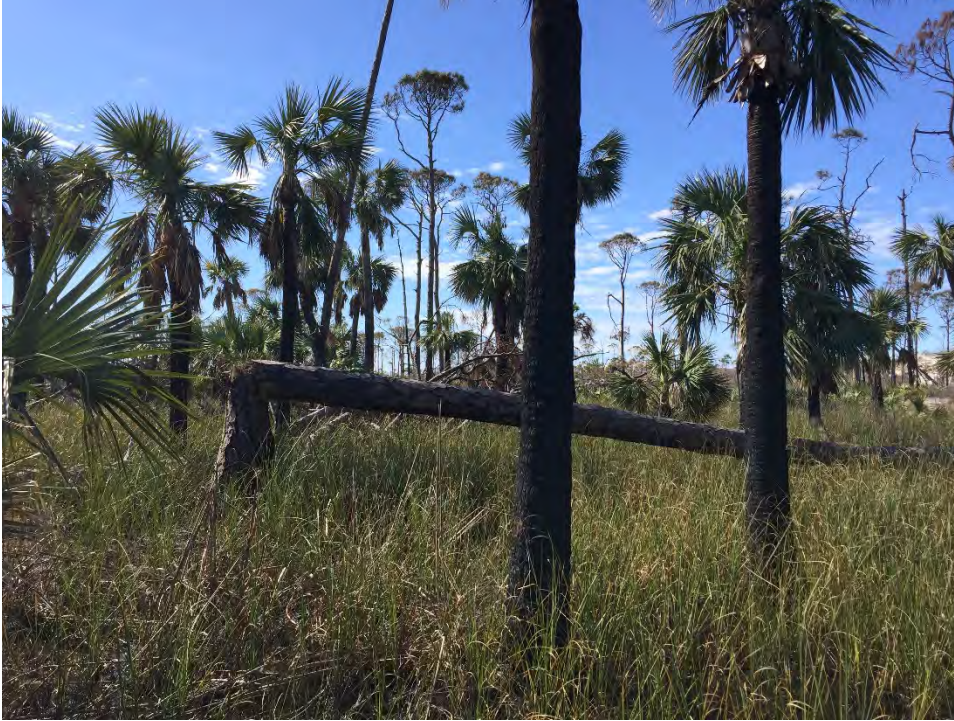
Figure 109. Wet flatwoods with minor damage.

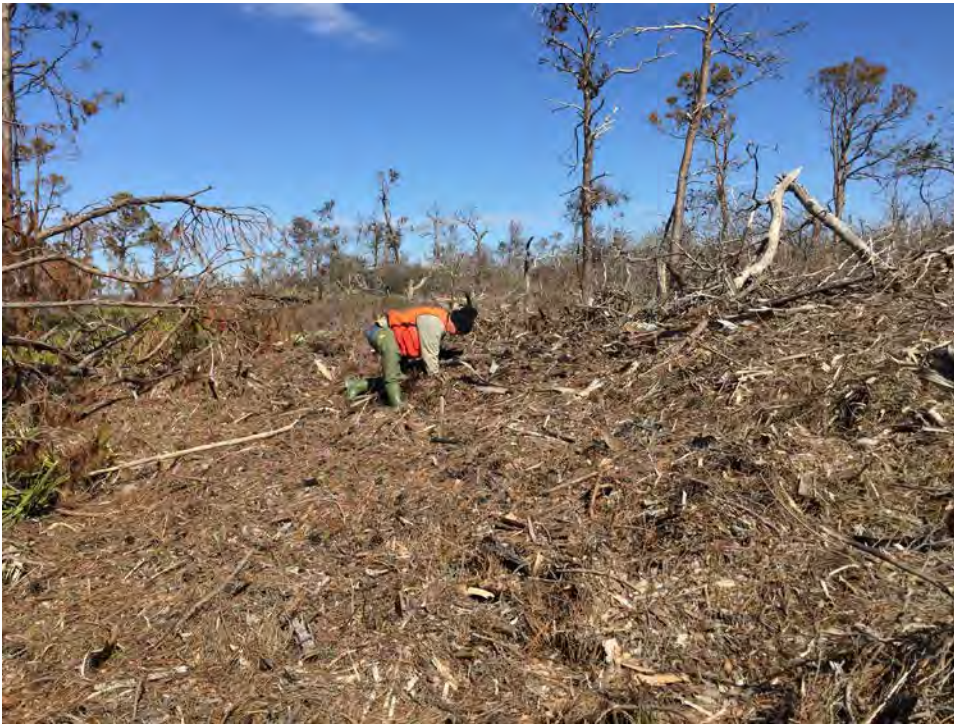
Figure 110. Heavy storm debris in scrubby flatwoods in Zone SJ-10.

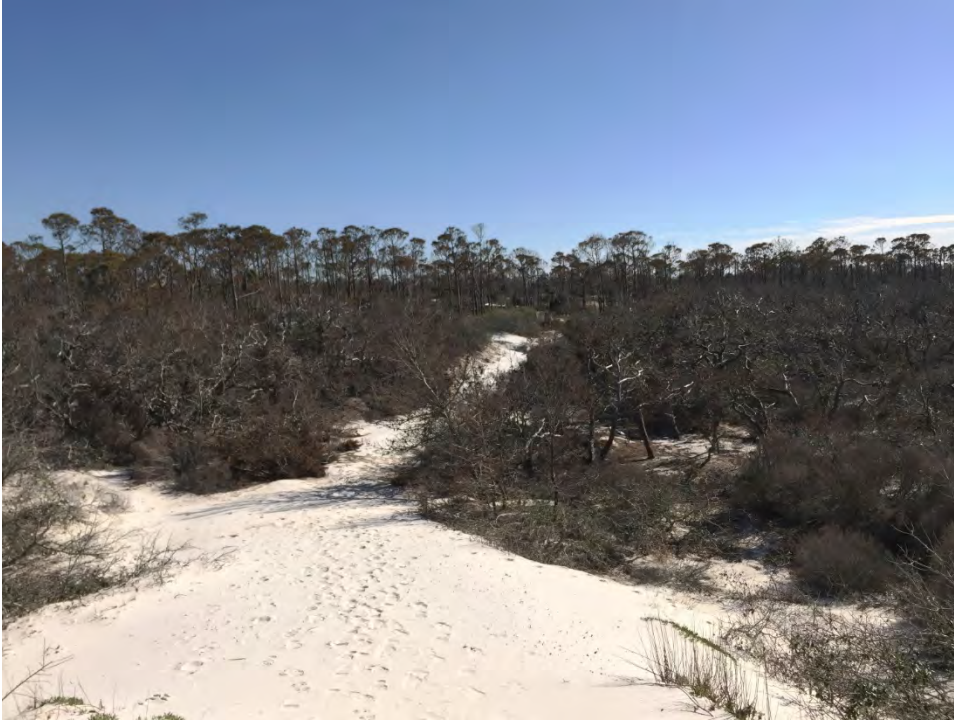
*Figure 112. An example of scrub with a high percentage of canopy and shrub death in Zone SJ-10.*

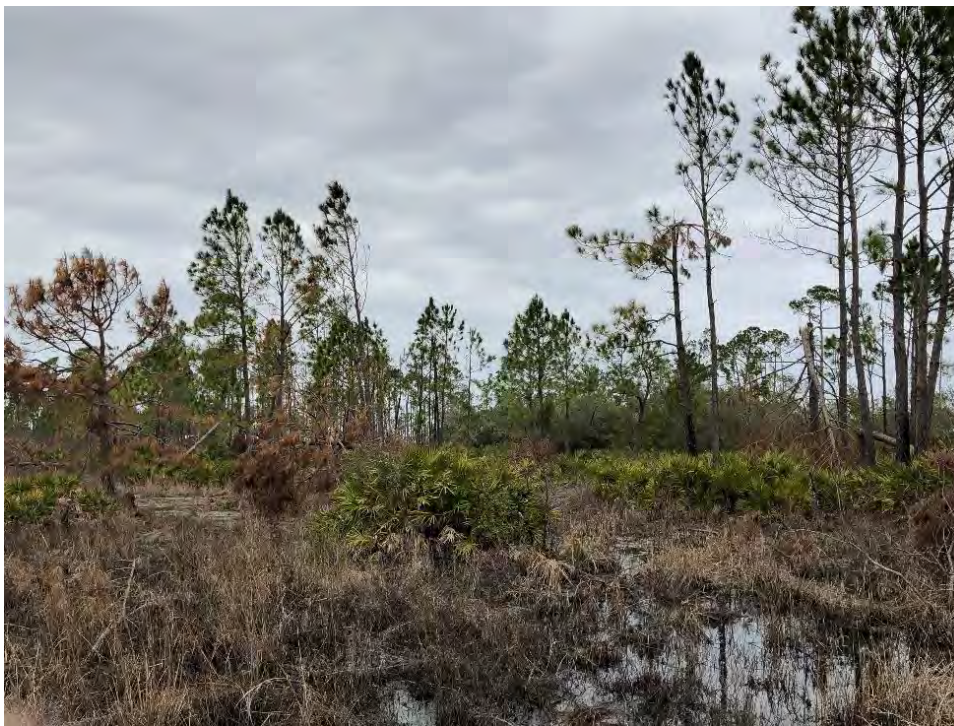
Figure 128. Salt water damage to pines.
