**Phase 1: Rapid Assessment and Evaluation  
Of Restoration Options at State Parks  
Affected by Hurricane Michael  
Task Assignment No.: FN-016  
Contract No.: 10109**

**Draft Interim Report to the Florida Park Service  
Department of Environmental Protection**

February 2019

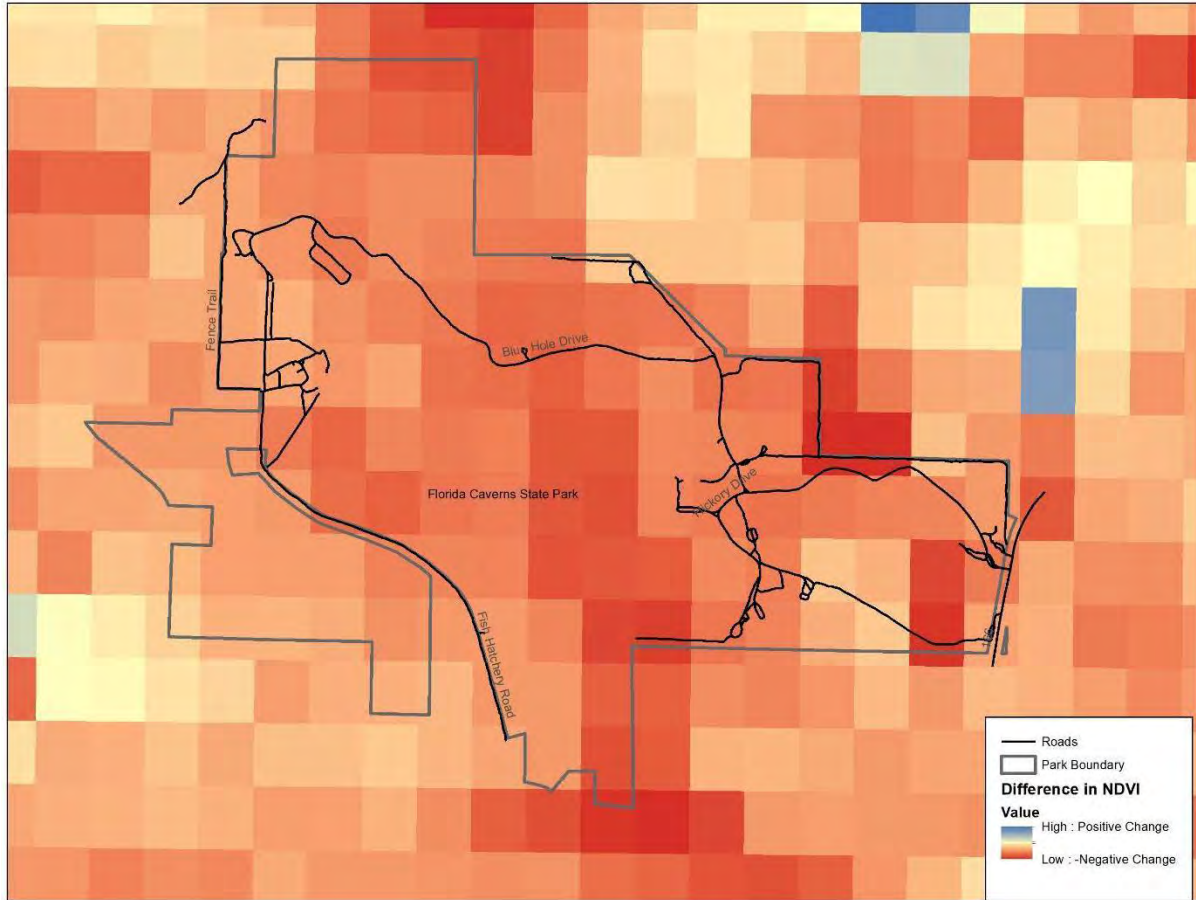
Figure 7. Difference in NDVI (dNDVI) from early-mid October 2017 and early to mid-October 2018. Low values (red) indicate a loss in “greenness” from the year before during the same period, an indication of severity of storm damage. Nearly all the park was severely impacted.

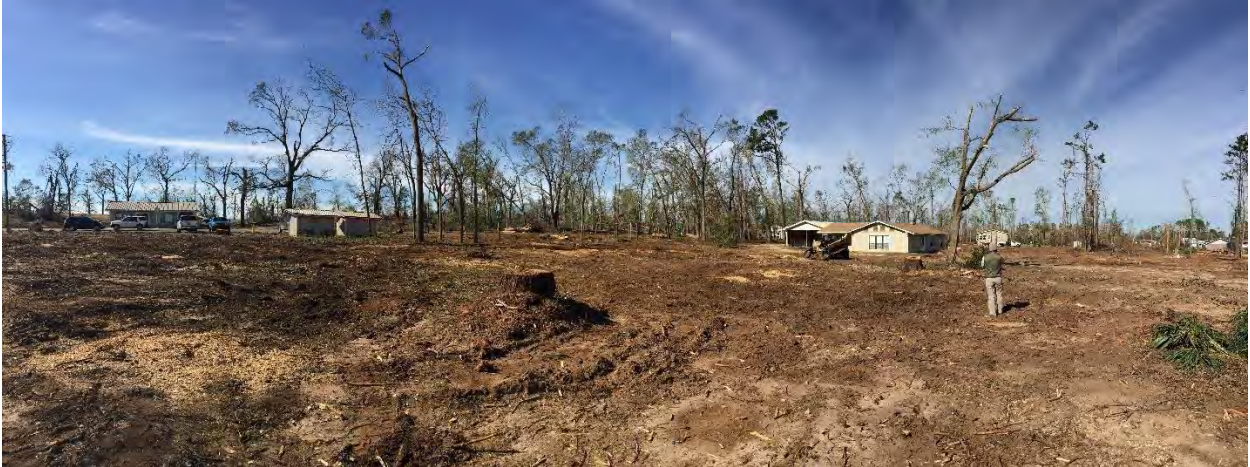
At the time of the field assessment, tree removal was already underway at the park, focusing on the immediate needs of clearing trees on and hanging over roads, structures, and staff safety areas (described as Phase 1 by the manager). The entrance to the park and the road in the north leading to the residences were early priorities because of the structural dangers to park infrastructure. The road leading to the rear residences is presently lined with stacked up timber that was removed from the road to give access to those residences. The park entrance directly north of the entrance station and around the two nearby houses is mostly cleared of vegetation following the work that has already been completed (Figure 11). This area, given its public visibility, will likely be an early restoration priority.

*Figure 11. Looking south from the park boundary toward the entrance station and residences.*

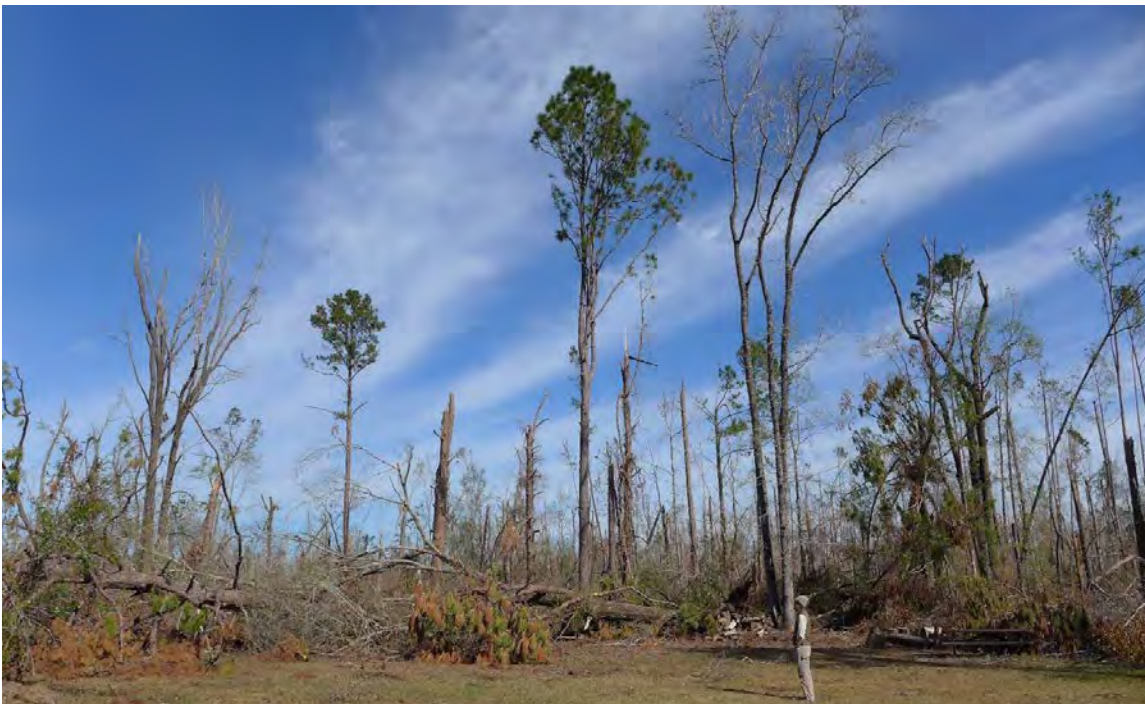
Significant canopy damage was observed in all areas we visited, with varying degrees of severity. These uplands represent the most feasible portions of the park for pine salvage removal. The increased sunlight due to the canopy damage may be a long-term benefit to some of these stands, especially in areas where fire has long been absent and the canopy was dominated by off-site pine (loblolly and slash pine) and invading hardwoods (i.e., laurel oak); these stands are currently classified as successional hardwood forest. These areas are potential opportunities for restoration (longleaf and/or desirable herbaceous species planting) once the increased fuel loads (downed trees) have been addressed. Along the entrance road in zones 1-3, 5, 7 and the southeastern portion of Zone 8 are visible examples (Figure 13). In these zones, most of the large hardwood trees appear to have been damaged and many of the remaining standing trees are pines (slash, loblolly, and longleaf pines), including a few scattered longleaf pine observed (Figure 14). Along the property line near the entrance a stand of large longleaf, most of which were blown down, was observed (Figure 15).

*Figure 14. Longleaf pine (largest tree in center) still standing post-storm near the Beech picnic shelter.*

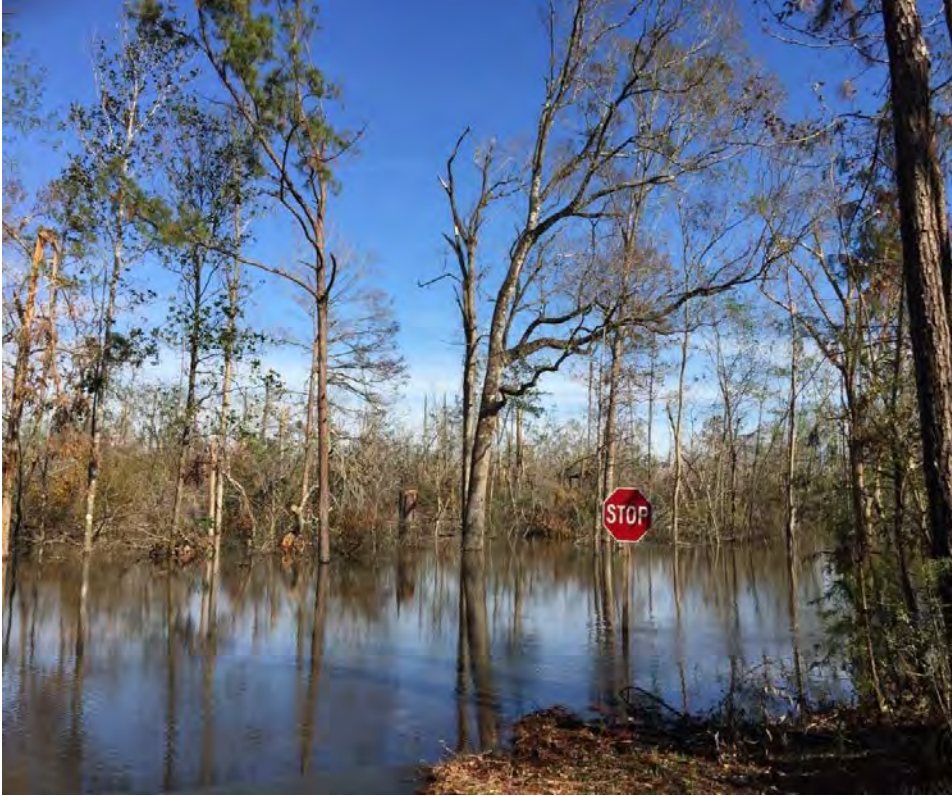
During the field assessment the forested wetland habitats (bottomland forest, alluvial forest) were minimally assessed due to the significant flooding from the Chipola River at the time. Significant canopy damage was observed in the areas that were assessed and high water remained in the bottomland forests (Figures 16 and 17). Because of high water and low potential for restoration, alluvial forests were not visited. Canopy damage may appear worse than it actually is because deciduous species are mostly leafless at this time. After leaf out in the spring, the full extent of canopy damage can be better assessed. Aside from areas of public access where safety concerns need to be addressed, we recommend exotic plant treatment and passive restoration (i.e. allow natural succession to proceed).

Figure 17. Bottomland forest near the exit to the campground looking toward the main road.

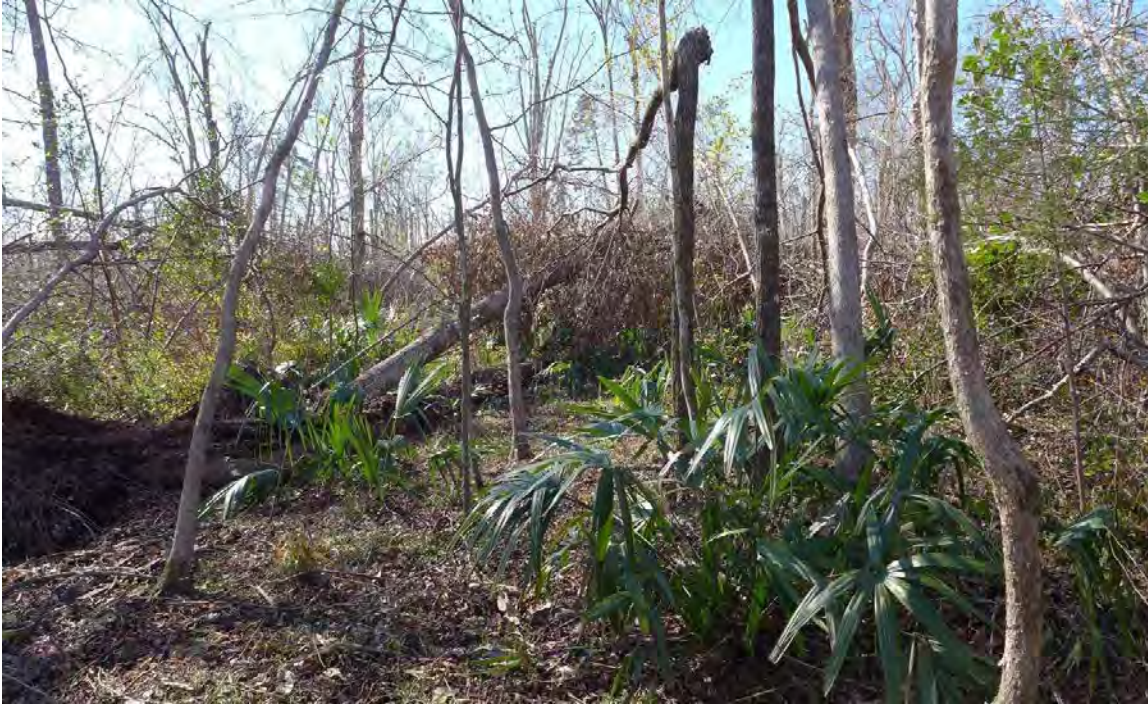
As with the forested wetlands, significant canopy damage occurred in the upland hardwood forests (Figures 12 and 18). These are mixed canopy forests dominated by a diverse suite of species including deciduous trees such as white oak (*Quercus alba*), Florida maple (*Acer saccharum* ssp. *floridanum*), and American beech (*Fagus grandifolia*), and evergreen species such as southern magnolia (*Magnolia grandiflora*), live oak (*Quercus virginiana*) and spruce pine (*Pinus glabra*). In undisturbed condition, the dense canopy of upland hardwood forests and multiple layers of midstory vegetation restrict air movement and light penetration, which maintains high relative humidity within this community. The groundcover is made up of shade-tolerant herbs, graminoids, and vines, several of which are rare in Florida and more common further north (i.e., mayapple (*Podophyllum peltatum*)). Given the significant canopy loss due to Hurricane Michael, the delicate microclimate of these areas will undoubtedly be changed causing unknown effects to the community structure and composition that will need to be evaluated through monitoring of vegetation changes. A concern of note is how the fragile spring ephemerals (wakerobin (*Trillium* sp.), mayapple (*Podophyllum peltatum*), and wild columbine (*Aquilegia canadensis*)) in the ground layer of this habitat at FCSP will respond to the change in light availability. Invasive species are another concern, especially in the areas where limestone outcrops are present. Japanese ardisia was seen thriving and fruiting in the hardwood forest near the Beech shelter (Figure 19) and Japanese honeysuckle was observed in many locations across this habitat type. These forests are sensitive to intensive management because of their rare resources and fragile microclimate and will likely need to recover on their own, aside from areas where downed trees need to be removed for public safety. Where trees must be removed because of safety concerns (i.e., near the Visitor Center and nature trails), leaving as much debris and logs on the forest floor as possible (as opposed to

Figure 18. Needle palm (*Rhapidothymus hystrix*) in a rich upland hardwood forest in southwest portion Zone 8.

removing these from the site) is recommended. This will help prevent erosion and help build the nutrient-rich soil back up, not only by decomposing but serving to catch falling leaves and hold them in place.

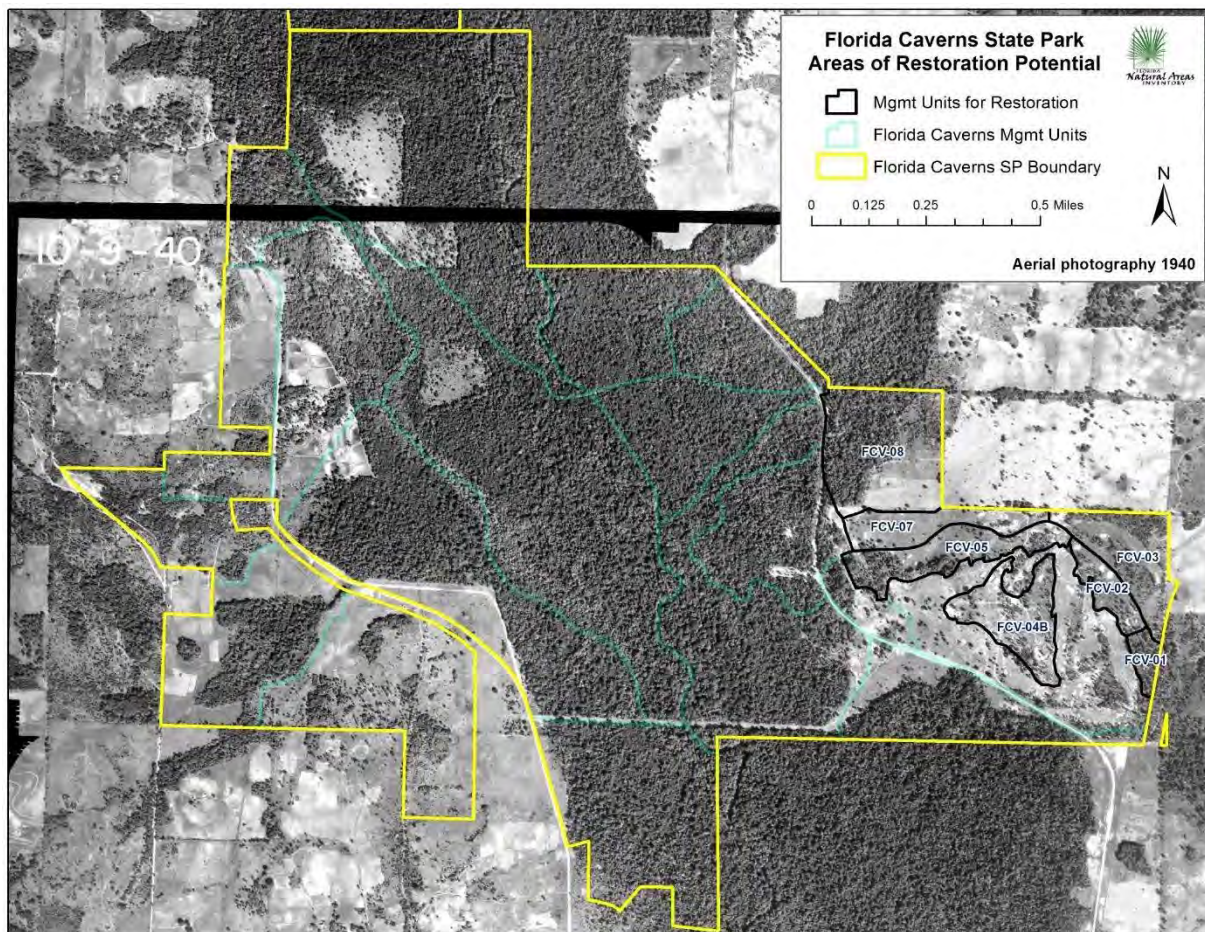
Aerial photography from 1940 indicates that the eastern corner of FCSP (Management Zones 1-3, 4B, 5, 7, and the southeast portion of 8 (Figure 22) has been cleared for a golf course for more than half a century, however the intervening natural habitat fragments suggest these areas were open canopy upland pine. These Zones represent a reasonable restoration opportunity, given the severe canopy loss. Prior to Hurricane Michael portions of this area were either dominated by off-site pine or significantly fire suppressed (classified as successional hardwood forest) as indicated by 2016 aerial photography. Many hardwood trees fell in the storm and the majority of the remaining canopy is pine. Given the current heavy fuel loads, situated adjacent to a neighborhood, and considering the visibility of these areas near the entrance drive, a well-planned restoration effort, reducing the overall fuel loads and introducing longleaf and native desirable herbaceous groundcover species, would not only create a more aesthetic entrance to the park but also provide a properly defensible buffer to the wildland urban interface in the eastern corner of the park.

Figure 22. Florida Caverns State Park management units with 1940 aerial photography. Management units prioritized for restoration are highlighted.

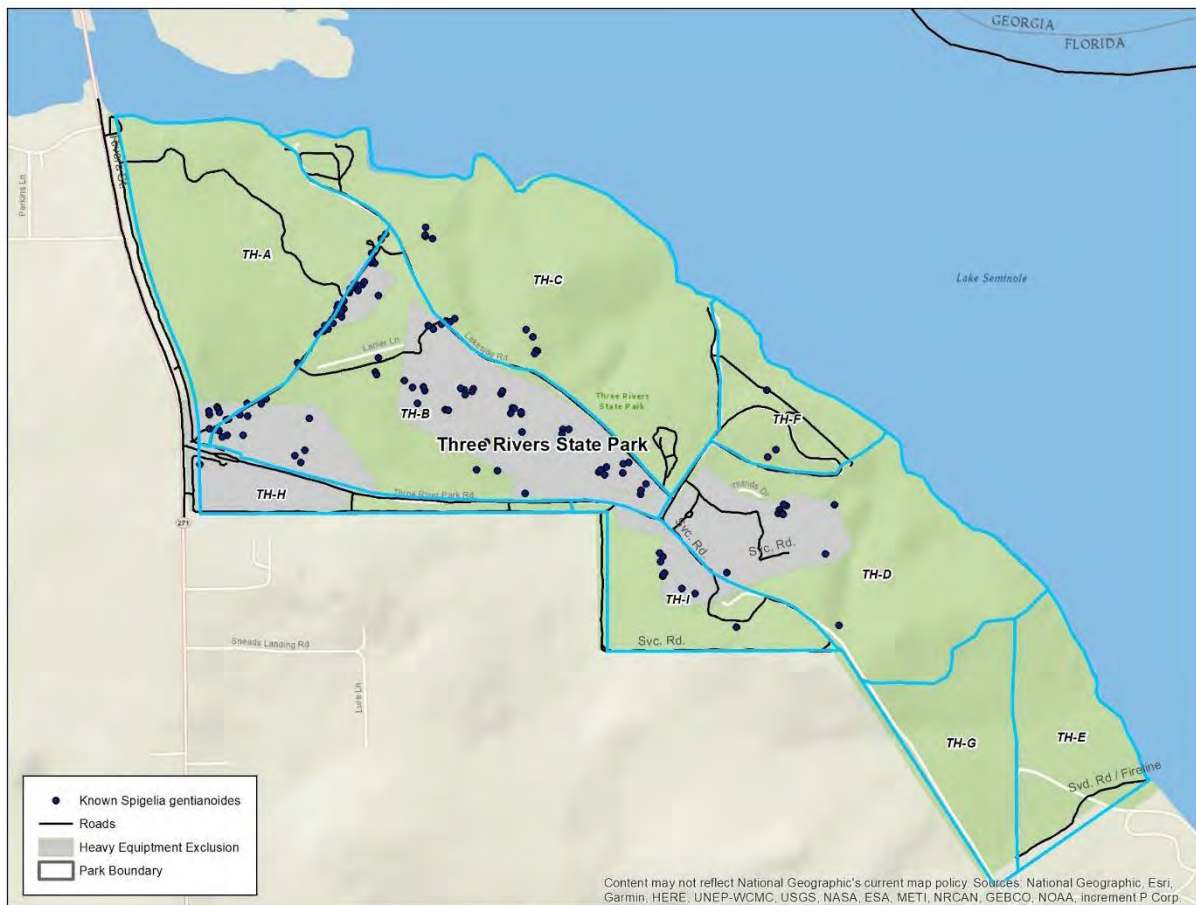
Figure 25. Recommended heavy equipment exclusion/reduction zones.

10. Prohibit (or greatly reduce) heavy machinery (e.g. harvesters, skidders, feller bunchers, etc.) in high priority *Spigelia gentianoides* areas with light to moderate damage and fuels (Figure 25) except where pre-existing roads or fire breaks exist.
11. All machinery from offsite should be cleaned by high pressure to remove possible seed sources or introduction of exotics species.
12. Prevent erosion and protect soils from compaction and rutting.
13. Leave scattered non-merchantable medium and large logs. Avoid exposing soils by completely removing litter and debris.

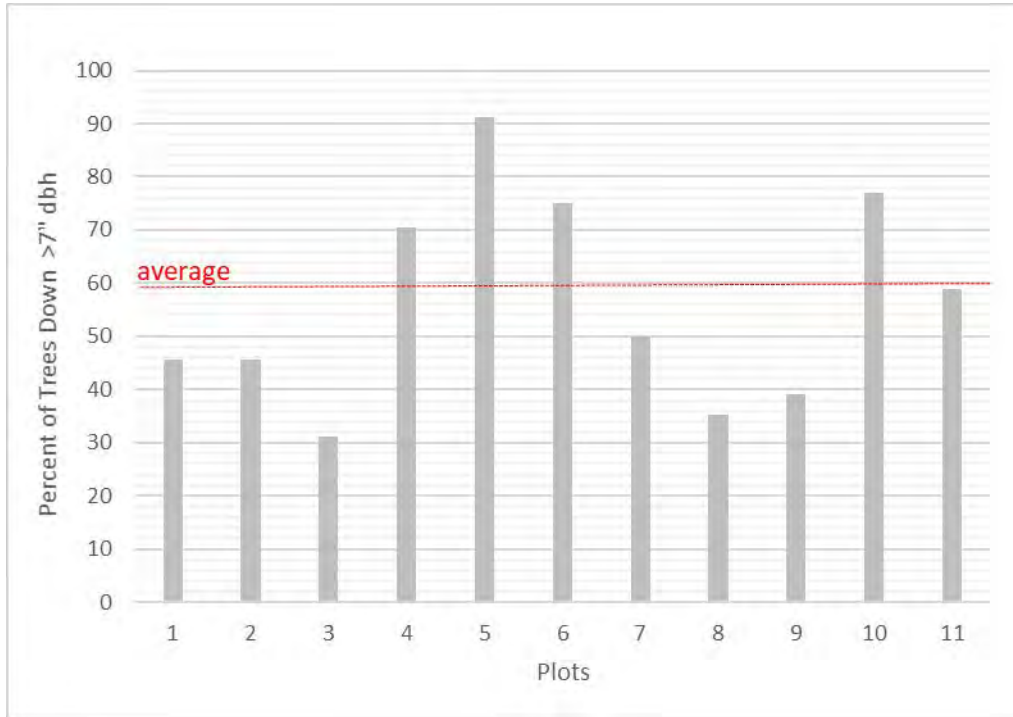
Canopy loss was variable, from light to severe in plots, with the overall damaged and downed trees averaging 60% across all plots. The most notable changes from the storm are in the form of heavy fuel loads of downed trees as well as increased sunlight to the surface. Both of these factors will drive changes in the plant composition and structure of the understory flora. The canopy damage was variable across the park, ranging from 31-91% in plots. Many of the upland pine sites had more moderate (~50%) damage allowing a fairly natural pine stand remaining. In our plots, an average of 64% of mature trees (>7" dbh) were down (Figure 28). Upland glade and mixed hardwood seemed to have the greatest number of trees down, 91% and 73% respectively, and upland pine and upland mixed hardwood seemed to have the least effects with average downed trees per plot near 50% for each. The damage includes entirely blown down trees (exposing the root balls) as well as broken main stems (forming "A frames").

Figure 28. Percent of trees (>7" dbh) down in each plot.

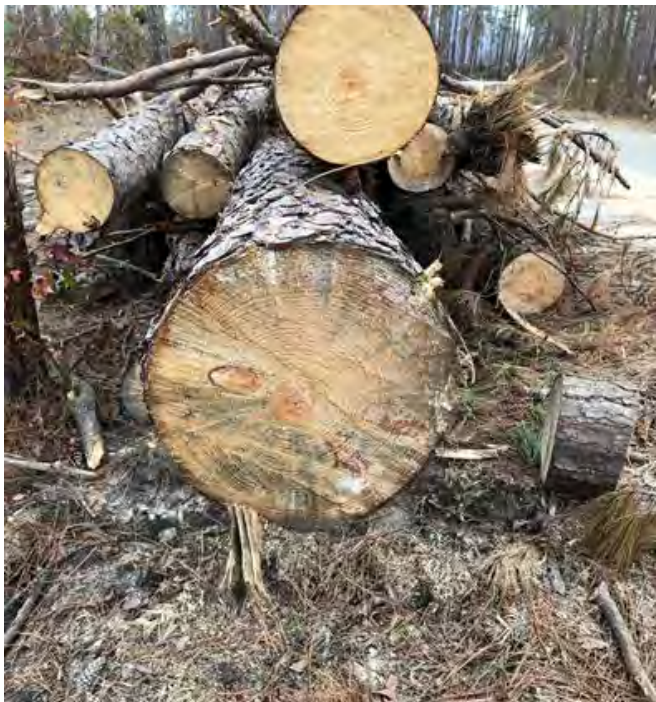
(Figure 30) at time of our survey. Blue stain was observed in some of these stacks on December 13 (Figure 31).

Figure 31. Stacked pine logs showing blue stain.

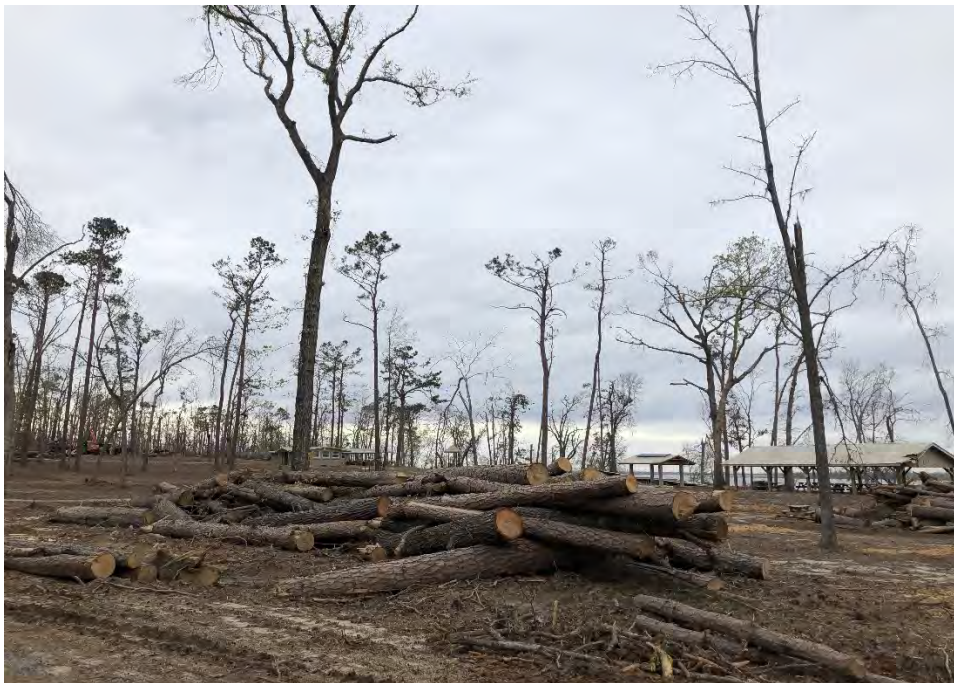
The areas near the campground and picnic areas are mostly cleared of large trees following the work that has already been completed (Figures 32 and 33). These places, given their visibility to the public, may be early restoration priorities.

*Figure 33. Day-use area at Three Rivers State Park after damaged tree removal.*

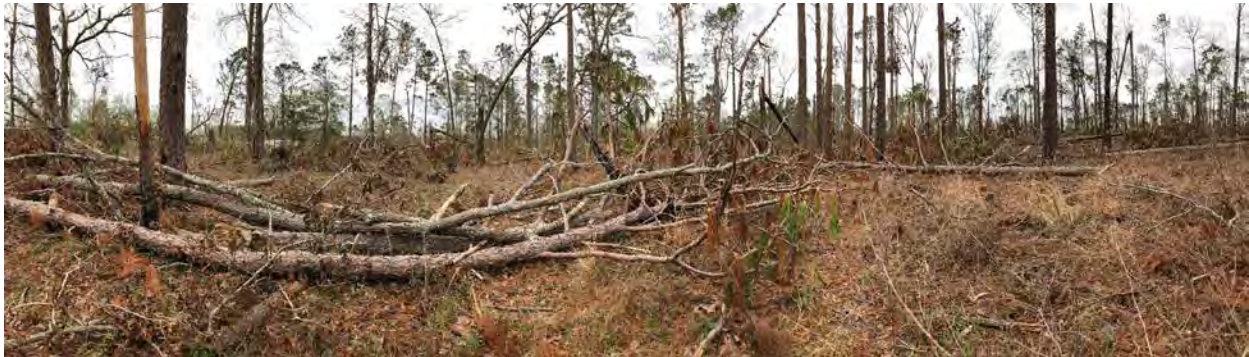
Figure 34. Zone TH-H along the entrance drive. The canopy damage to this area is moderate and remaining is still a majority longleaf pine canopy is near desired future conditions as far as canopy cover and basal area.

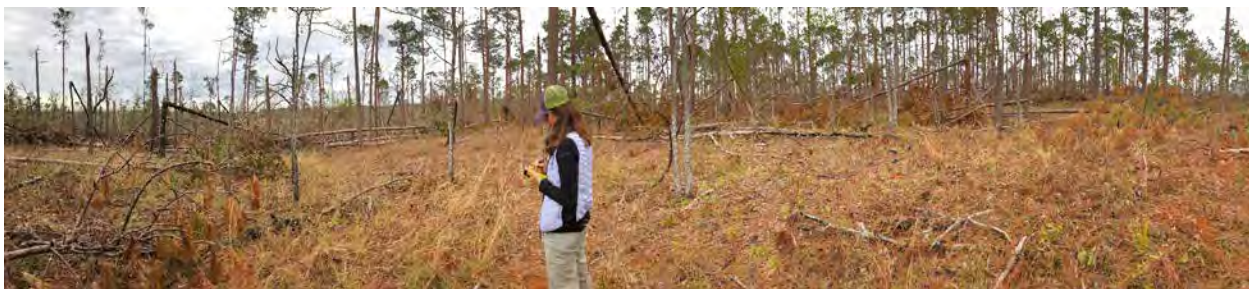
Figure 35. Upland pine in Zone TH-I where you can see variable tree loss with severe canopy damage in the left of the photo and moderate to light damage in the right.

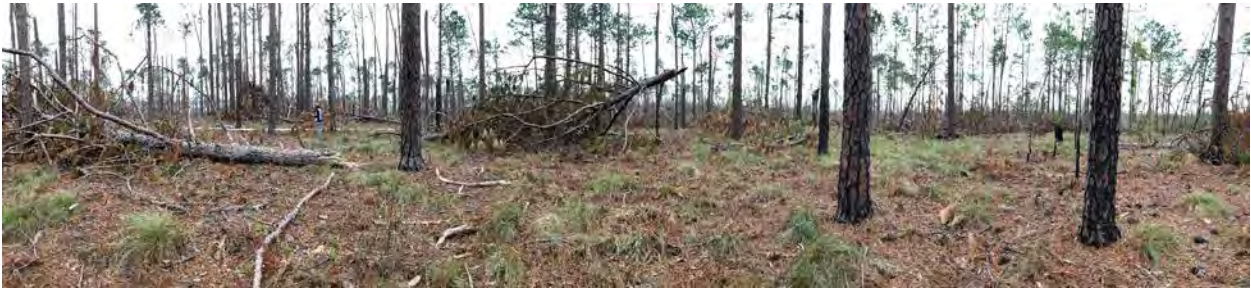
The only area of significant wiregrass (*Aristida stricta*) cover seen during the field assessment is in a portion of the upland pine in Zone TH-I. The canopy over this wiregrass only suffered moderate damage

(Figure 36). Minimizing equipment impacts to the groundcover and returning fire would be the most efficient method to restoring desired future conditions.

Figure 36. Notable wiregrass cover in an area of moderate hurricane canopy damage in Zone TH-I.

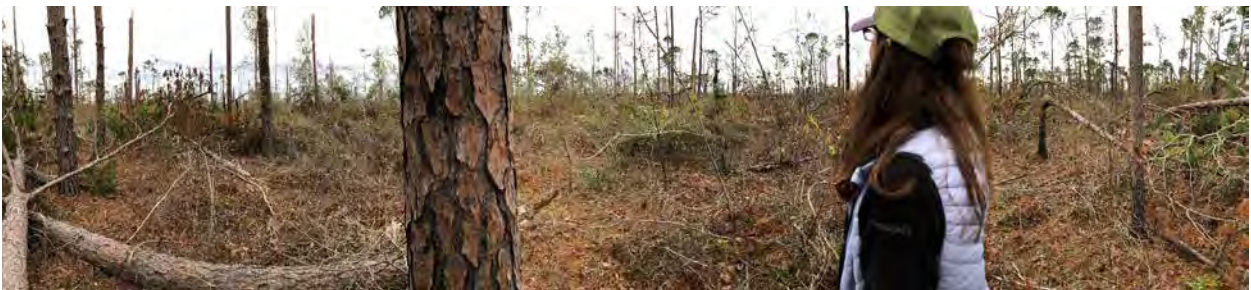
The increased sunlight resulting from the canopy damage may be a long-term benefit to groundcover in some stands (particularly those highlighted in the mechanical restriction zones, Figure 37) at TRSP where fire exclusion has resulted in hardwood invasion of the canopy and shrub layers. A good example of this is in a portion of Zone TH-A where vines such as muscadine (*Vitis rotundifolia*) and earleaf greenbrier (*Smilax auriculata*) are common, shrubs cover is greater than desirable and is made up of weedy species such as winged sumac (*Rhus copallinum*), and laurel oak (*Quercus hemisphaerica*), and herbaceous species only make up a minor component of the groundcover (Figure 37). Places such as this are good opportunities for restoration (longleaf and/or desirable herbaceous species planting) once the increased fuel loads (downed trees) have been addressed. These areas represent the best opportunity for salvage logging to contribute to long-term restoration.

Figure 37. Portion of Zone TH-A with severe canopy damage and heavily invaded with vines and shrubs. This area is an excellent candidate for restoration efforts.

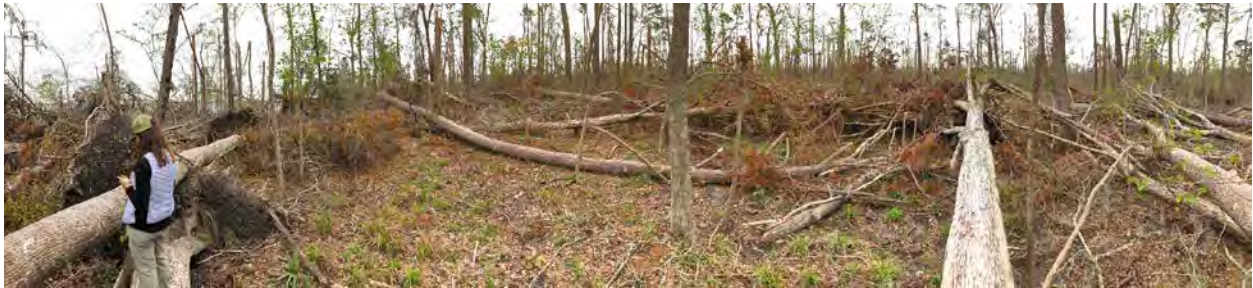
Significant canopy damage occurred in the upland hardwood forests at TRSP (Figure 39). These are mixed canopy forests dominated by a diverse suite of species including deciduous trees such as white oak (*Quercus alba*), Florida maple (*Acer saccharum* ssp. *floridanum*), and American beech (*Fagus grandifolia*), and evergreen species such as southern magnolia (*Magnolia grandiflora*), live oak (*Quercus virginiana*) and spruce pine (*Pinus glabra*). The dense canopy of upland hardwood forests and multiple layers of midstory vegetation restrict air movement and light penetration, which maintains high relative humidity within this community. The groundcover is made up of shade-tolerant herbs, graminoids, and vines, several of which are rare in Florida and more common further north (i.e., Carolina lily (*Lilium michauxii*)). Given the significant canopy loss due to Hurricane Michael, the delicate microclimate of these areas will undoubtedly be changed causing unknown effects to the community structure and composition that will need to be evaluated through monitoring of vegetation changes. A concern of

Figure 39. Rich upland hardwood forest adjacent to Lake Seminole in southwest portion Zone TH-C.

In order to maintain the rich soil layer present in upland hardwood forests, leaving as much debris and logs on the forest floor as possible (as opposed to removing it from the site) will help achieve desired future conditions (except in areas where trees removal is necessary for safety concerns). This will help prevent erosion in these sloping forests and help build the nutrient-rich soil back up, not only by decomposing themselves but serving to catch falling leaves and hold them in place. Several rare plant species occur in the upland hardwood forest (Figure 39) at TRSP including but not limited to bay star-vine (*Schisandra glabra*), Baldwyn's spiny-pod (*Matelea baldwyniana*), and green adder's-mouth orchid (*Malaxis unifolia*). All of these populations should be revisited when it is phenologically appropriate to evaluate the populations post hurricane.

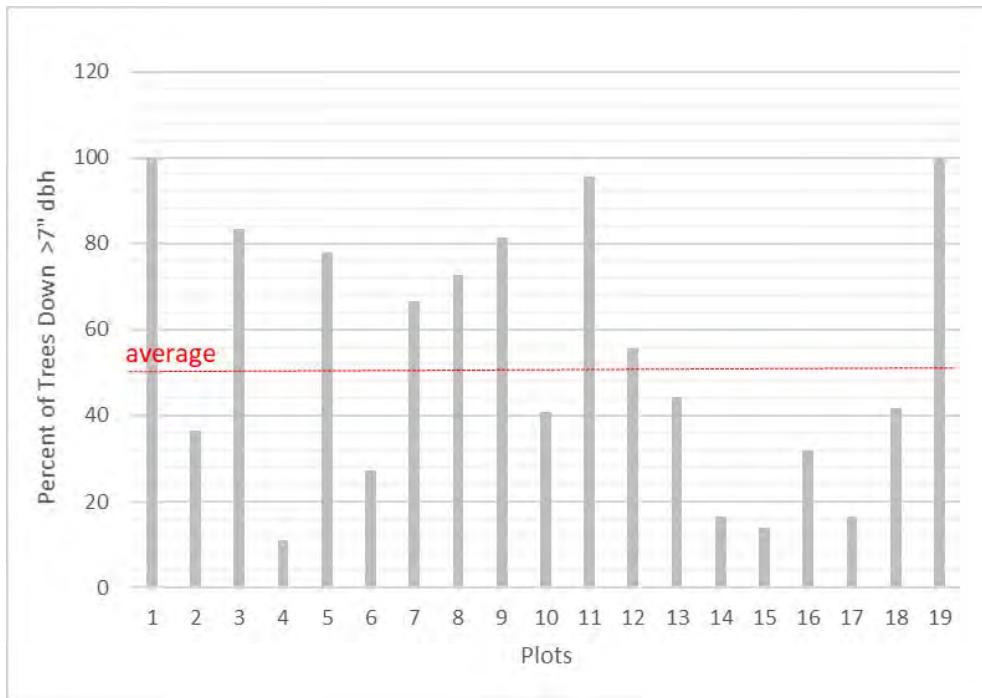
A field assessment was completed on December 12 and January 8, 2018. FNAI scientists surveyed accessible areas on foot and vehicle to evaluate aspects of the habitat conditions that cannot be observed via aerial photography or satellite imagery. The canopies of all habitats that were observed during the short field assessment suffered variable damage, from moderate to severe, and the change this will bring to each habitat is the most significant aspect of the storm effects. The canopy damage was variable across the park, ranging from 11 to 95% removal in our plots. On average, the damage was

much more moderate (~50%) (Figure 46). Upland pine and sandhill were highly variable with 13-95% of trees down in plots, allowing a fairly natural pine stand remaining in most areas due to the patchiness of damage and canopy loss (Figure 44). In some cases, especially where fire suppression or even-age regrowth occurred after logging, added homogeneity will likely benefit ground cover and longleaf seedling recruitment.

Figure 46. Percent of trees >7" dbh down in plots.

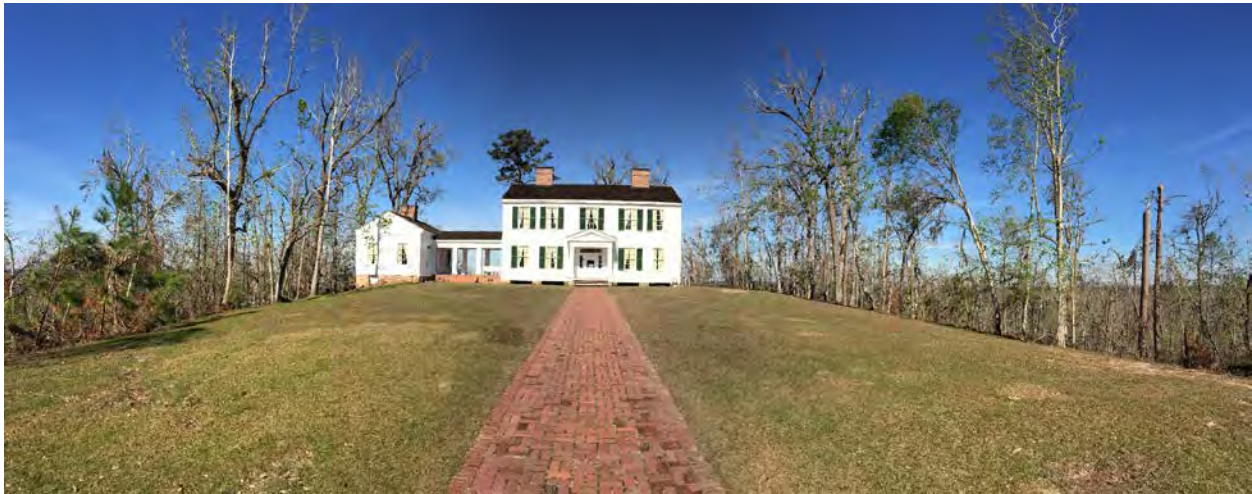
Figure 48. The Gregory House with canopy damage evident in adjacent slope forests.

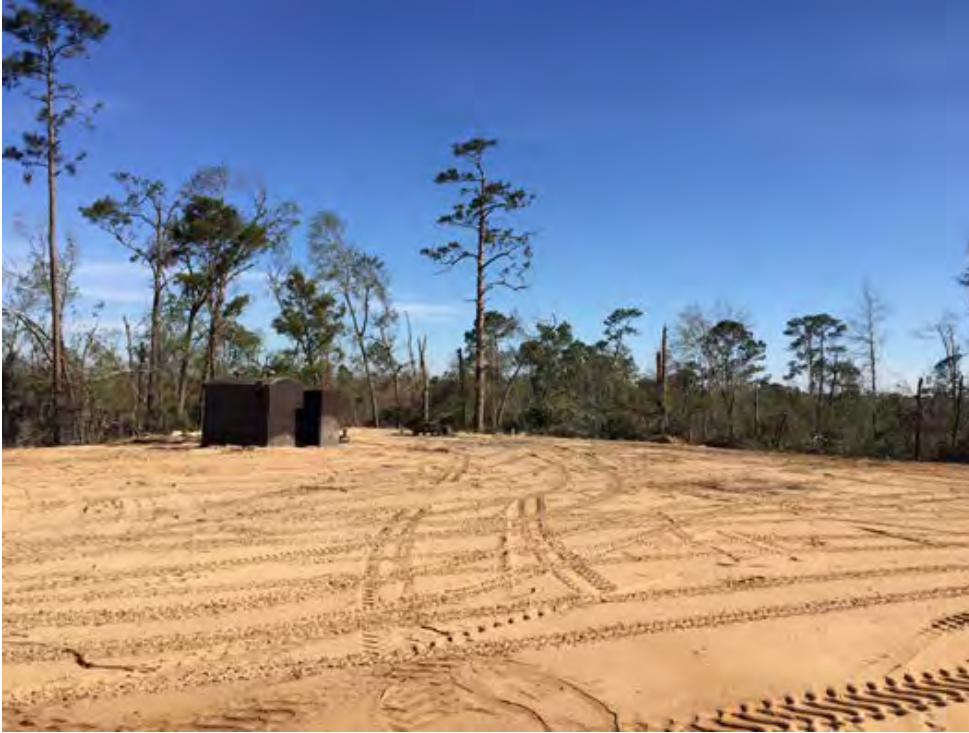
Figure 49. The picnic area after hurricane debris was removed.

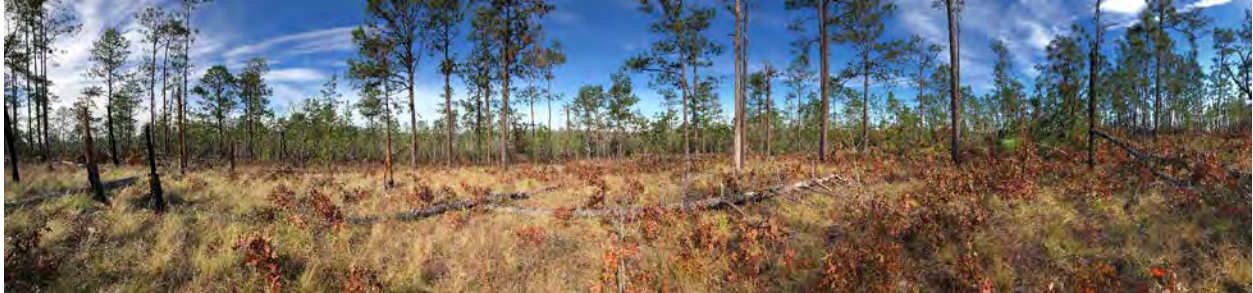
An area of high quality, but fragmented, sandhill is present in the Rock Creek Tract along both sides of the main entrance road in zones TY-A, TY-B, TY-C, and TY-D. A portion of this sandhill (in TY-A) was assessed during the field survey (Figure 50). An older mature canopy of longleaf is present over a high quality groundcover dominated by wiregrass, tree damage is patchy and varies between light (Figure 50)

*Figure 50. High quality sandhill in Zone TY-A with little damage to the canopy from the hurricane.*

and severe (Figure 51). Only minor debris removal along hiking trails or firebreaks is recommended for such areas of where intact groundcover is present.

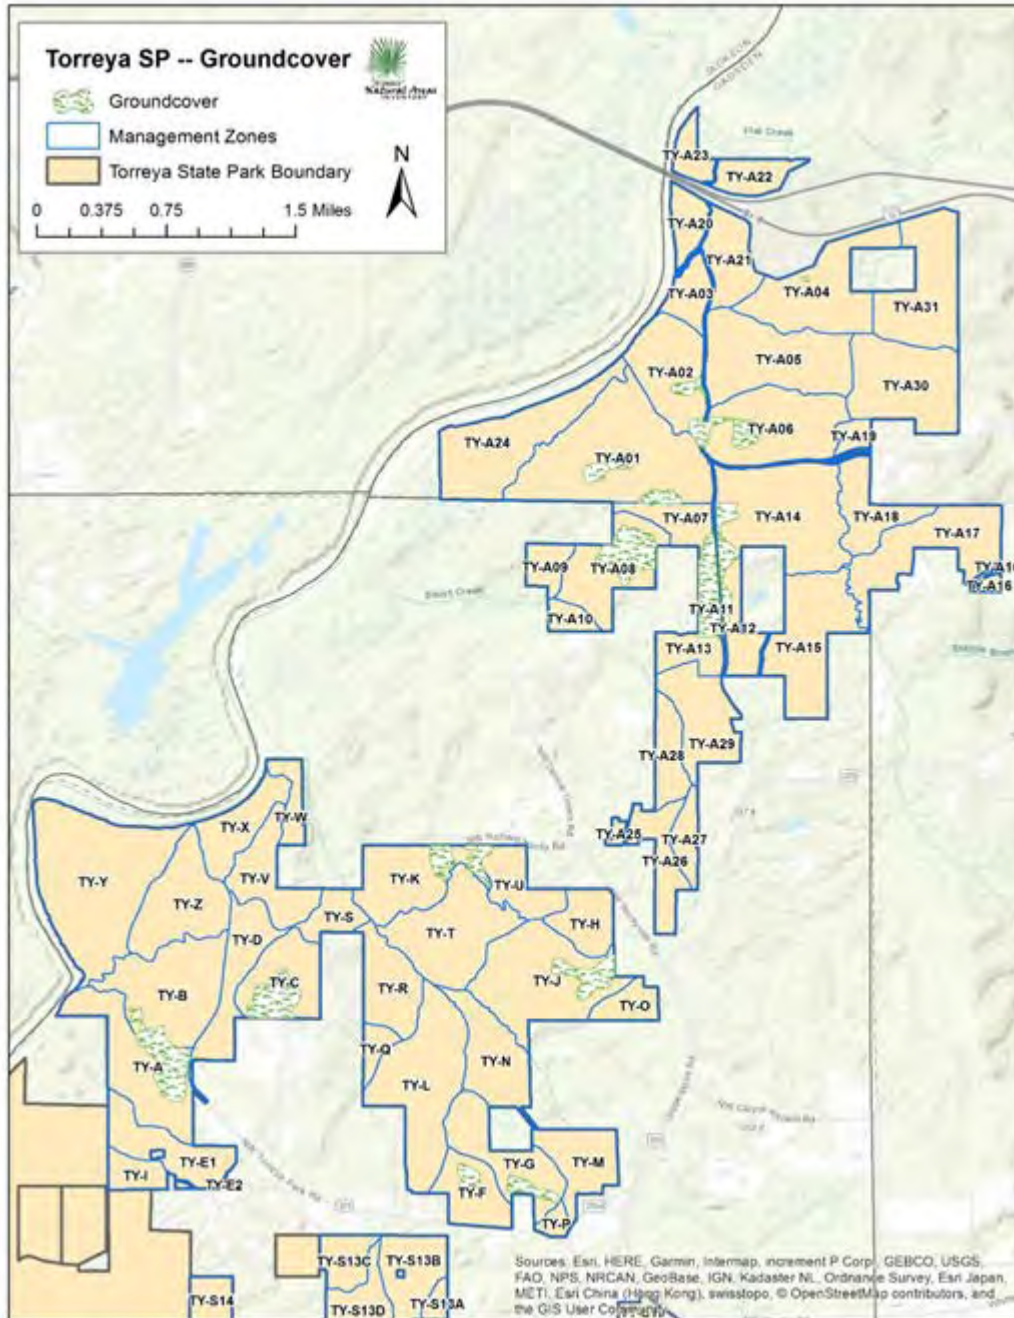
Additional pockets of uplands (mostly sandhill with some upland pine) with intact groundcover are present throughout the Aspalaga and Rock Creek Tracts (Sweetwater Tract not assessed) and mapped based on the field surveys, aerial photography (historic and current) interpretation, and interviewing the park Biologist, Mark Ludlow. This does not represent all the intact groundcover (i.e. diverse assemblage of native groundcover including wiregrass and other graminoids and herbs) but should capture the majority of contiguous and ecologically significant patches (Figure 52).

Figure 52. Areas of significant intact groundcover determined by field surveys, aerial photograph interpretation, and expert interview.

b) Avoid harvesting damaged areas if safe operations require removal of trees as described in 5a.
10. Flag and avoid significant groundcover areas (Figure 52) to the extent possible.

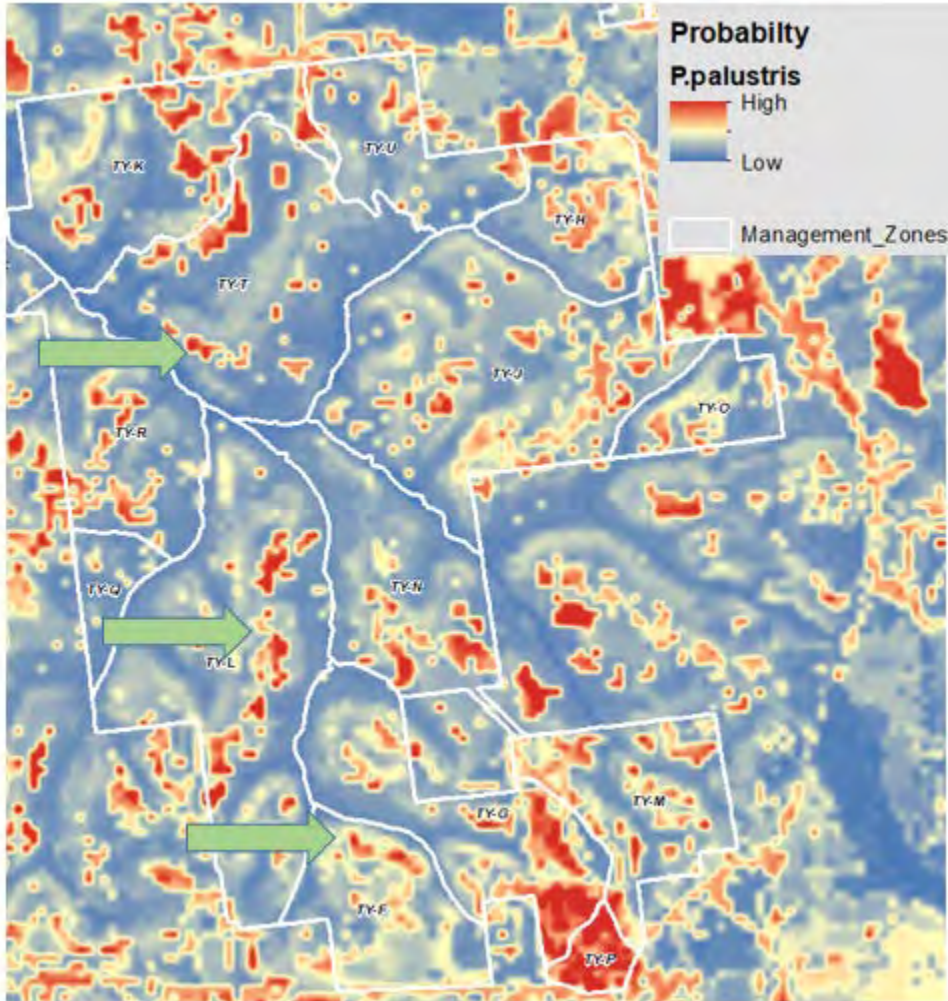
In zone TY-F, which is dominated by off-site planted slash pine, longleaf was observed along the edge of the plantation where the plantation neared the ravine edge and the habitat was fire excluded and nearing successional hardwood forest (Zone TY-F, Figures 51, 52, 55). These remnant longleaf pines represent a significant resource that, if left intact, would provide a seed source for restoration. This occurrence is likely to occur the slope forest ecotones of other plantations where it was undesirable to plant trees due to the increasing slope. This potential is also indicated by FNAI’s predictive long leaf model (Figure 53).

Figure 53. Indications of possible longleaf pine along upper slopes. Examples highlighted by green arrows.

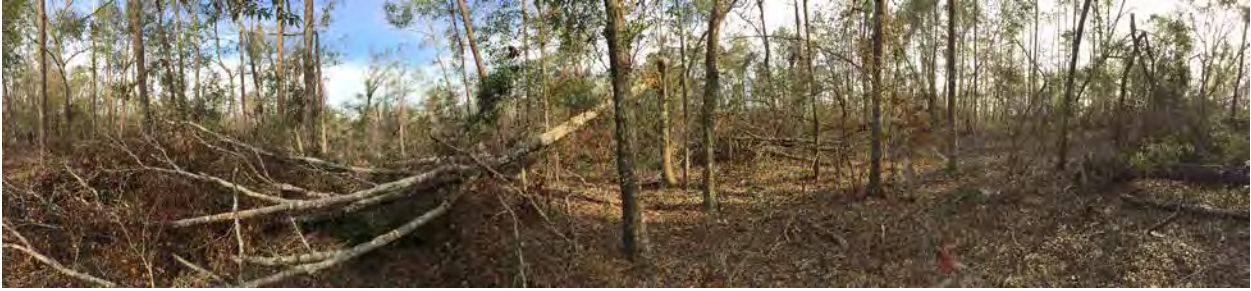
The increased sunlight due to the canopy damage from the hurricane may be a long-term benefit to some of these stands in areas where fire has long been absent and the canopy was dominated by off-site pine (loblolly and slash pine) and invading hardwoods (i.e., laurel oak), currently classified as successional hardwood forest (Figure 54).

*Figure 54. Successional hardwood forest between the pine plantation and ravine system in Zone TY-F with remnant longleaf pine.*

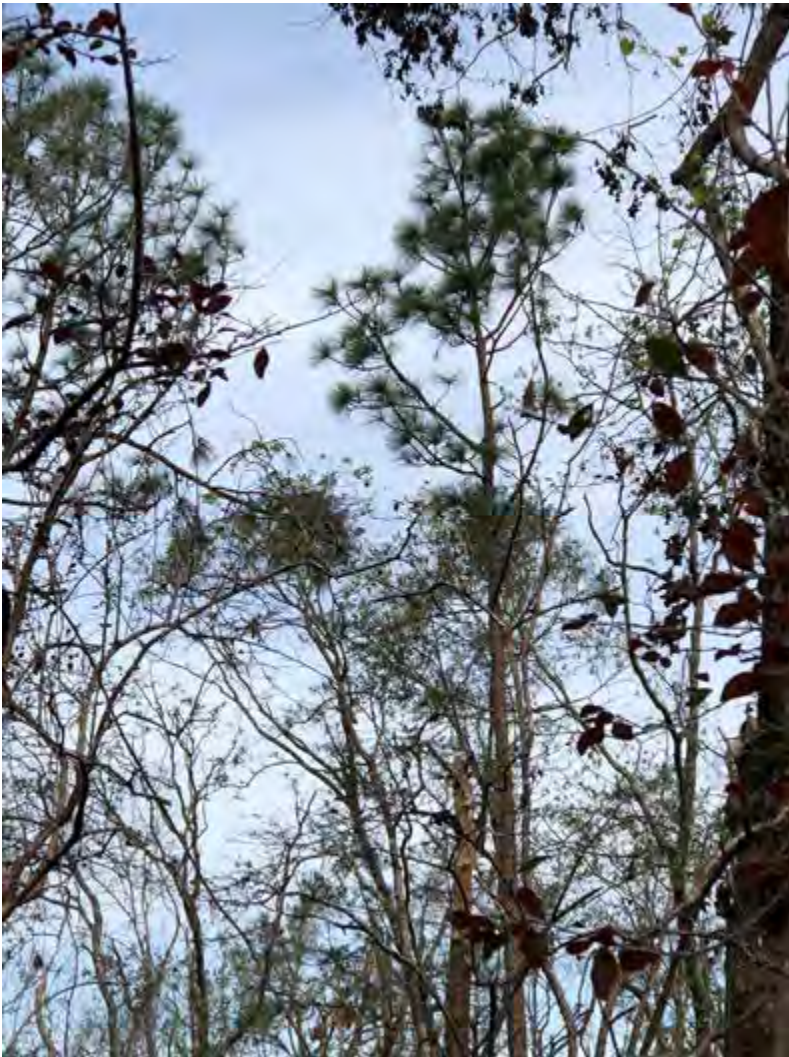
*Figure 55. Remnant longleaf pine between the pine plantation and ravine system in Zone TY-F.*

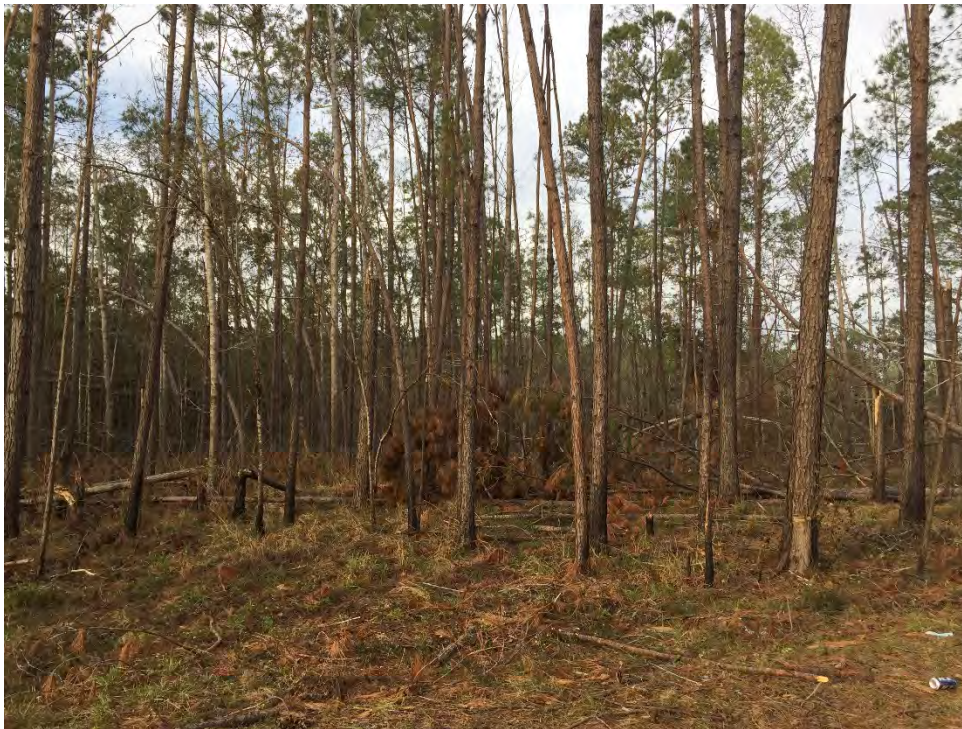
*Figure 56. Pine plantation along Aspalaga Road in TY-A14.*

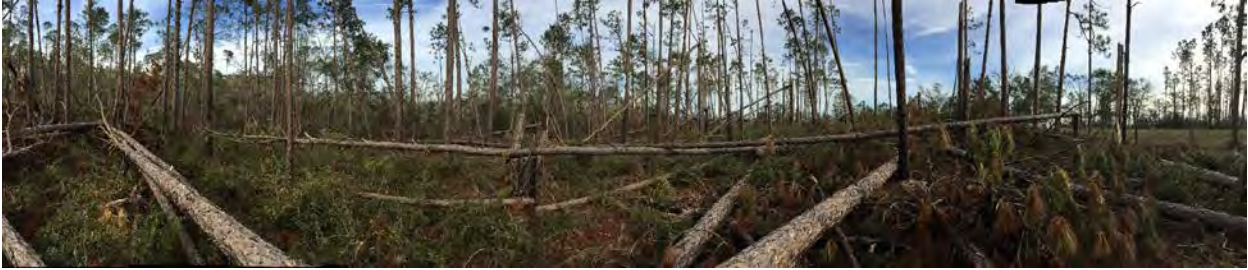
Figure 57. Older portion of the slash pine plantation with heavy damage in Zone TY-F.
