**Phase 1: Rapid Assessment and Evaluation  
Of Restoration Options at State Parks  
Affected by Hurricane Michael  
Task Assignment No.: FN-016  
Contract No.: 10109**

**Draft Interim Report to the Florida Park Service  
Department of Environmental Protection**

February 2019

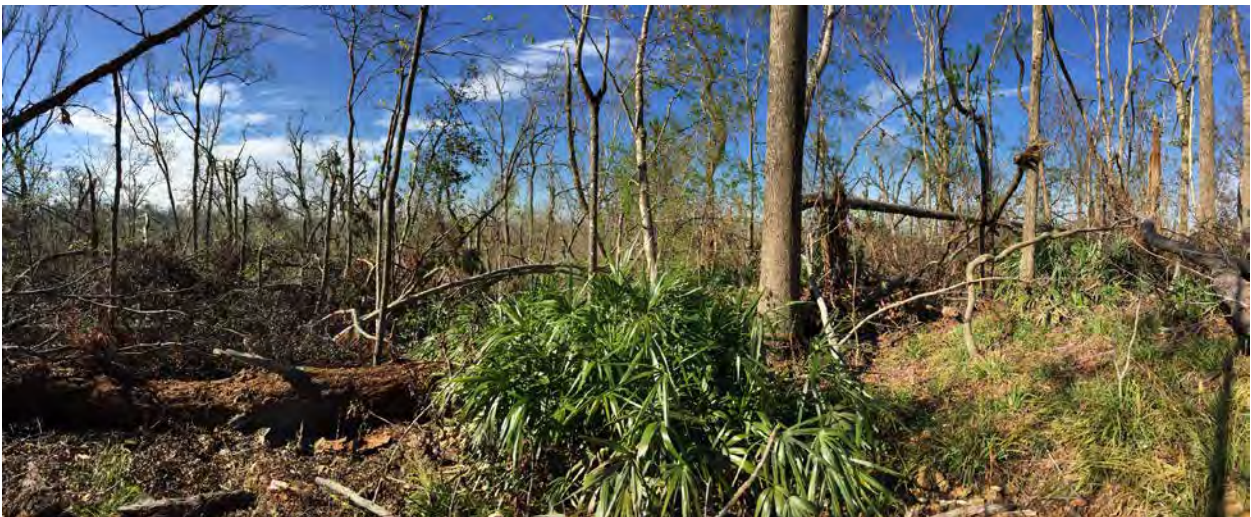
As with the forested wetlands significant canopy damage occurred in the slope forests (Figures 58 and 59). These are limited rich hardwood communities with mixed canopies on ravine slopes dominated by a diverse suite of species including deciduous trees such as white oak (*Quercus alba*), Florida maple (*Acer saccharum* ssp. *floridanum*), and American beech (*Fagus grandifolia*), and evergreen species such as southern magnolia (*Magnolia grandiflora*), live oak (*Quercus virginiana*) and spruce pine (*Pinus glabra*) among others. Several rare tree species occupy this globally significant habitat including American bladdernut (*Staphylea trifolia*), Florida yew (*Taxus floridana*), Florida torreya (*Torreya taxifolia*). The dense canopy and multiple layers of midstory vegetation restrict air movement and light penetration, which maintains high relative humidity within this community. The groundcover is made up of shade-tolerant herbs, graminoids, shrubs, and vines, several of which are rare in Florida and/or more common further north (i.e., narrow-leaved trillium (*Trillium lancifolium*), croomia (*Croomia pauciflora*), Carolina lily (*Lilium michauxii*) and eastern leatherwood (*Dirca palustris*) among many others). Given the significant canopy loss due to Hurricane Michael, the delicate microclimate of these areas will undoubtedly be changed causing unknown effects to the community structure and

Figure 59. Needle palm in slope forest with heavy canopy damage in Zone TY-Z.

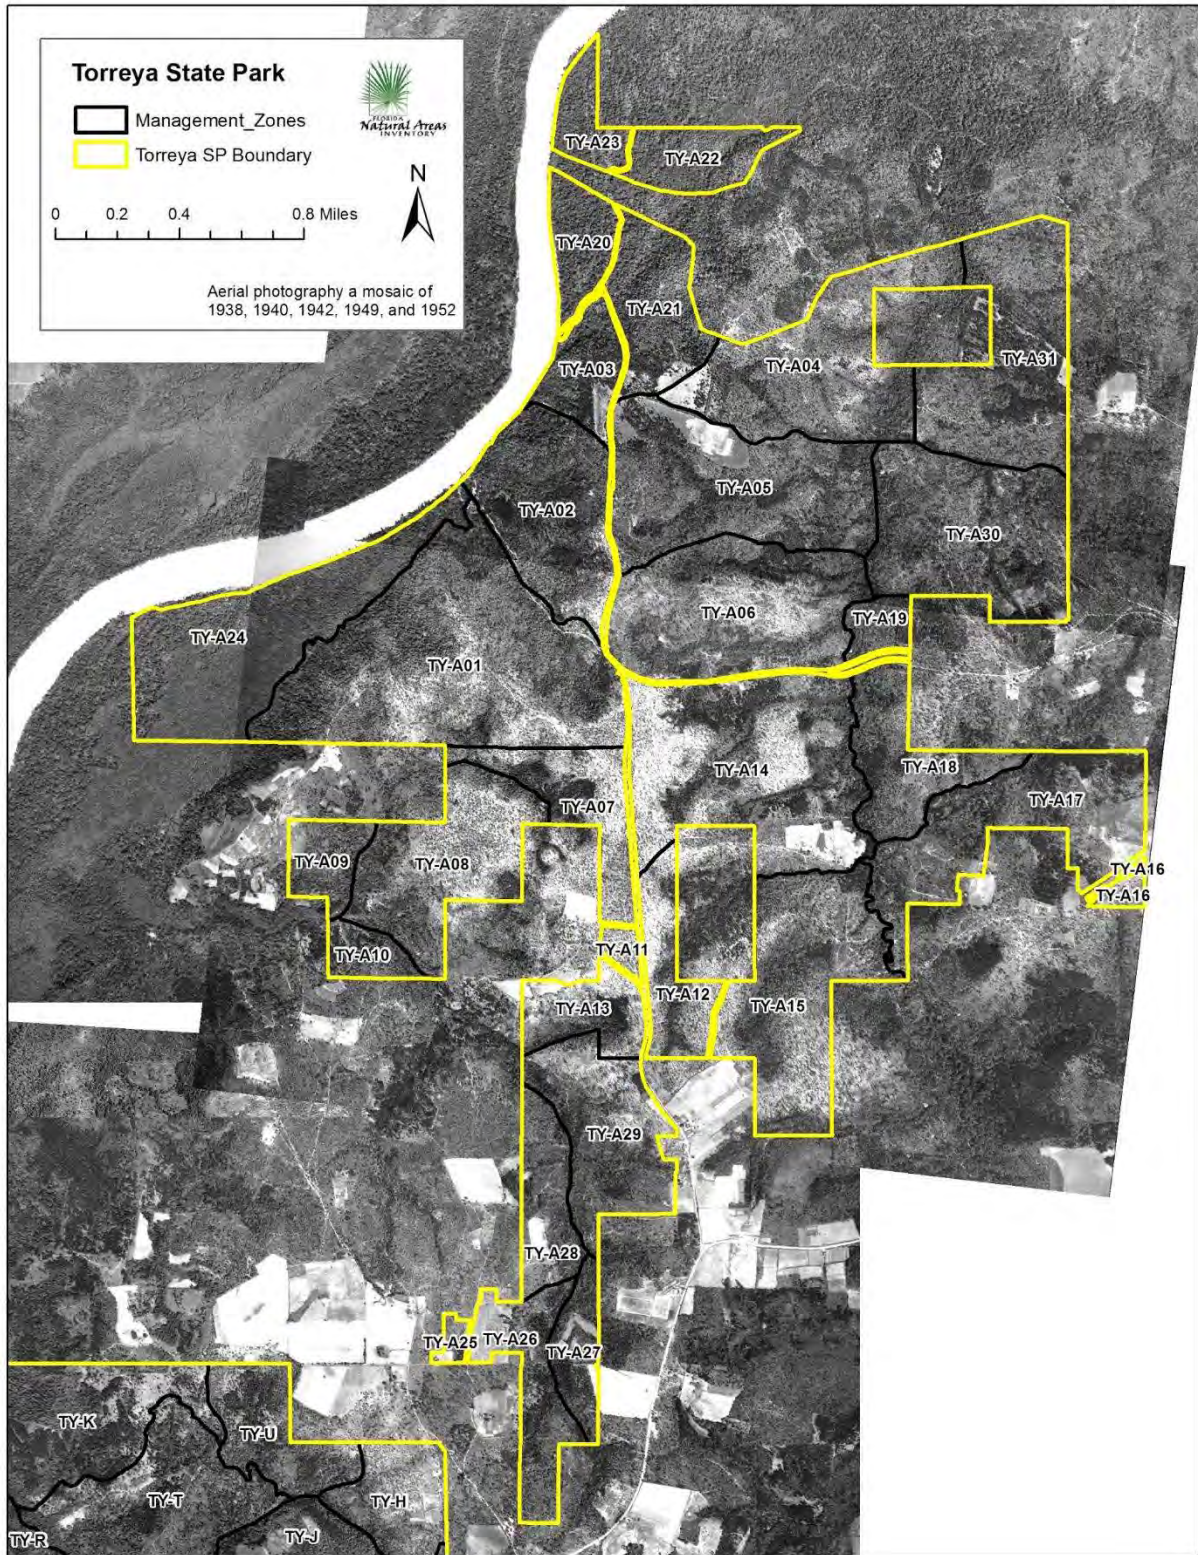
Significant canopy damage was observed in the upland pine stands in Zones TY-A03 and TY-A21 in the northern reaches of the Aspalaga Tract. This area represented some of the heaviest damage observed in the all the parks to date as it's on a high ridge of greater than 250 feet above the Apalachicola River. As evident from the historic imagery (See Figures 60-62), heavy land clearing and soil removal occurred

Figure 60. Torrey State Park, Aspalaga Tract Management Units with aerial photography in a mosaic from 1938, 1940, 1942, 1949, and 1952.

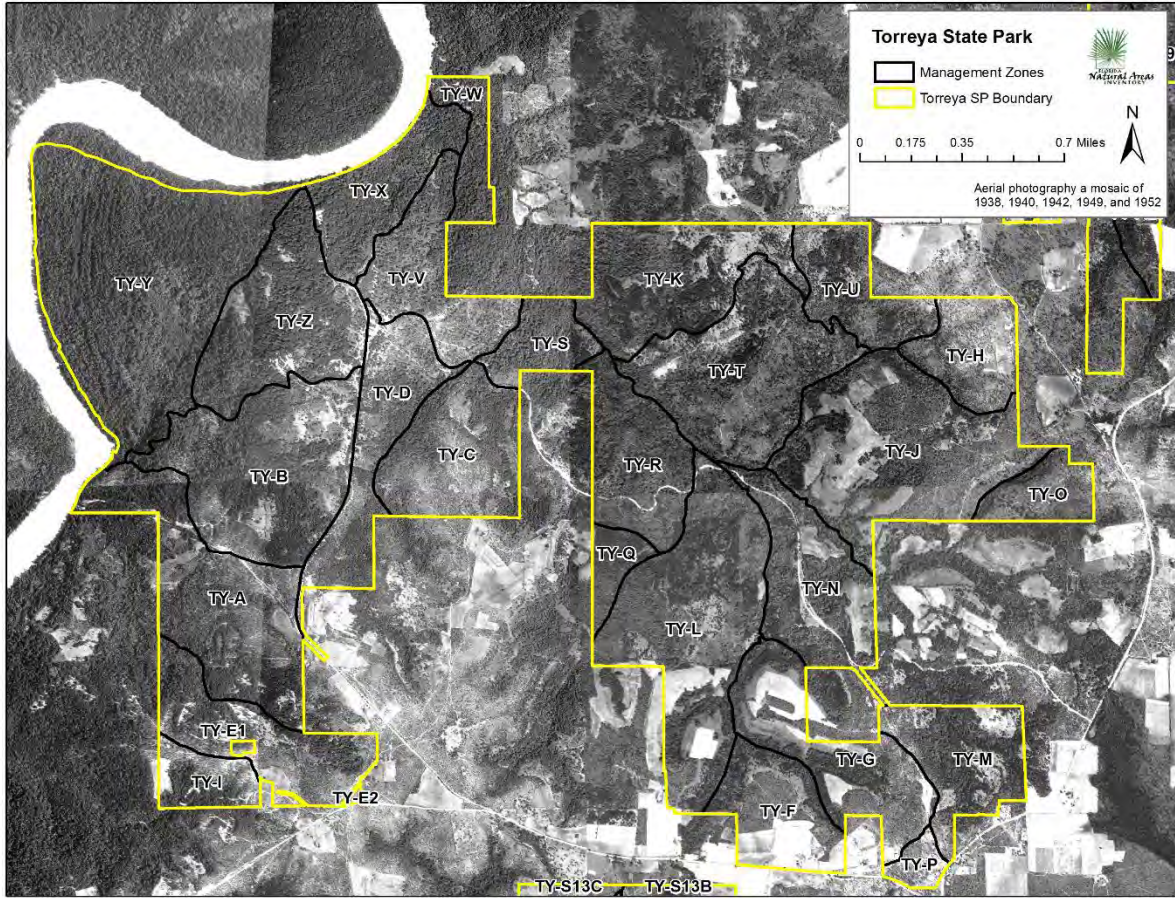
Figure 61. Torrey State Park, Rock Creek Tract Management Units with aerial photography in a mosaic from 1938, 1940, 1942, 1949, and 1952.

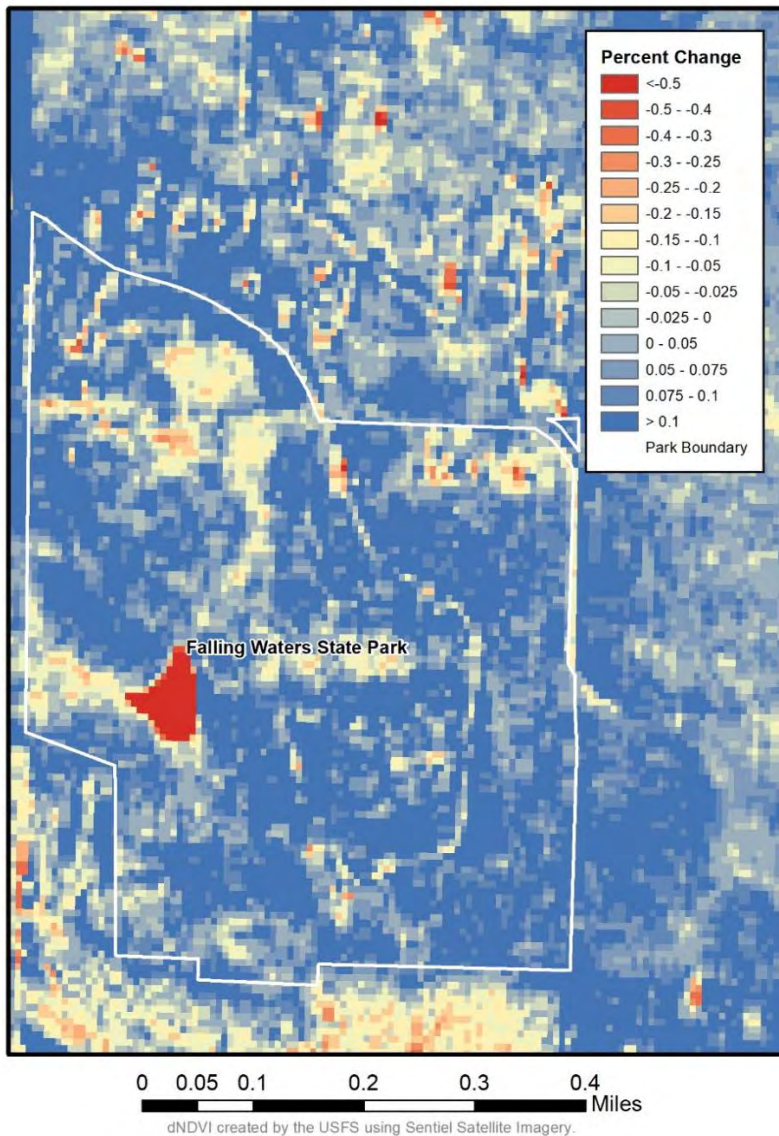
Figure 63. The dNDVI shows relatively low change values indicating light to moderate damage which is consistent with on the ground inspections.

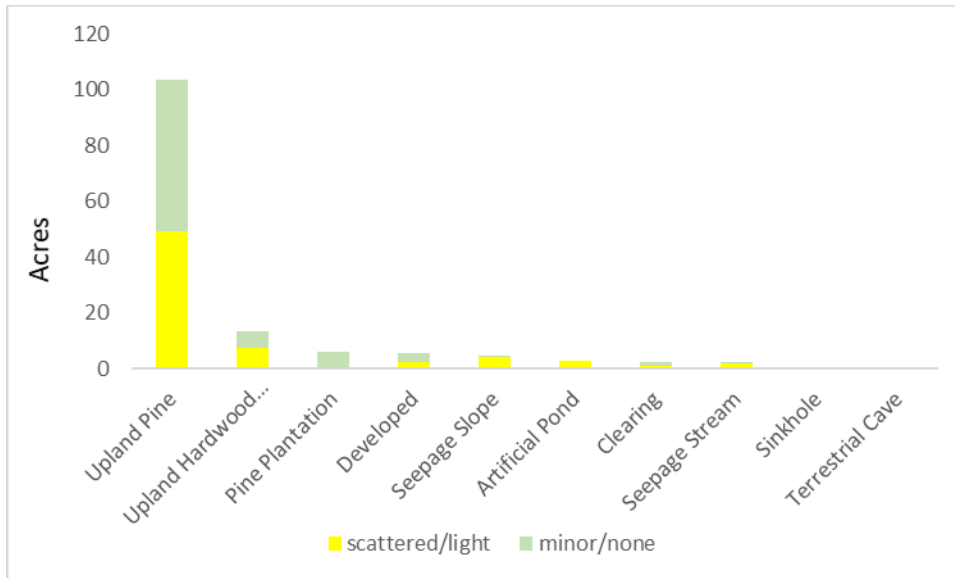
Figure 64. dNDVI Estimated Acres by Damage Class

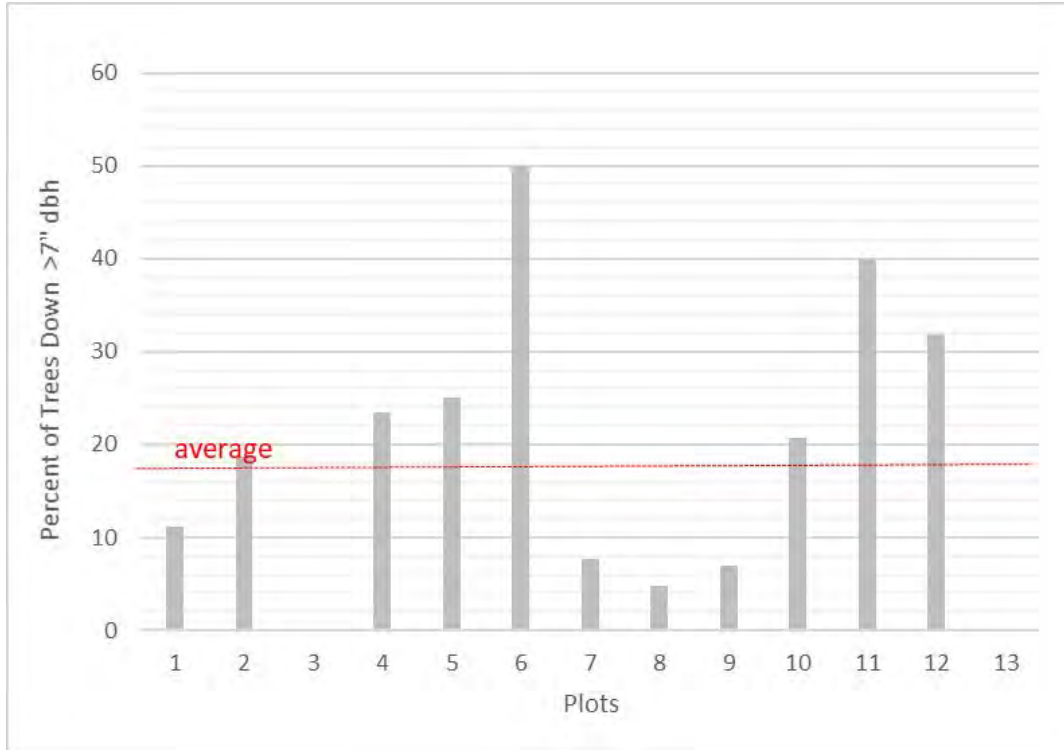
A field assessment was completed on January 15, 2018. The canopy damage varied across the park, ranging from 0 to 47% of trees >7" dbh downed in our plots. On average, the damage was light (20%) (Figure 64). The majority of plots were in upland pine/sandhill; the highest proportion of downed trees per plot observed was 47% and the lowest was 0% with an average of 20%. The plot in upland hardwood had 20% of trees down.

Figure 65. Percent of trees down in all plots at Falling Water State Park.

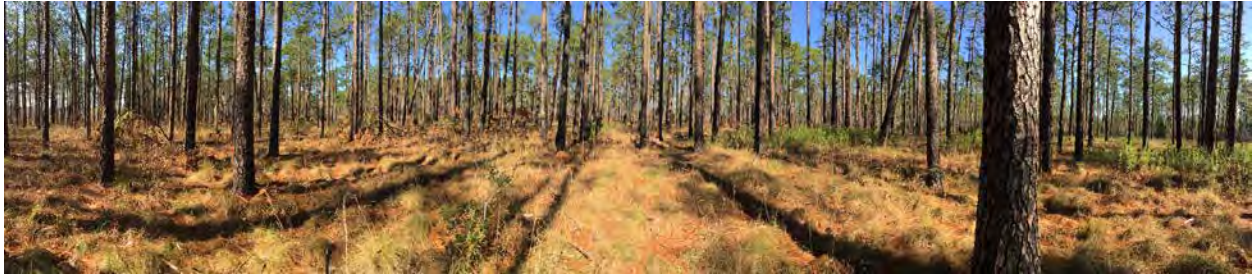
Figure 68. Upland pine with light damage in Zone FW-B.

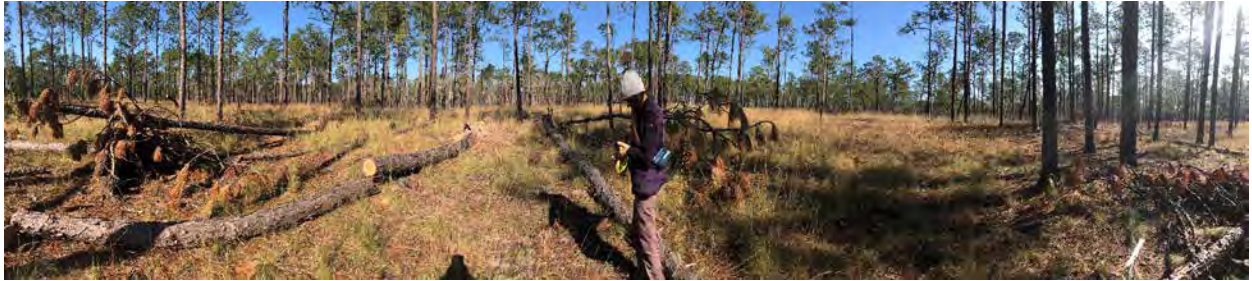
Figure 69. Upland pine with moderate damage.

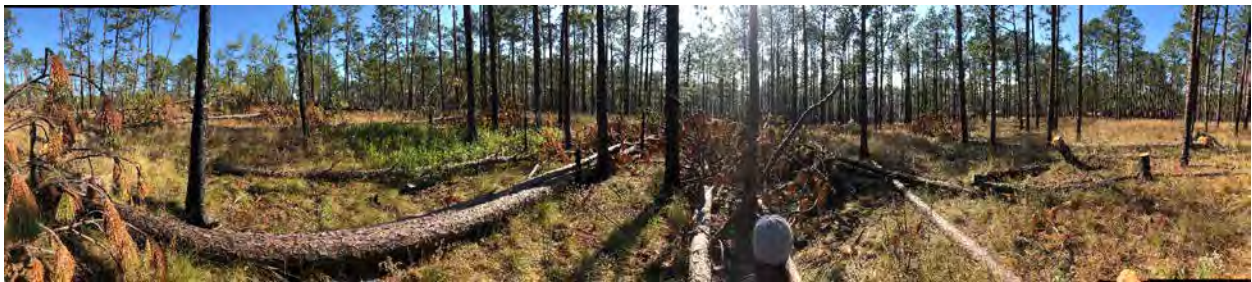
Figure 70. Heavy damage in upland pine in Zone FW-B.

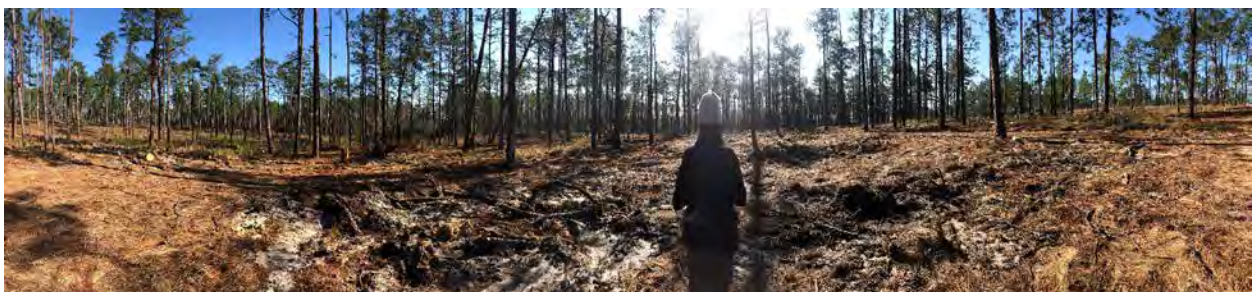
A few small areas were observed where heavier tree clearing had occurred and created some ground disturbance. Fire should help these areas rehabilitate and monitoring of these areas for invasive plant species recruitment is recommended. One such area is along the paved road in Zone FW-A (Figure 71). Wiregrass was dense here prior to the equipment impacts and is currently damaged but may recover as it was still green at the time of the survey. This is a very small portion of the overall excellent quality habitat.

Figure 71. Small section of Zone FW-A along the paved road where tree damage was heaviest and small scale soil disturbance to the groundcover was observed due to tree removal.

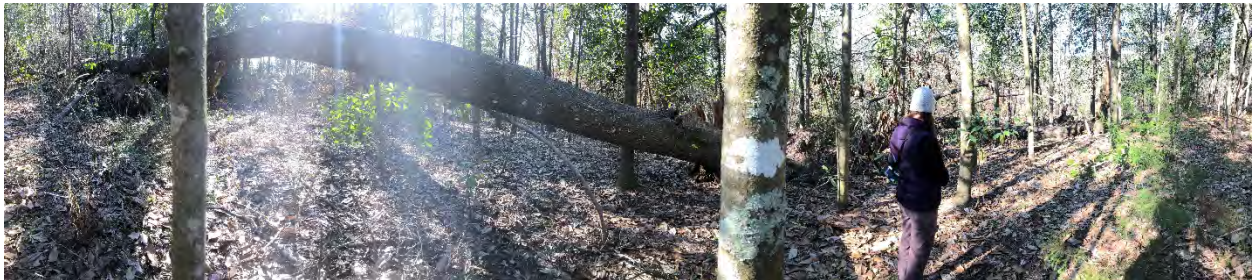
Figure 72. Upland hardwood forest near the falls in the south portion of Zone FW-B.

Upland hardwood forests are mixed canopy forests dominated by a diverse suite of species including American beech (*Fagus grandifolia*) and pignut hickory (*Carya glabra*), and evergreen species such as southern magnolia (*Magnolia grandiflora*), and laurel oak (*Quercus hemisphaerica*) among others. The dense canopy of upland hardwood forests and multiple layers of midstory vegetation restrict air movement and light penetration, which maintains high relative humidity within this community. The groundcover is made up of shade-tolerant herbs, graminoids, and vines such as sarsaparilla vine (*Smilax pumila*) and partridgeberry (*Mitchella repens*). In closed canopied habitats such as upland hardwood forest (see FNAI 2010), increased sunlight caused by tree damage from the hurricane can drastically change the microclimate of these formerly closed canopied forests. The successional changes that will occur over the next 20-50 years in such habitats are unknown at this point. However, damage is fairly minimal at this site (Figure 72). Minor canopy damage occurred in the upland hardwood forest at FWSP (Figure 72) with about 20% of trees knocked down. Canopy cover is still fairly high, with about 50% canopy cover and 20% subcanopy cover. Early successional species, such as laurel cherry (*Prunus caroliniana*), and invasive species, such as Japanese climbing fern (*Lygodium japonicum*) or Chinese privet (*Ligustrum sinense*), may show increases within newly formed canopy gaps. Community structure and composition monitoring post storm is recommended to document and better understand these successional transitions. Aside from areas of public access where safety concerns need to be addressed, we recommend exotic plant treatment and passive restoration (i.e. natural succession).

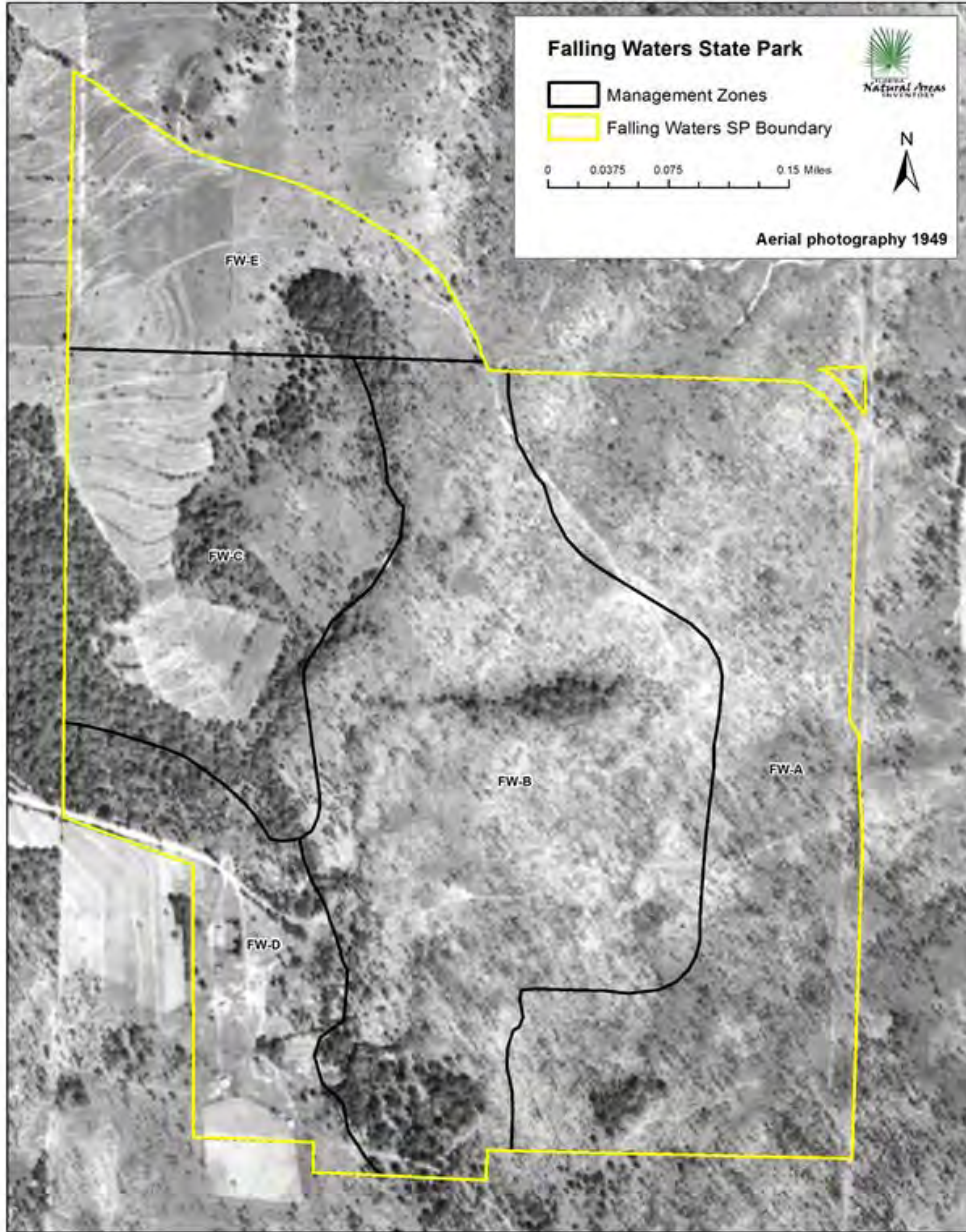
Aerial photography from 1949 indicates that most of the park was historically dominated by upland pine with sandhill occupying smaller, sandier soil areas (Figure 73). The northwestern and southwestern corners (portions of Zones FW-E, FW-D, and FW-C) were cleared for agriculture as early as 1949.

Figure 73. Falling Waters State Park management units with 1949 aerial photography.

The northwest corner of the park was cleared historically (as evidenced in the 1949 photography, See Task 3, Figure 73) and therefore is significantly different from the excellent quality habitat nearby in the forest. The area south of the campground in Zone FW-C has a canopy of slash and loblolly pine (*Pinus elliotii* and *Pinus taeda*), lacks wiregrass, and has a higher shrub cover than the rest of the park (36-45% cover compared with variable including <1% to 16-25% cover in the remaining areas of the park). Canopy damage in this portion is heavy (Figure 74) and this could be an area where small-scale timber removal followed by replanting with longleaf pine and wiregrass could benefit this small portion of Zone FW-C.

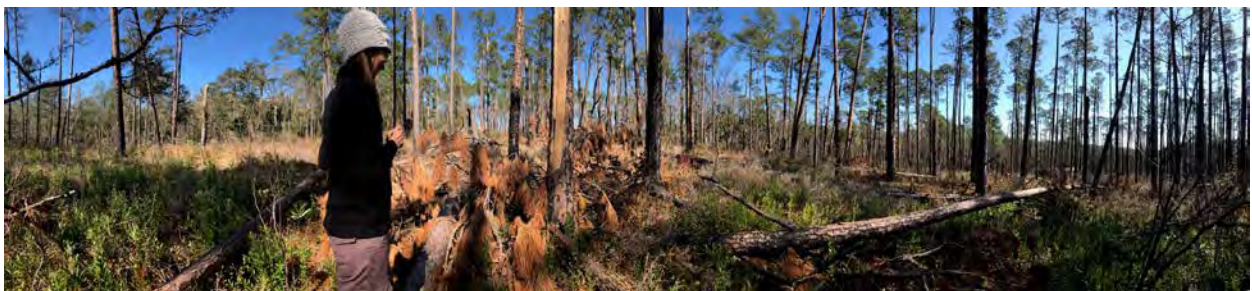
Figure 74. Heavy damage in upland pine just south of the campground in Zone FW-C.

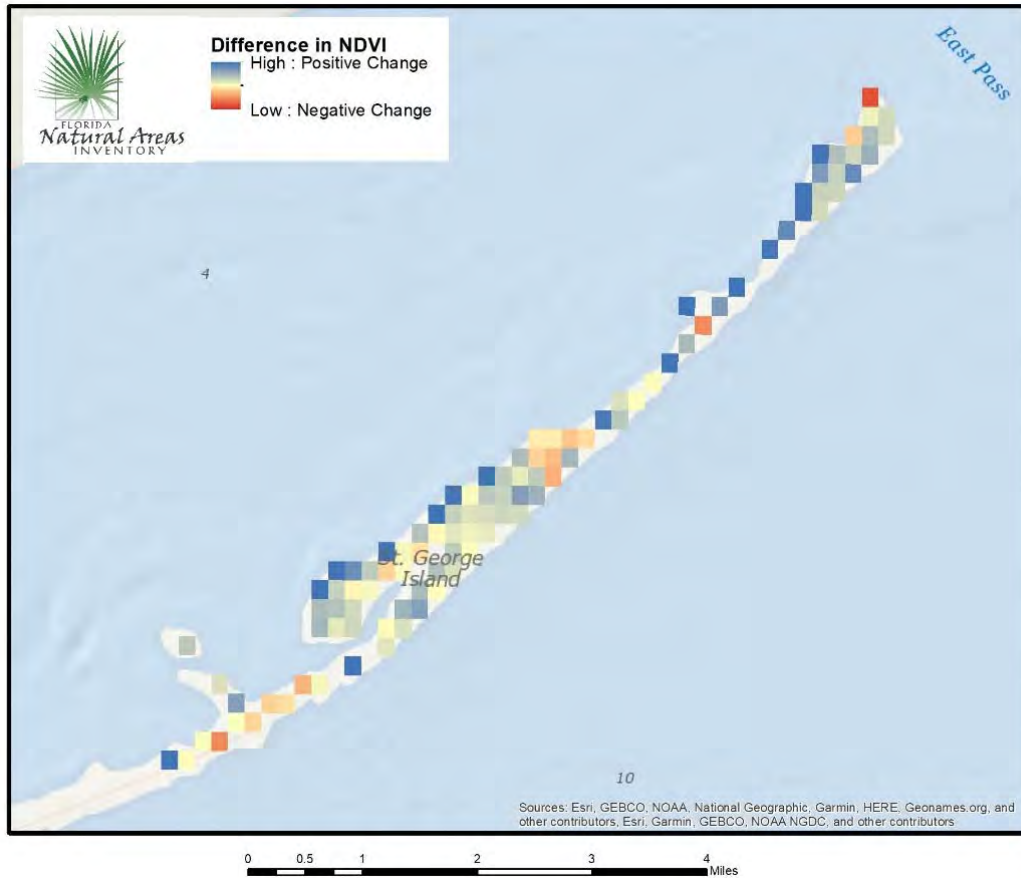
Figure 75. The dNDVI shows relatively low change values indicating light to moderate damage which is consistent with on the ground inspections.

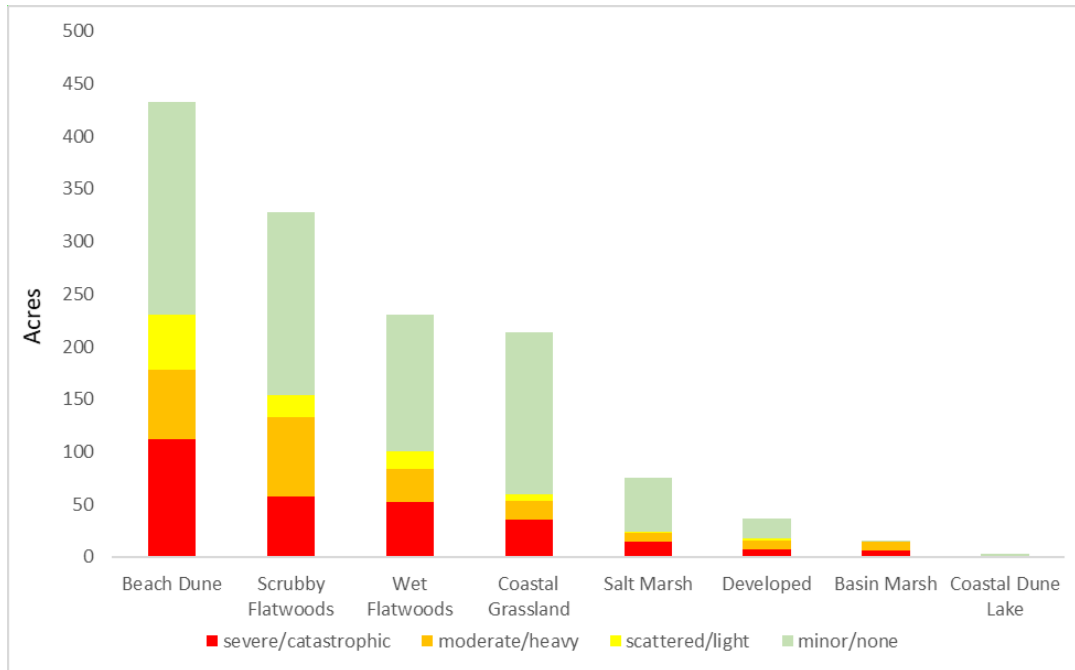
Figure 76. dNDVI Estimated Acres by Damage Class.

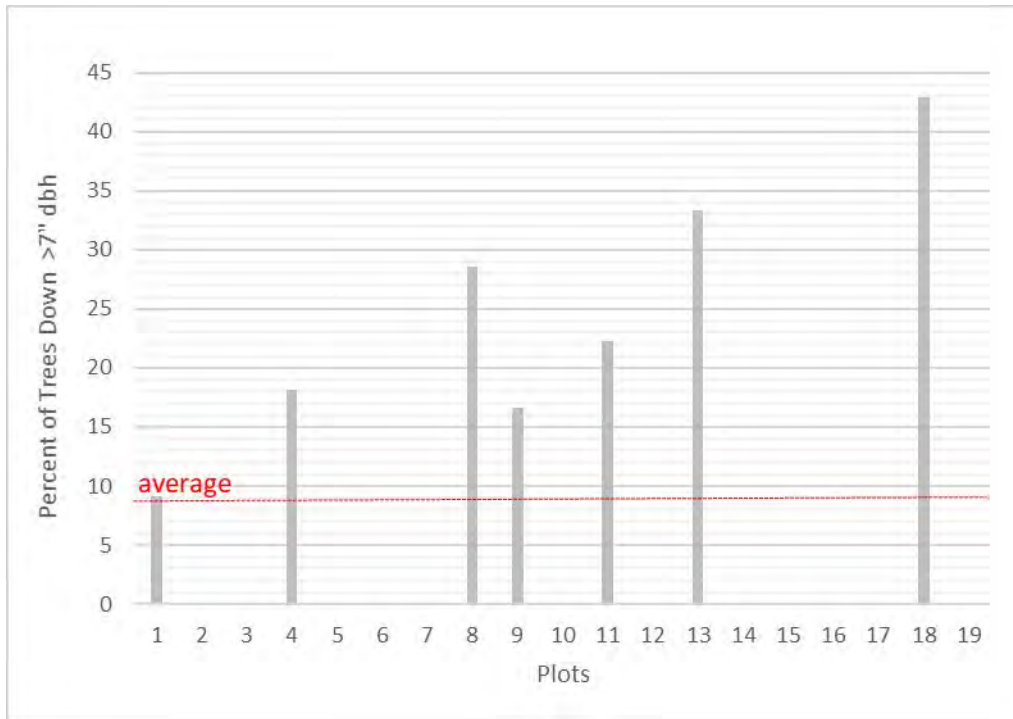
The most significant change to pine dominated natural communities as a result of the storm was tree damage. Generally, the canopies of all habitats that were observed during the field assessment had experienced some damage. The damaged trees are both blown down from the roots, the stem broken forming “A frames”, or the trees are standing dead from salt water influence. Damage was generally light in most places with downed trees observed ranging from 0 to 46% in our plots (Figure 77). On average, damage was light (9%) (Figure 77). Downed and dead trees result in increased fuel loads and increased sunlight availability to the ground layer. Increased sunlight to the forest floor may increase herbaceous plant diversity and abundance but this may be mitigated by the increased fine fuels present post storm. Increased fine fuels from storm damage may increase the risk of wildfire under dry

Figure 77. Percent of trees (>7" dbh) down in all plots at St. George Island State Park.

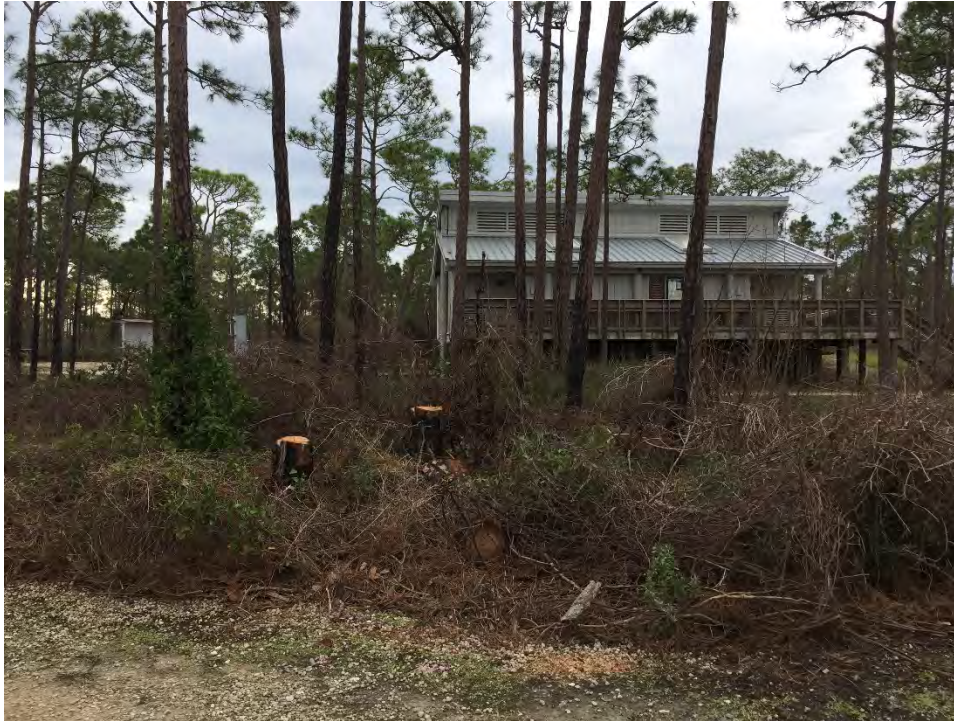
At the time of the field assessment, tree removal was already completed throughout the campground and youth camp areas, focusing on the immediate needs of clearing trees on and hanging over roads and structures (Figure 79). Storm debris remains heavy in some low areas away from the roads and facilities.

*Figure 79. Trees removed around the campground.*

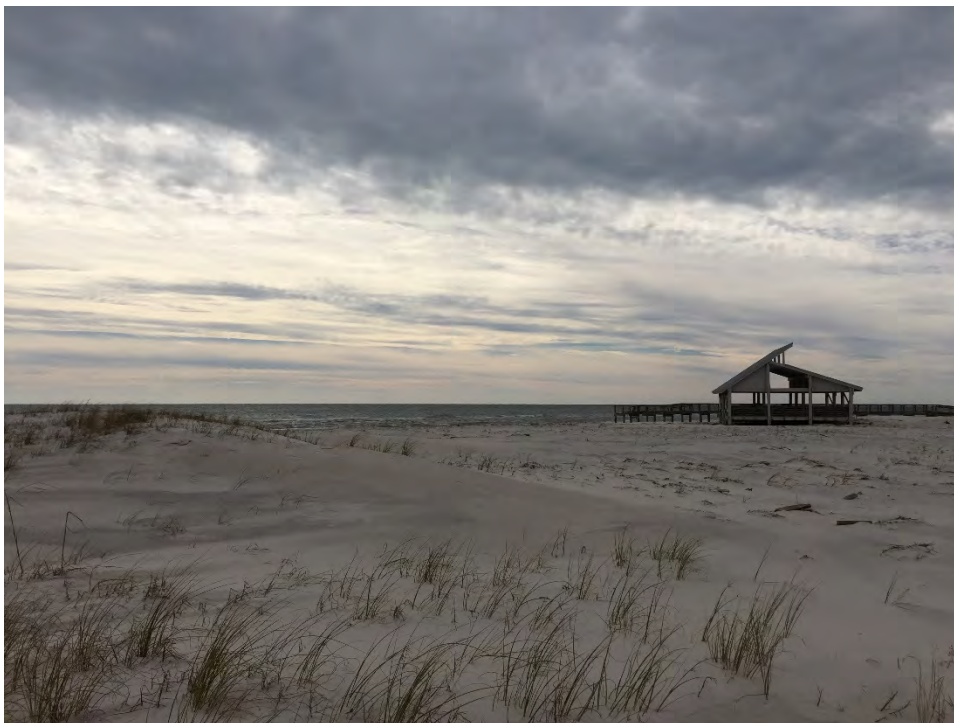
The two beach pavilion and bathroom complexes were not evaluated during the field survey but the land manager stated that structural damage had occurred during the storm, likely from both surge and wind. The dune landscape around these day-use areas is heavily changed because many of the primary dunes were washed out (Figure 80). Beach crossovers were seen to have structural damage (Figure 81).

*Figure 80. Beach day-use area in SG-12 post-storm.*

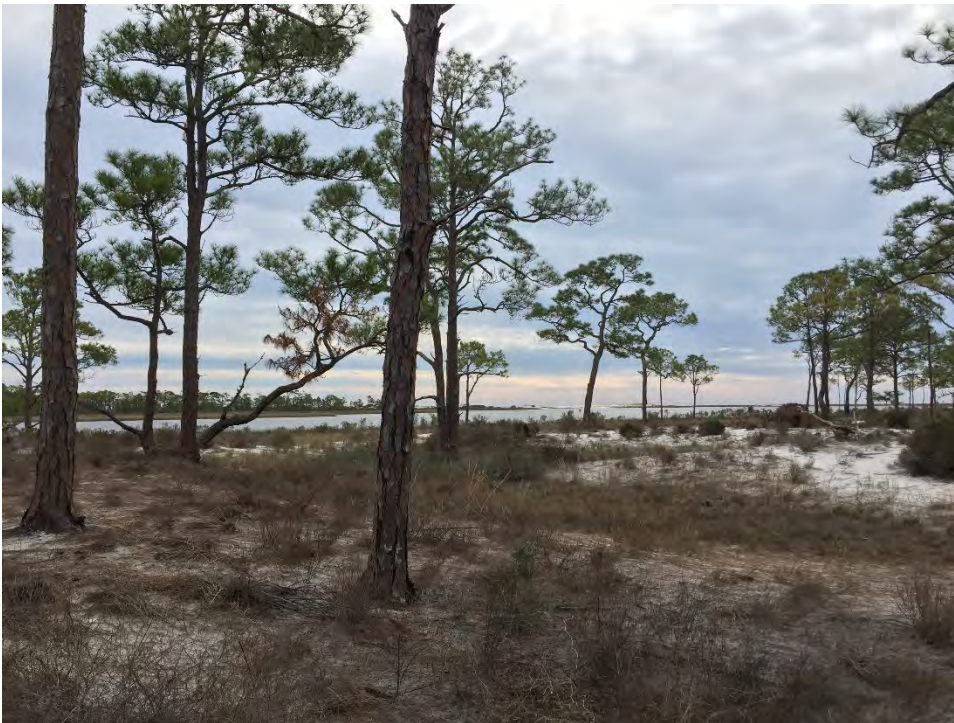
*Figure 83. Scrubby flatwoods with no canopy damage.*

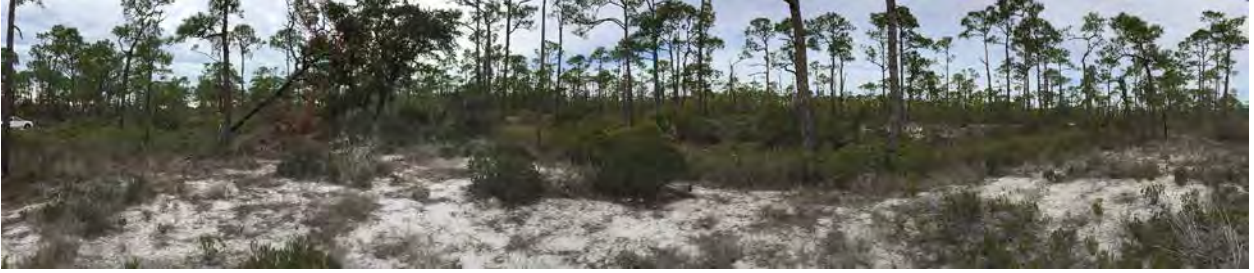
*Figure 84. Scrubby flatwoods with light damage from wind.*

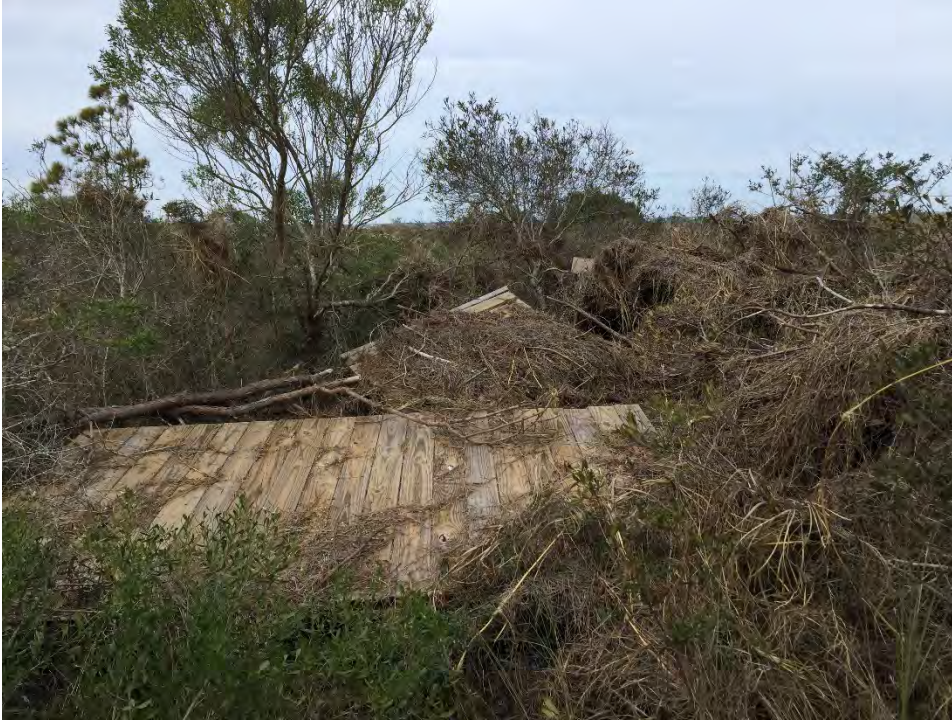
Figure 86. Heavy debris and portion of boardwalk accumulated in a wet flatwoods in Zone SG-14.

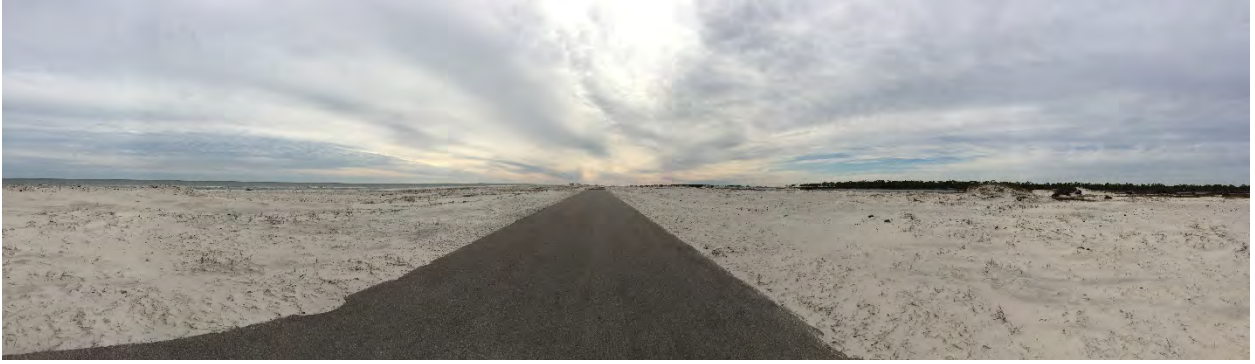
The dune system at SGISP has variable damage. The primary dunes on the east and south sides of the main park road were severely damaged. Some are heavily eroded or sheared off on the ocean side and some have been completely removed, leaving a wide flat sand surface where the dunes once stood (Figures 87 and 88). In this case, much of the sand was deposited on the vegetated, landward side of the dunes (coastal grassland) and on the park road. Some of the highest dunes observed during the field survey, on the north and west side of the main park road, appeared fairly intact but have light to moderate erosion (Figure 89). Heavy storm debris was observed at the base of one tertiary dune in Zone SG-01, a result of the storm surge that was blocked by the extremely tall dune (Figure 90). This tertiary dune did experience some sand deposition as well; it remains in fairly good condition.

*Figure 87. Park road with flattened dune system on both sides.*

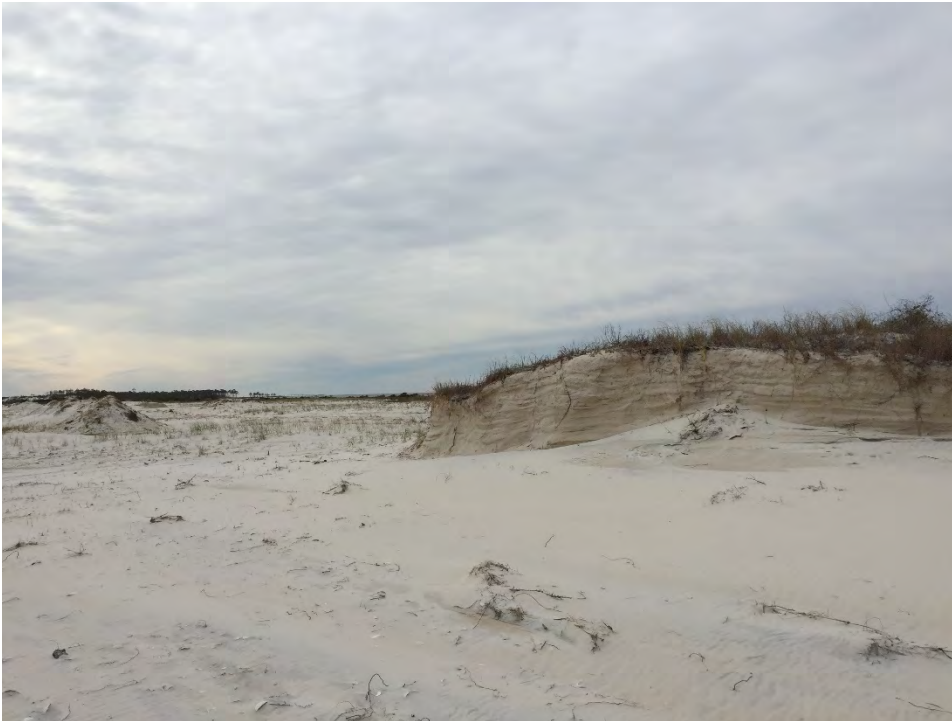
*Figure 88. Sheared off primary dune.*

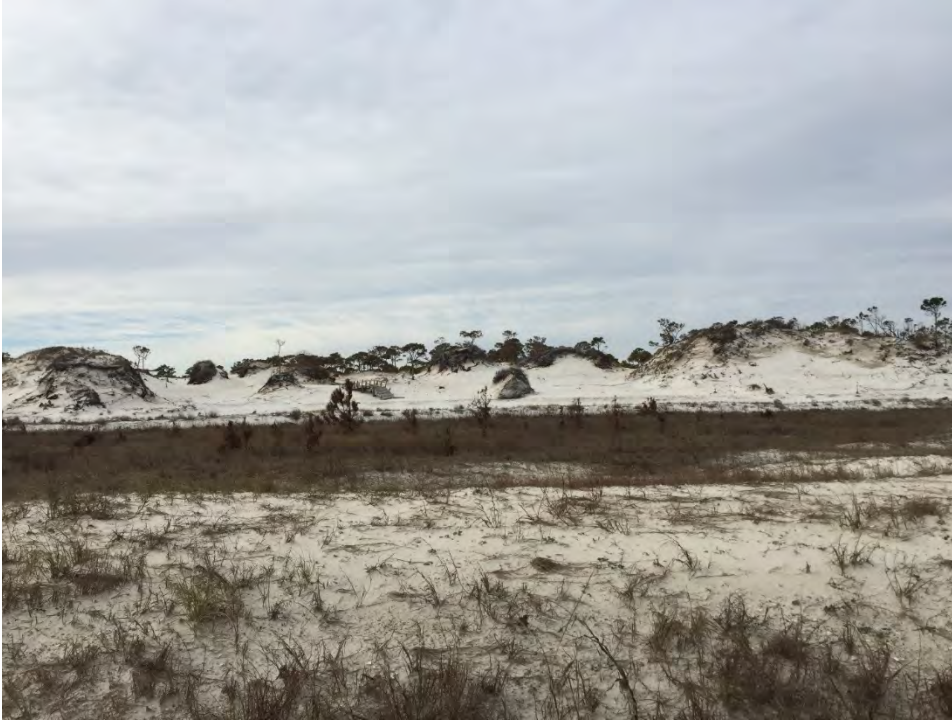
Figure 89. Tertiary dune with coastal grassland in the foreground.

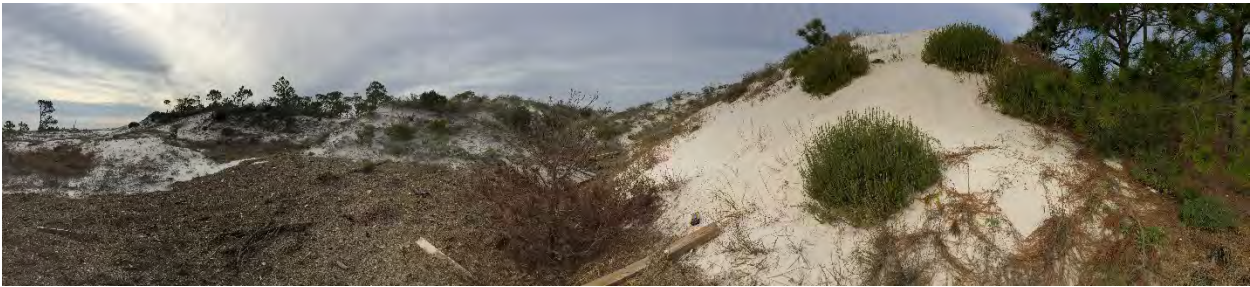
Figure 90. Tertiary dune with heavy debris at its base and some sand accumulation in Zone SG-01.

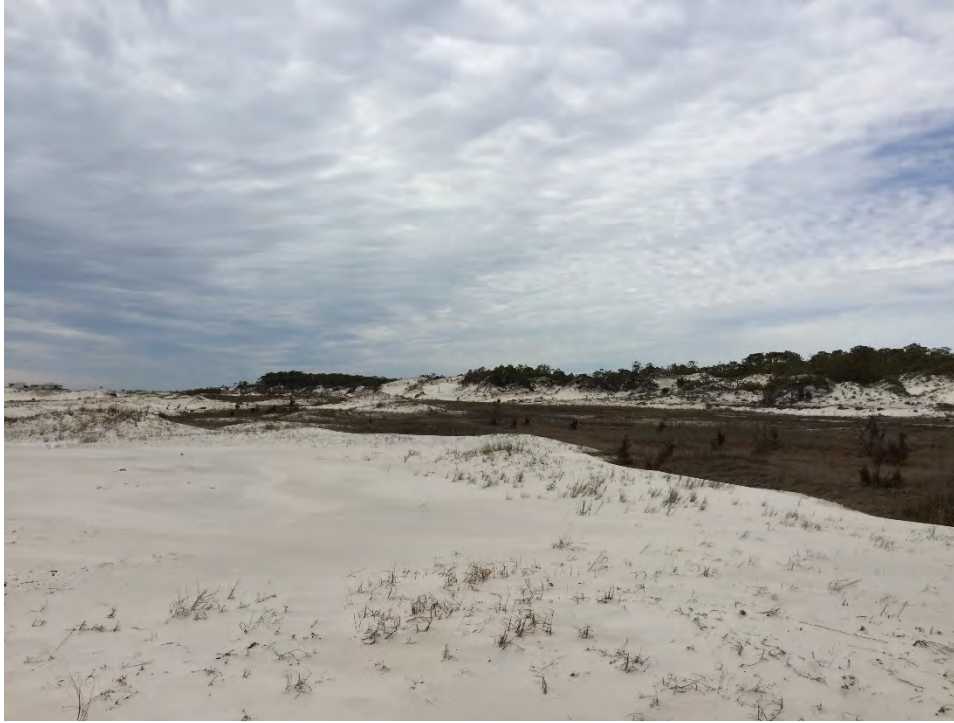
*Figure 91. Coastal grassland beyond beach dune.*

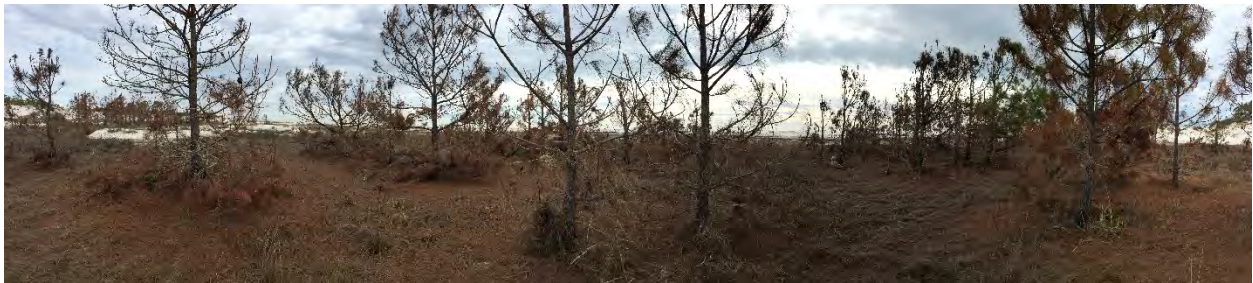
*Figure 92. Slash pine in coastal grassland that were killed by salt water.*

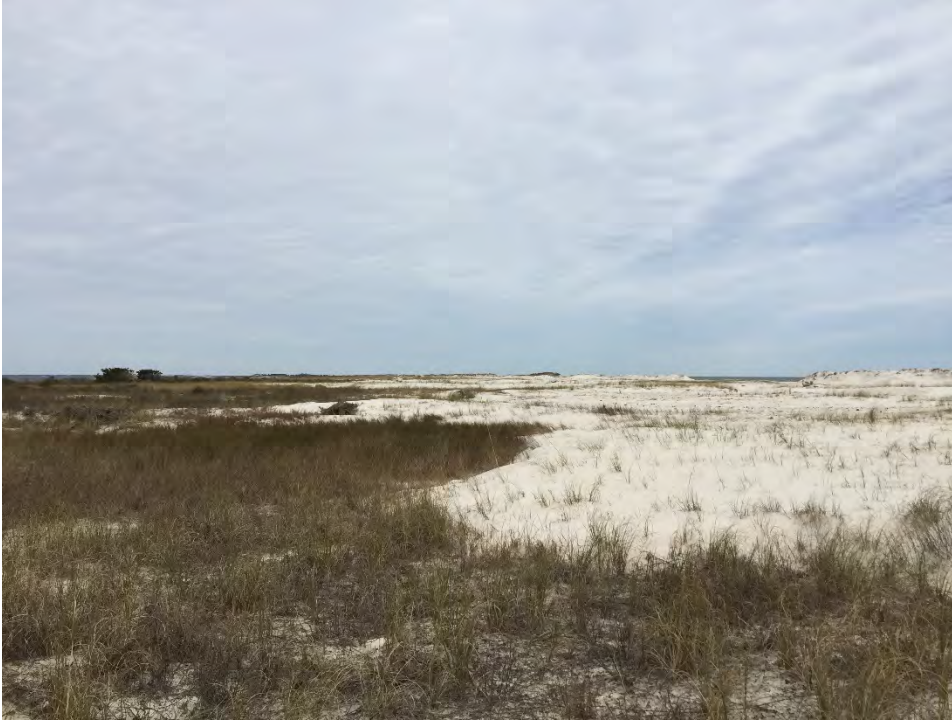
*Figure 93. Coastal grassland with sand deposition from adjacent dune.*

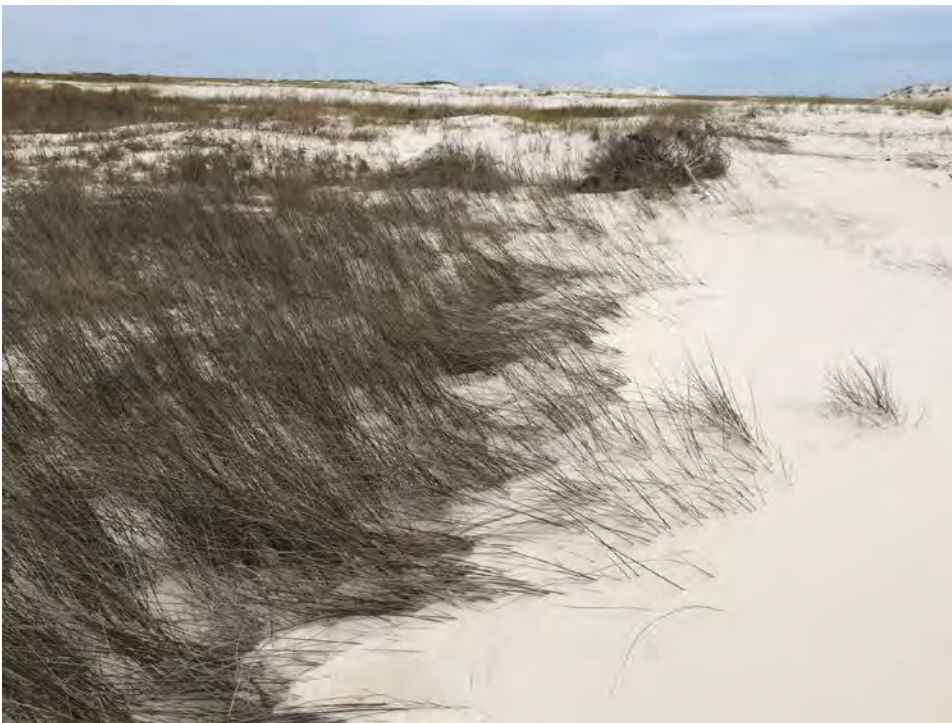
*Figure 94. Graminoids in a coastal grassland in Zone SG-14 partially buried by sand from nearby washed out dune.*
