**Phase 1: Rapid Assessment and Evaluation  
Of Restoration Options at State Parks  
Affected by Hurricane Michael  
Task Assignment No.: FN-016  
Contract No.: 10109**

**Draft Interim Report to the Florida Park Service  
Department of Environmental Protection**

February 2019

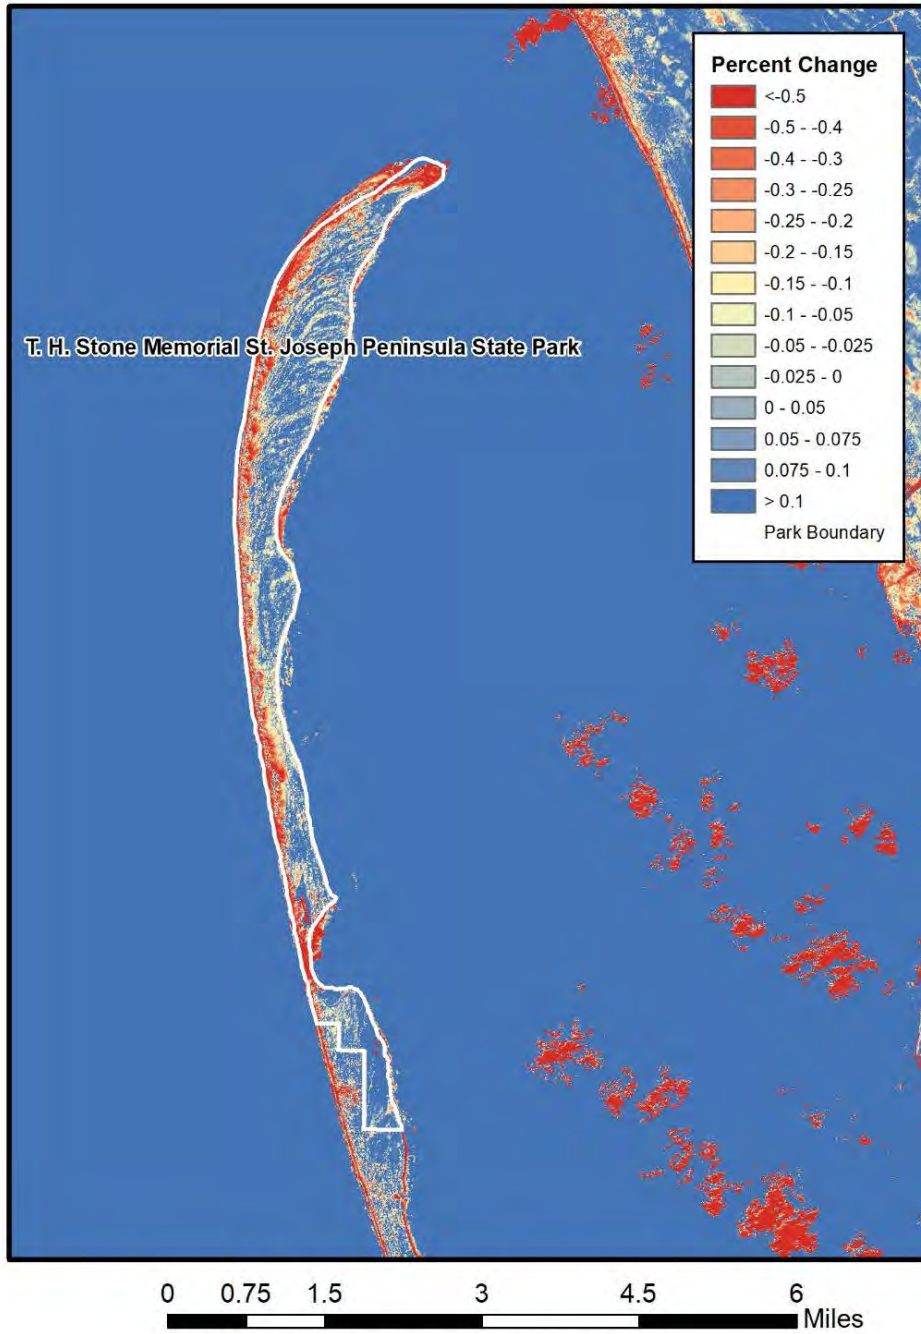
Figure 95. The dNDVI shows relatively low change values indicating light to moderate damage which is consistent with on the ground inspections.

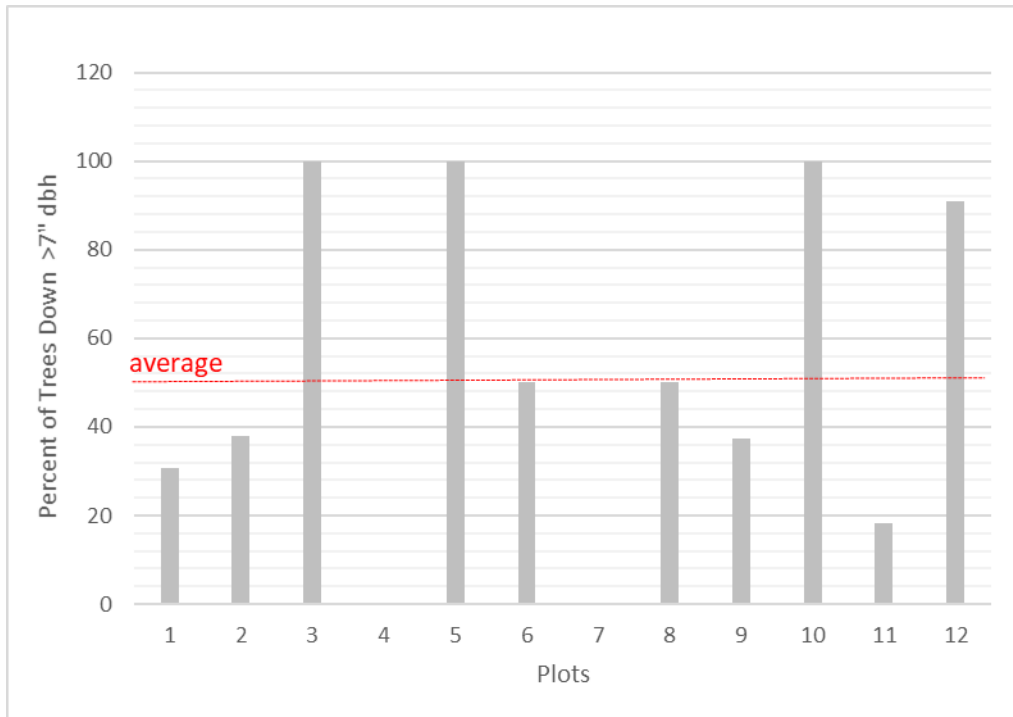
forming “A frames”, or the trees are standing dead from salt water influence. Damage was variable, from light to severe with downed trees occasionally observed ranging from 0 to 100% removal in our plots. On average, the damage was 56% (Figure 97). Damage was generally lighter in the flatwoods areas and heavier in scrub areas dominated by sand pine. Downed and dead trees create increased fuel loads as well as increased sunlight to the ground layer. Increased sunlight to forest floor may increase herbaceous plant diversity and abundance. There is also fine fuel present. Increases to fine fuels from storm damage will increase the risk of wildfire under dry conditions but also allow for better fuel continuity for prescribed burns done under more favorable conditions. A table below lists other variables measured in the plots (Figure 98).

Figure 97. Percent of trees (>7" dbh) down in all plots at St. Joe Peninsula State Park.

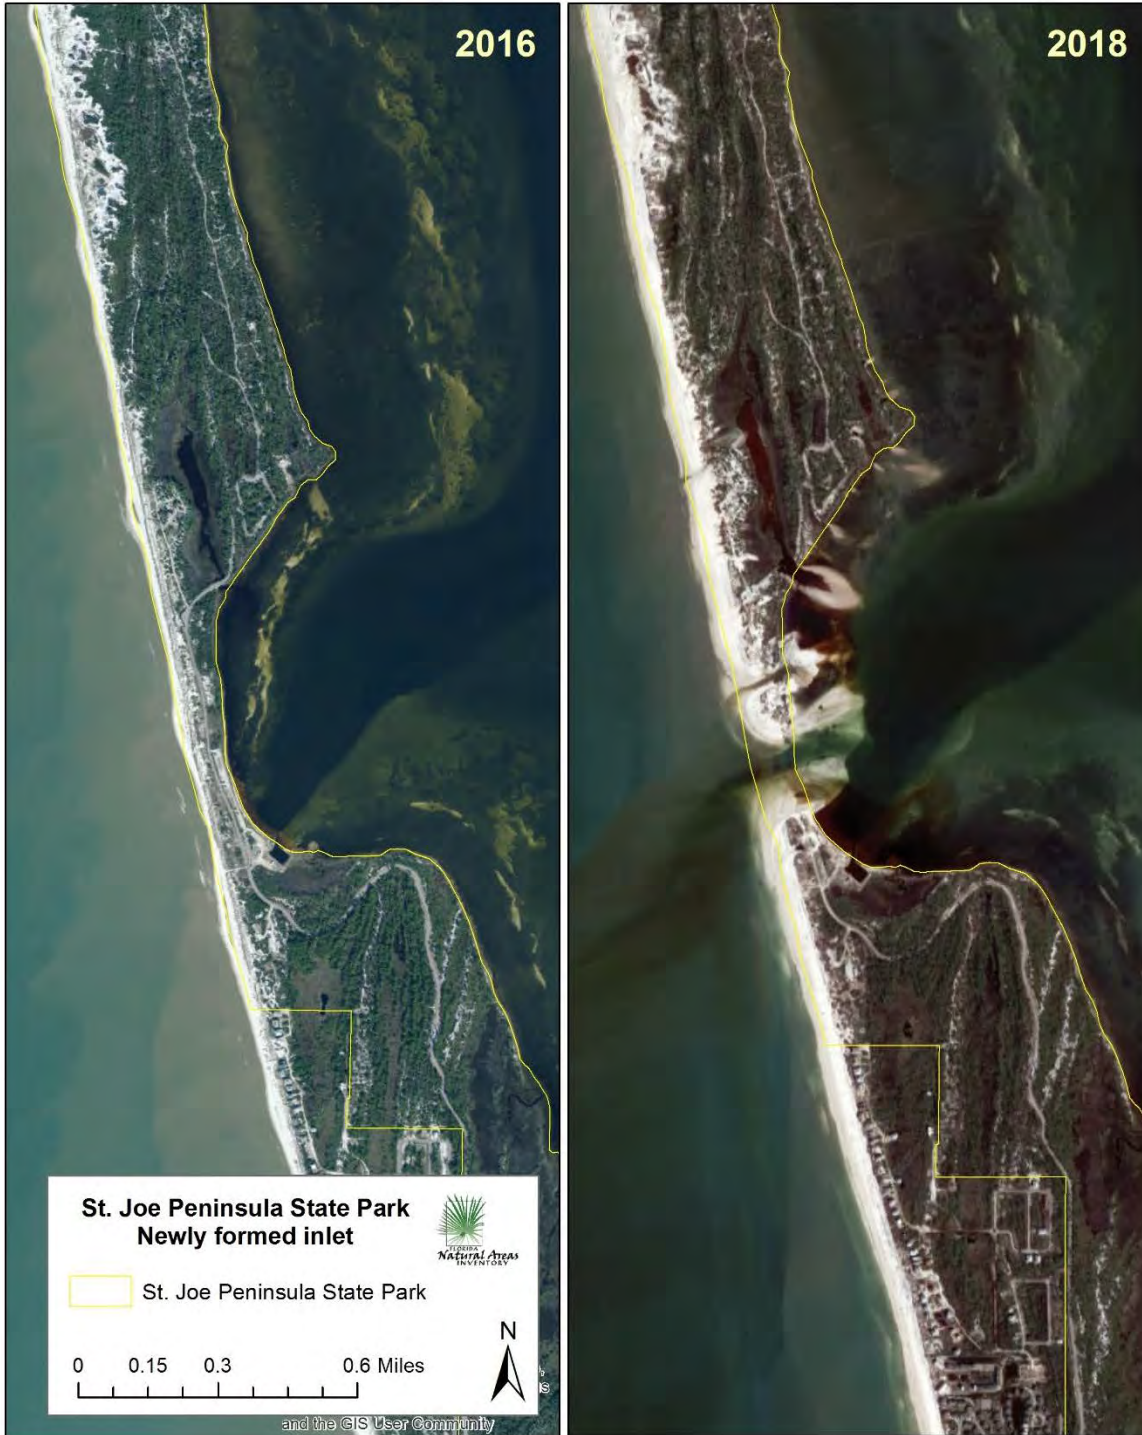
(Figures 99 and 100). This poses the most challenging obstacle to reopening the majority of the park as well as hurricane cleanup and restoration. The campgrounds, cabins, picnic area, staff housing and most of the parks day use areas are all north of the breach. Solutions to this are being considered by the Park Service and will significantly affect all future restoration efforts north of the breach.

Figure 99. Newly formed breach at Eagle Harbor in St. Joe Peninsula State Park. Imagery from 2016 and October 13, 2018 (post-storm).

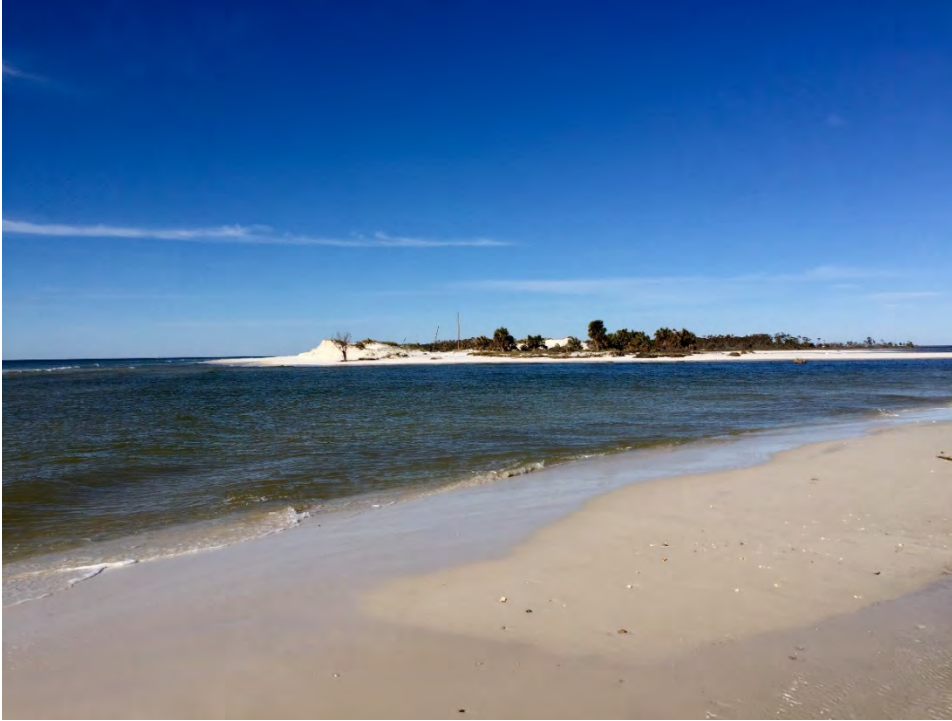
Figure 100. The newly formed breach looking north.

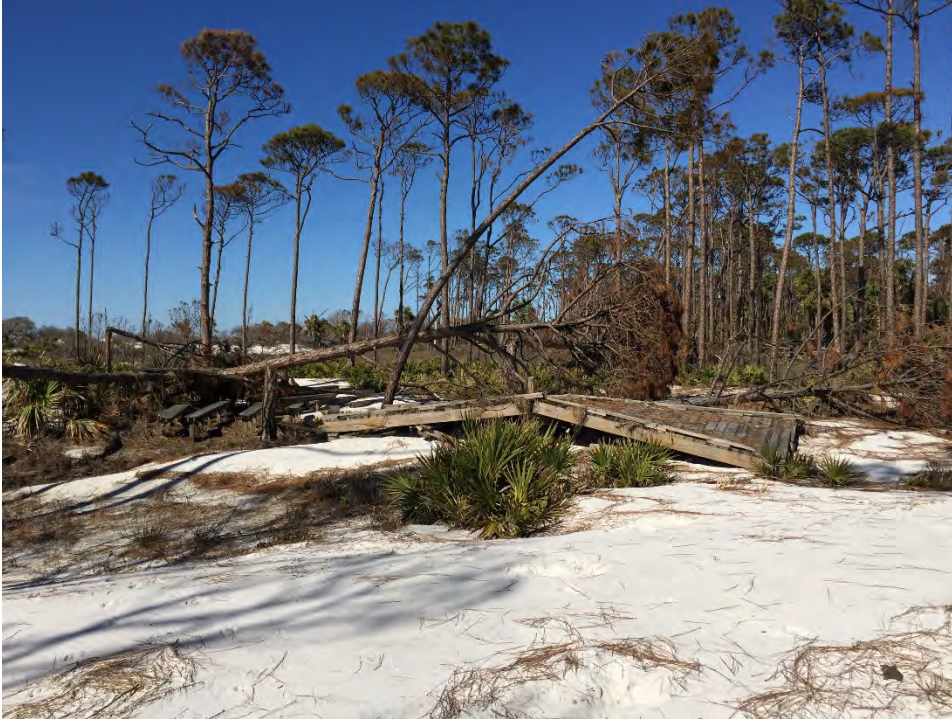
deposition from a nearby washed out dune (Figure 103). The ~500 m boardwalk that previously stretched between the Shady Pines and Gulf Breeze Campgrounds was washed out and pieces of it are deposited throughout the area in the flatwoods and marsh (Figure 103). Trees are still remaining on roads (Figure 104) and picnic tables and debris are widely deposited. The Gulf Breeze Campground and picnic area were not visited during the site visit but according to the park manager both were heavily impacted. The cabins were structurally impacted by storm surge flooding and currently have damaged trees around them. The boardwalk leading to beach access on the southern edge of the wilderness area was also washed out due to storm surge flooding (Figure 105).

*Figure 103. Sand deposition from nearby washed out dune and washed up portion of boardwalk in the Shady Pine campground.*

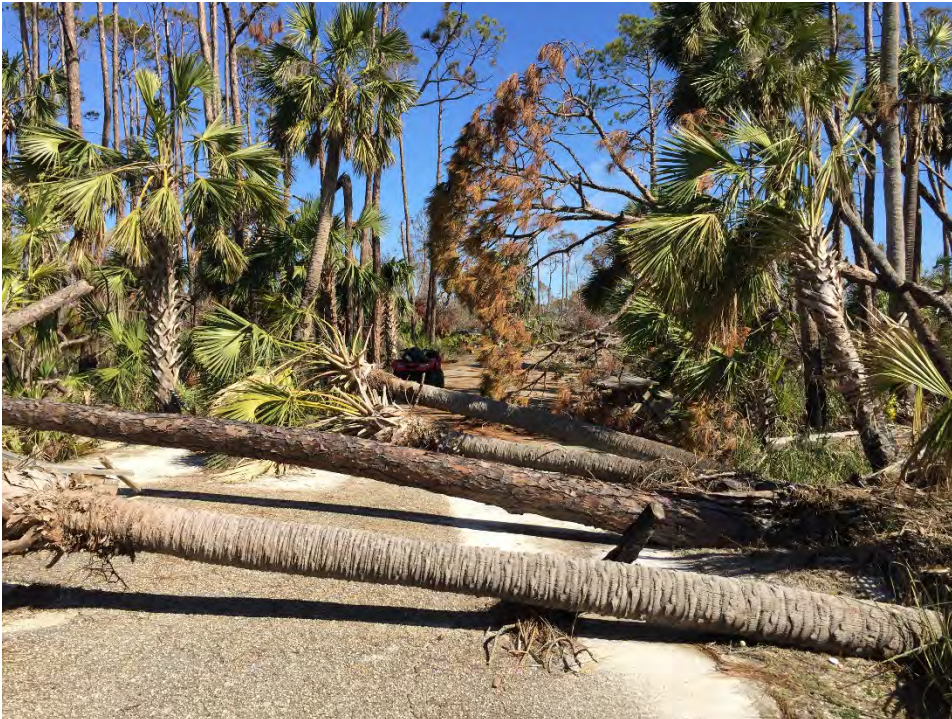
*Figure 104. Trees remaining on the road leading to the Shady Breeze Campground.*

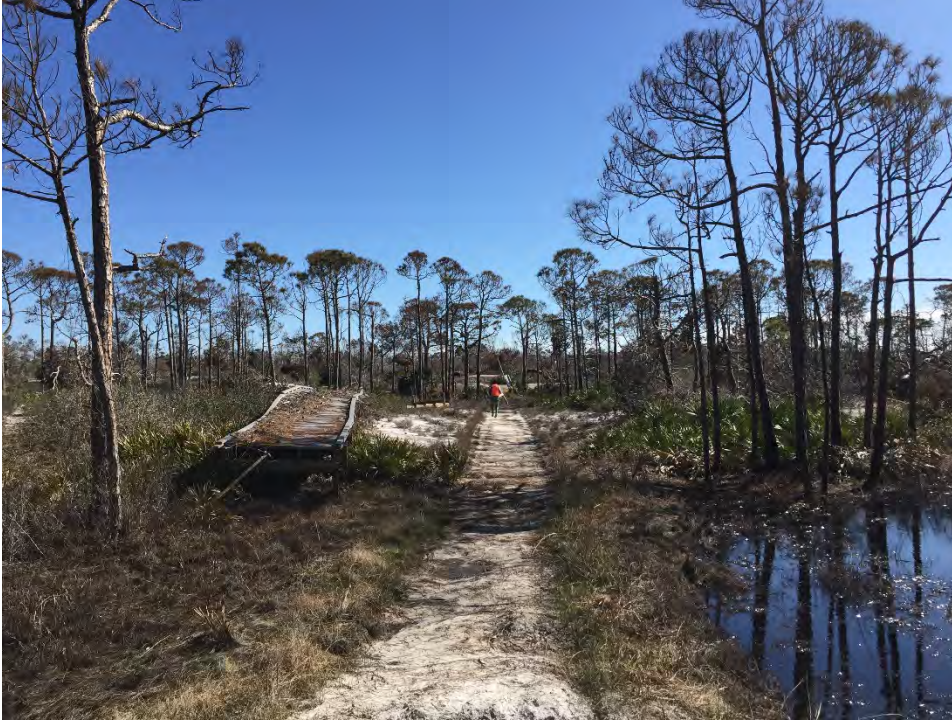
Figure 105. Boardwalk leading to beach access on the southern edge of the wilderness area.

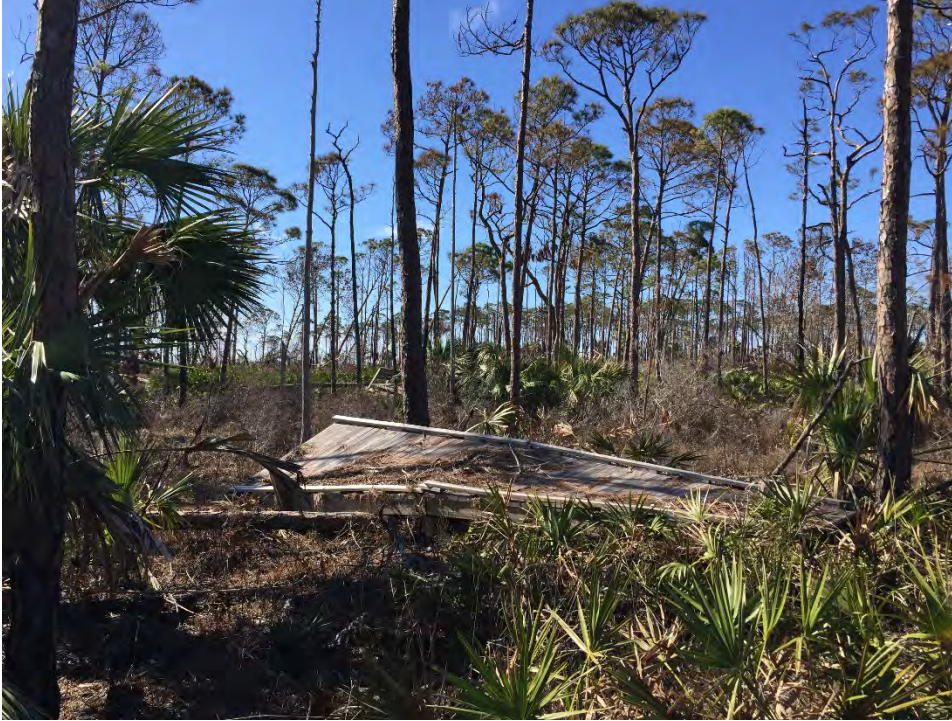
Figure 111. Heavy storm debris in scrubby flatwoods with a portion of a boardwalk in Zone SJ-10.

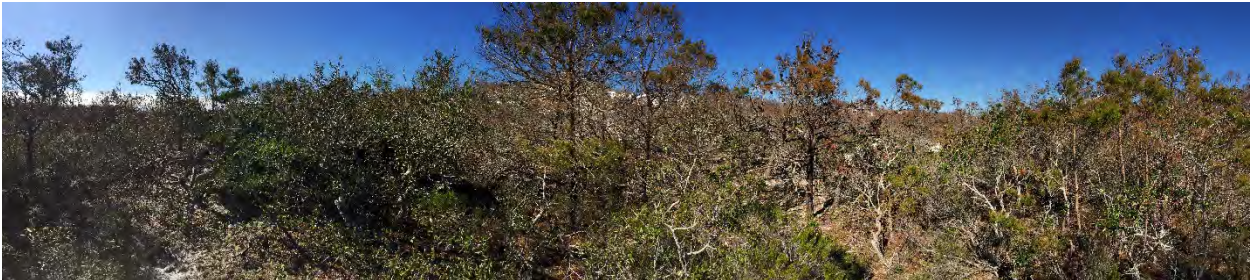
Canopy damage observed during the field assessment in scrub was variable from almost complete loss to moderate (Figures 112 and 113). The canopy and shrub layers in many scrub stands visited had major damage from salt water exposure or inundation. Sand pine needles and sand live oak leaves were salt burned. The sand pine needles were fully browned and likely dead at the time of the field survey. Damaged sand pines with fully browned needles will likely not regenerate but the sand live oaks were seen resprouting (Figure 114). This additional fuel load is expected to increase flammability in areas where extensive damage is present. Reintroducing fire as soon as feasible is the only further restoration the scrub on SJSP needs, which is required to attain desired future conditions and mitigate storm related damage.

*Figure 113. An example of scrub with a lower percentage of canopy and shrub death in Zone SJ-10.*

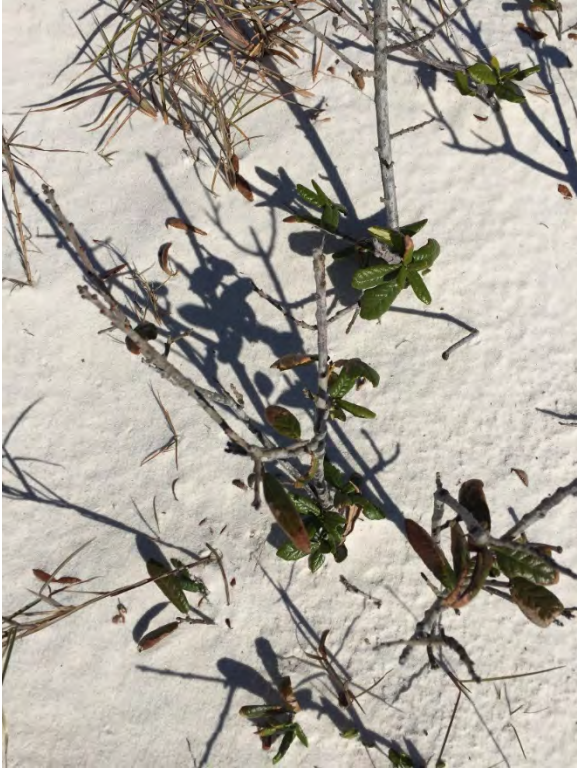
Figure 114. Resprouting sand live oak.

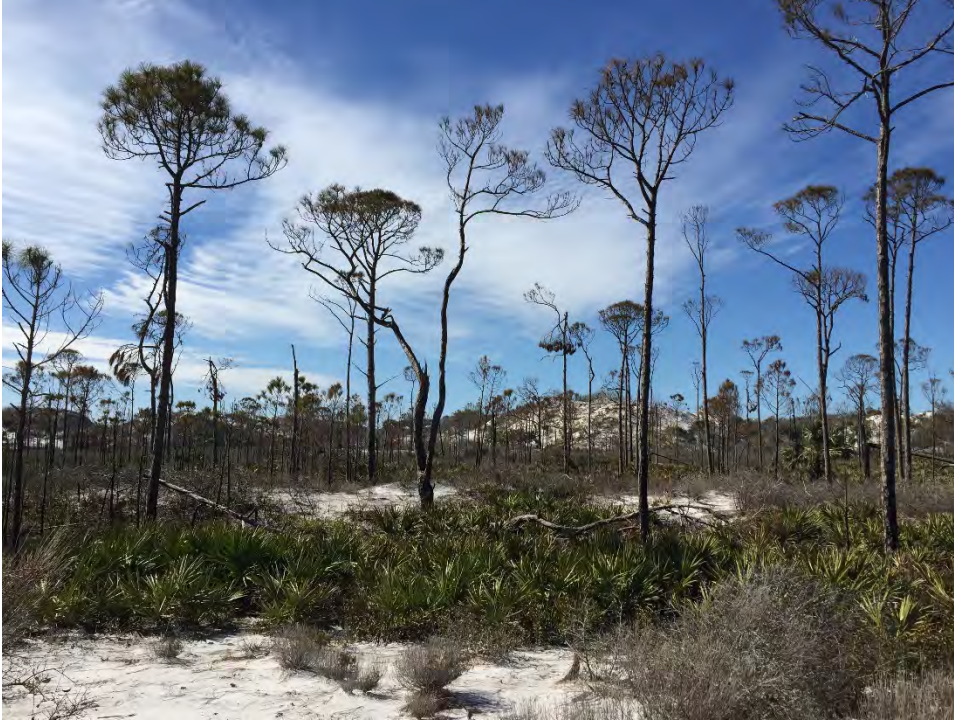
*Figure 115. Tall dune seen from the flatwoods looking east in Zone SJ-09.*

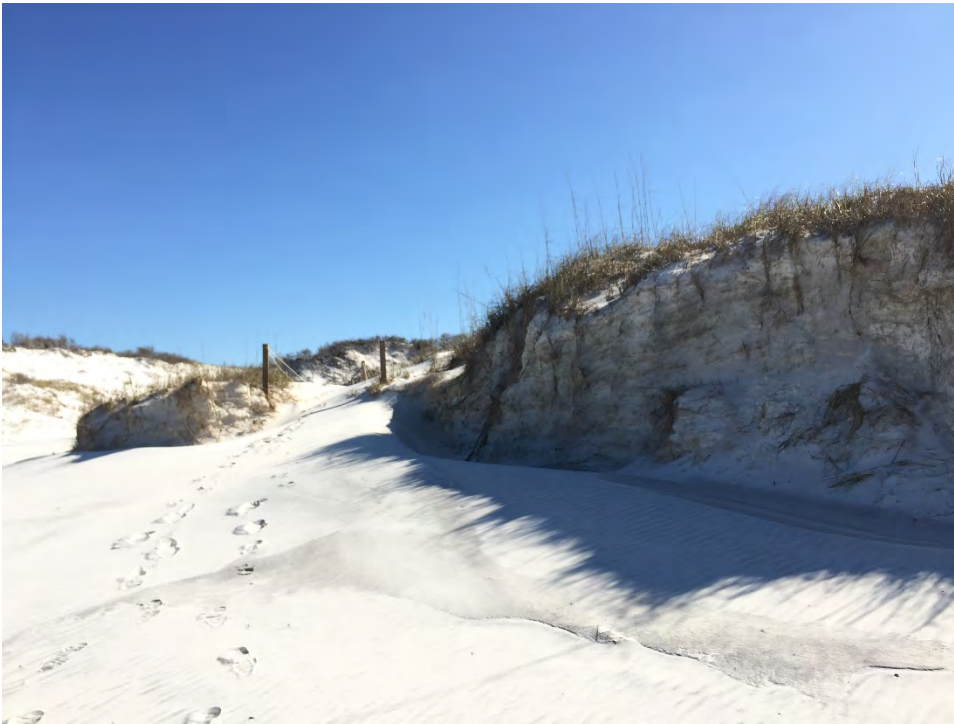
The dune system at SJSP has variable damage. Some of the highest dunes observed during the field survey appeared fairly intact from the landward side (Figure 115) but are sheared off on the ocean side (Figure 116) and some have been completely removed by the force of the wind and water (Figures 117 and 118), leaving a wide flat sand surface where the dunes once stood. In this case, much of the sand was deposited on the vegetated landward side of the dune (i.e., flatwoods).

*Figure 116. Sheared off dune in Zone SJ-09.*

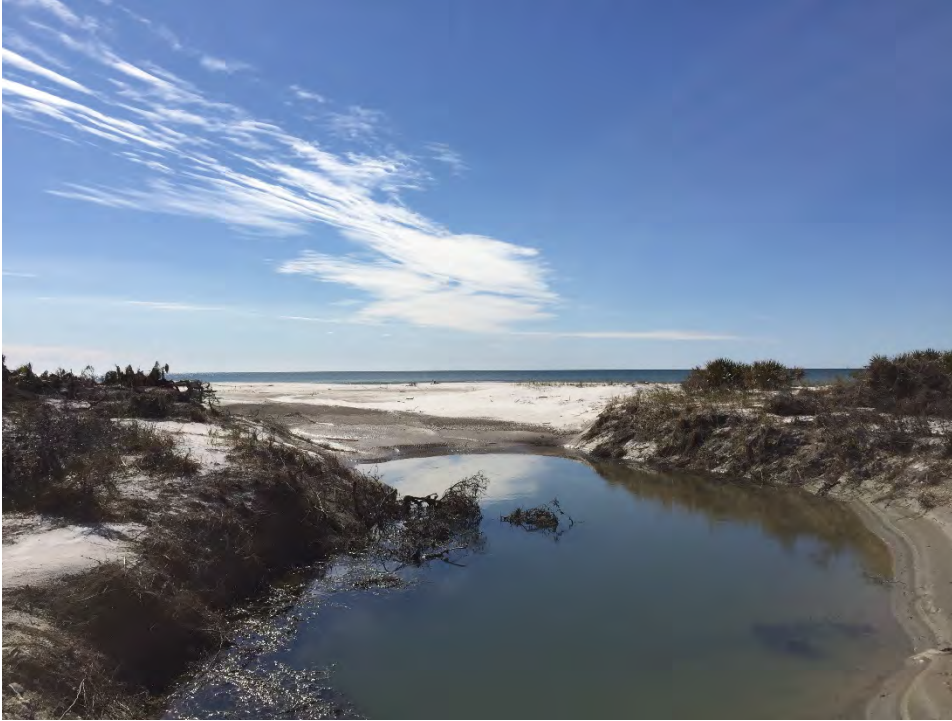
*Figure 117. Area where the dune blew out and the wind actually caused a deep pool of water near where the dune use to be.*

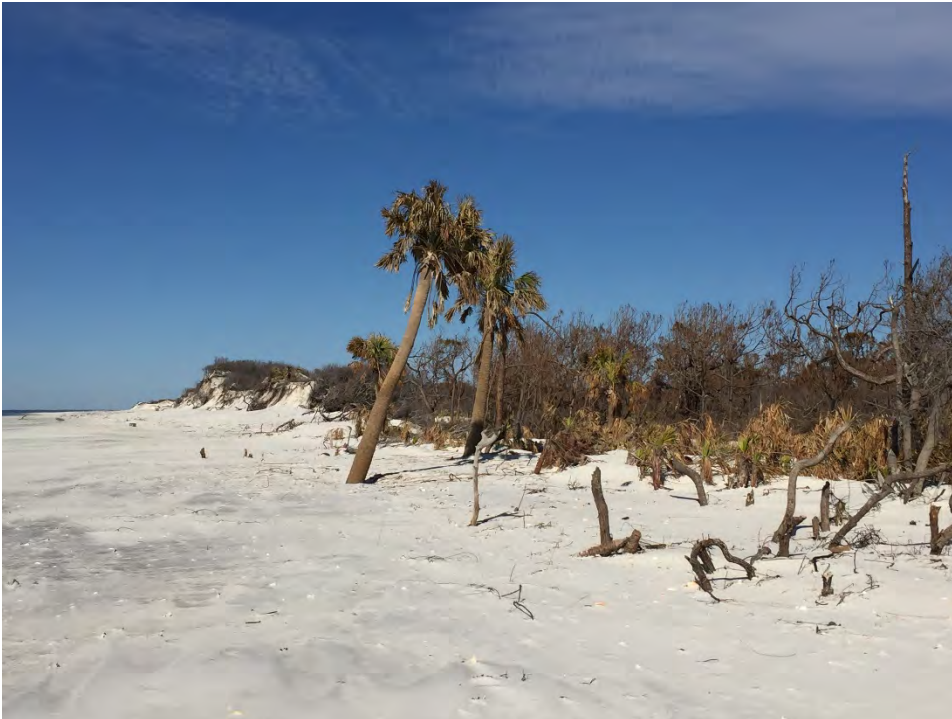
*Figure 118. Area where dune was washed out, vegetation seen here used to be on the back side of the dune.*

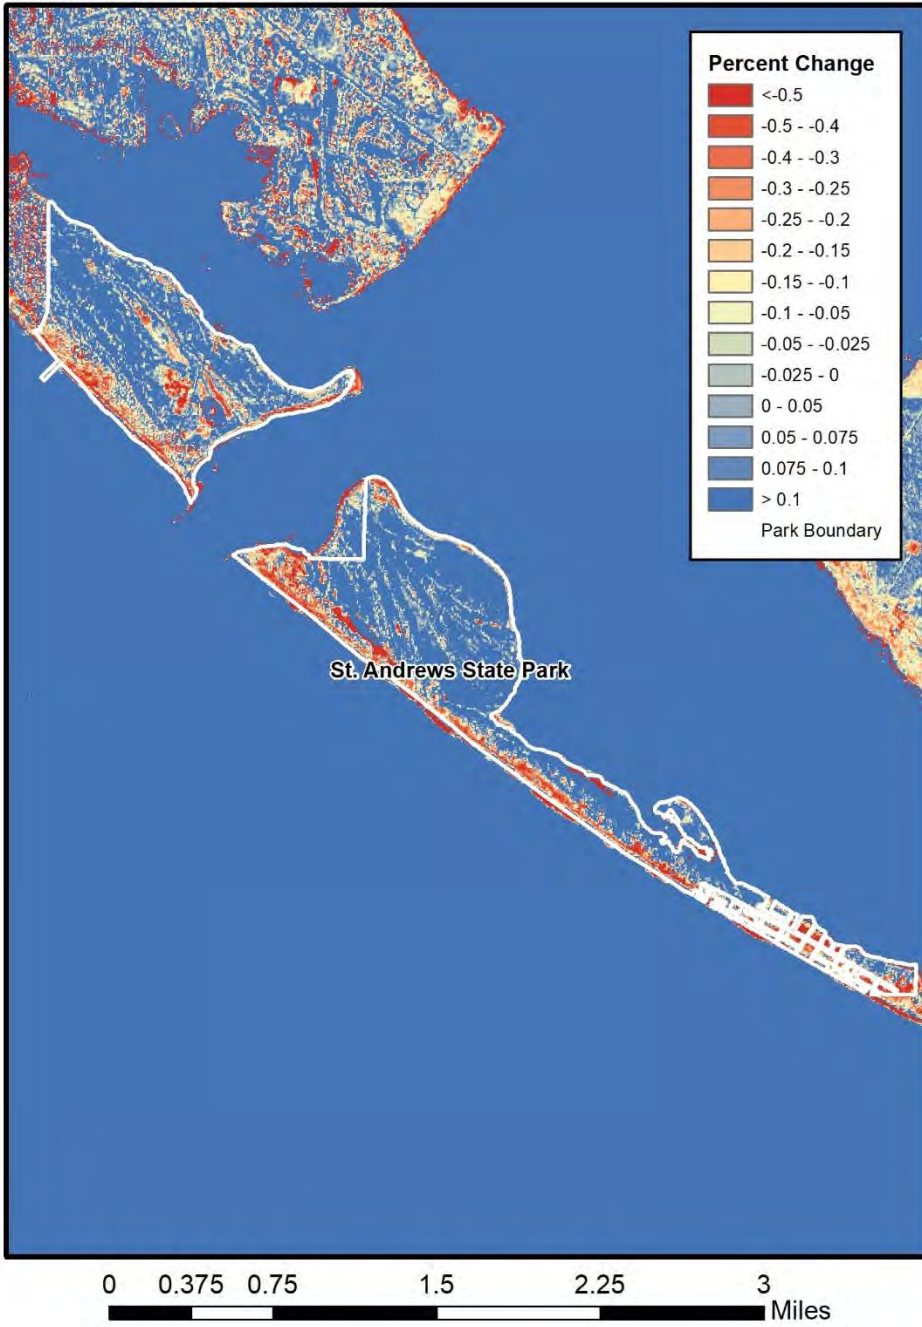
Figure 119. The dNDVI shows relatively low change values indicating light to moderate damage which is consistent with on the ground inspections.

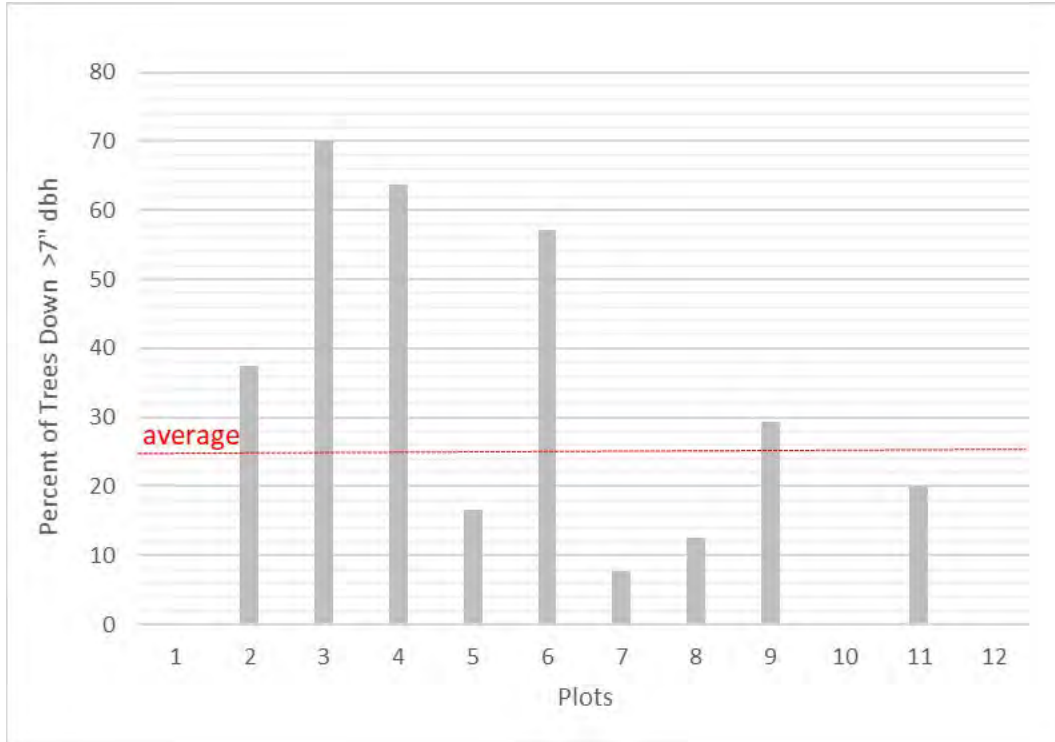
Figure 121. Percent of trees (>7" dbh) down in all plots at St. Andrews State Park.

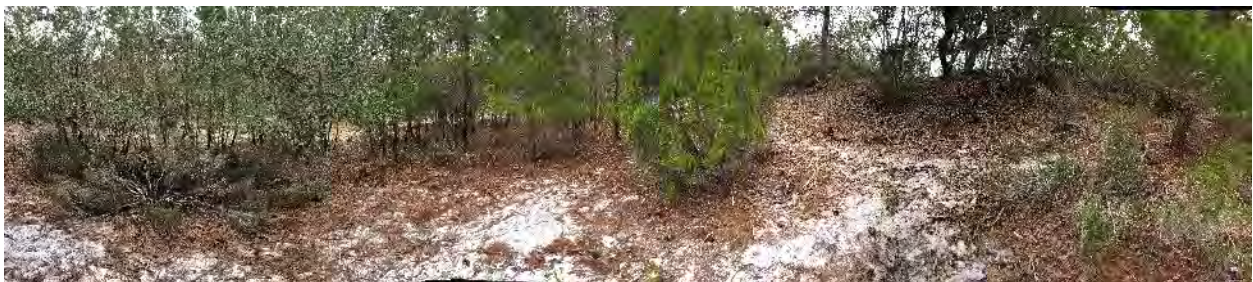
Canopy damage observed during the field assessment in scrub was variable from severe to light (Figures 123-125). The canopy and shrub layers in many scrub stands that were visited had major damage due to salt water. Decadent, older growth sand pines had almost 100% mortality in exposed areas. The sand pine needles were fully browned and likely dead at the time of the field survey. Damaged sand pines with fully browned needles will likely not regenerate but the sand live oaks are likely to resprout. This additional fuel load is expected to increase flammability in areas where extensive damage is present. Reintroducing fire as soon as feasible is the only further restoration the scrub on SASP needs, which is required to attain desired future conditions and mitigate storm related damage.

Figure 123. Light damage to Scrub

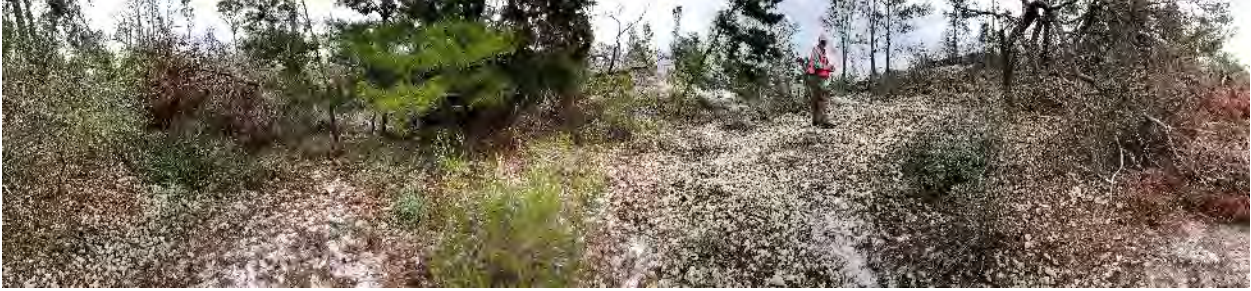
Figure 124. Moderate damage to scrub.

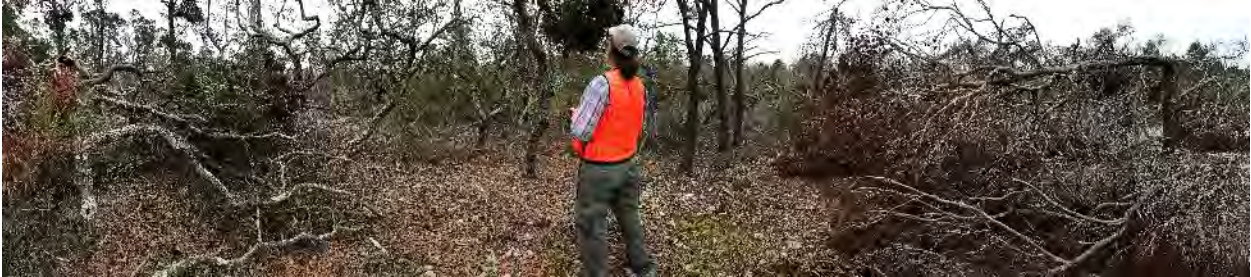
Figure 125. Heavy damage to scrub.

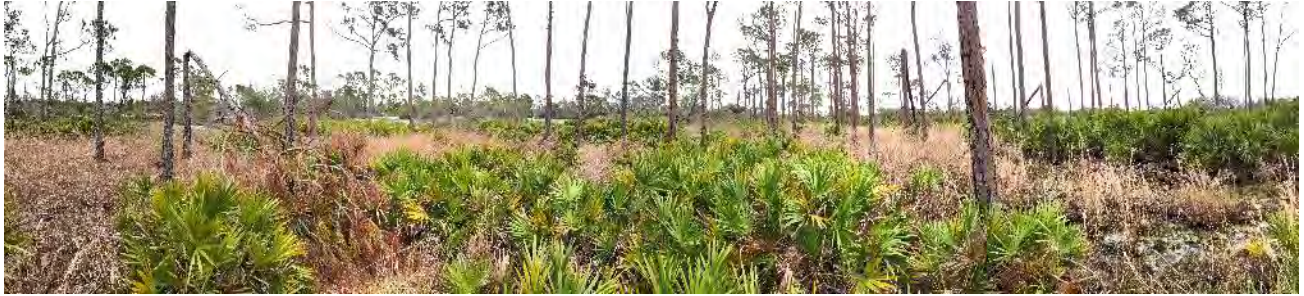
Figure 126. Mesic Flatwoods with light damage (ocean side).

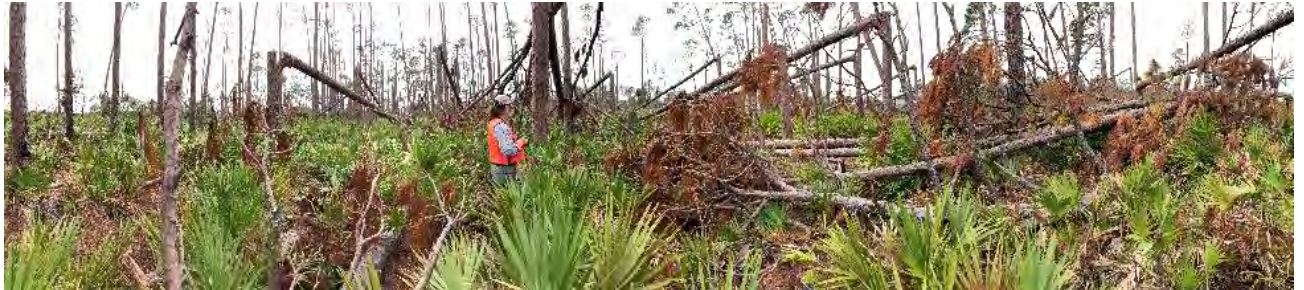
Figure 127. Mesic flatwoods with heavy damage.

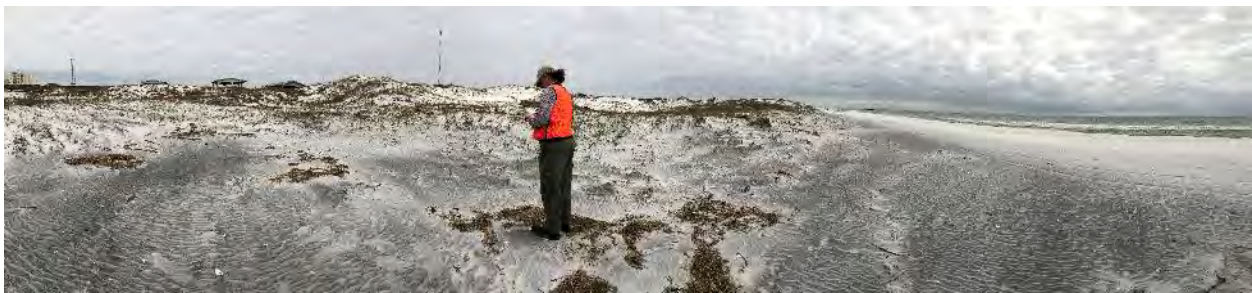
The dune system at SASP has variable damage. The primary dune system has light to severe damage but is generally intact likely due to the northerly winds (Figures 129). The major damage to the dune system was to seaoats and other vegetation. However, because the root system was generally protected it is likely that these dunes will recover more rapidly than those observed in other parks.

Figure 129. Beach dune damage observed at SASP.

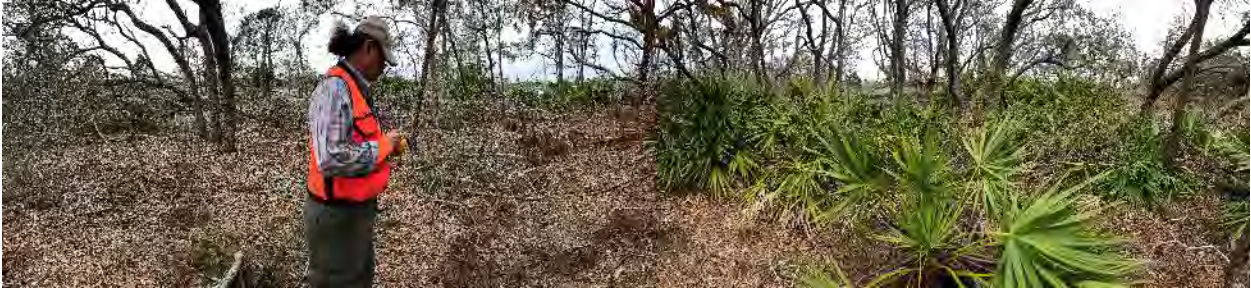
The storm caused variable damage from light to heavy. Heavy damage was generally isolated to small pockets and consisted of heavy canopy thinning with scattered downed trees (Figure 130). The oldest sand pines experienced heavy damage and high mortality. Damage to large sand live oaks consisted of heavy defoliation and limb loss with only occasional downed trees. Small trees of all species were generally undamaged.

*Figure 130. Typical damage observed in maritime/xeric hammock.*
